KOKO (NEE CAMDEN PALACE THEATRE)

Appendix J

Intrusive Structural Investigation Site Reports

The Hope Project – Site Visit Report No.2

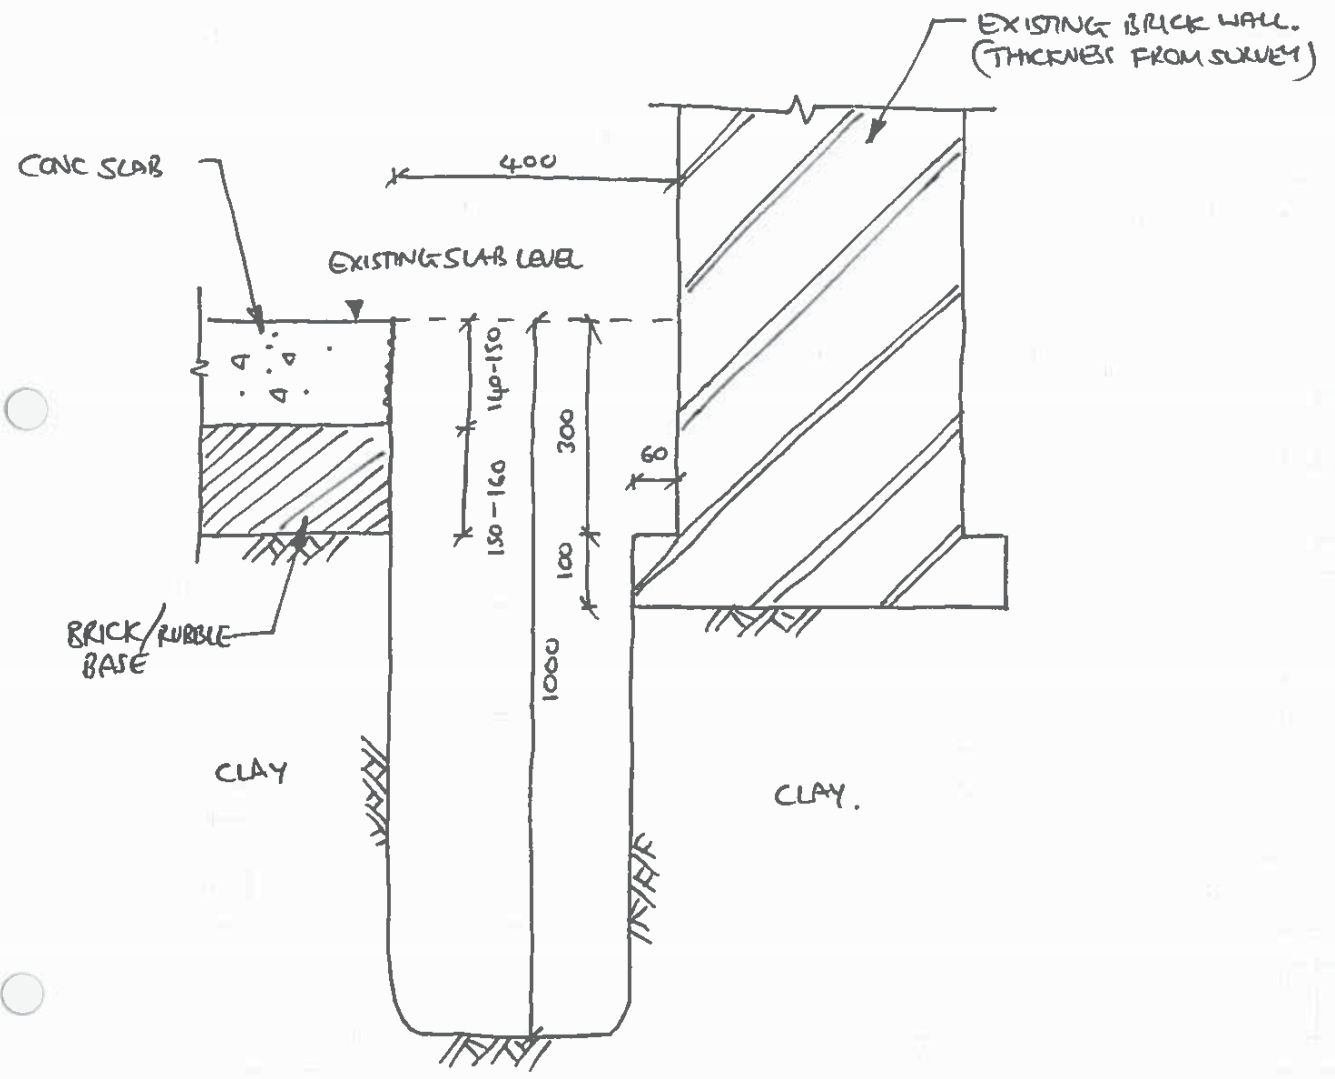
HOPE + ANCHOR TRIAL PIT (B23)
 1:10 @ A4.

1.1 Trial pit exposed load bearing masonry bearing directly on clay approximately 400 mm below existing slab level (location B23)

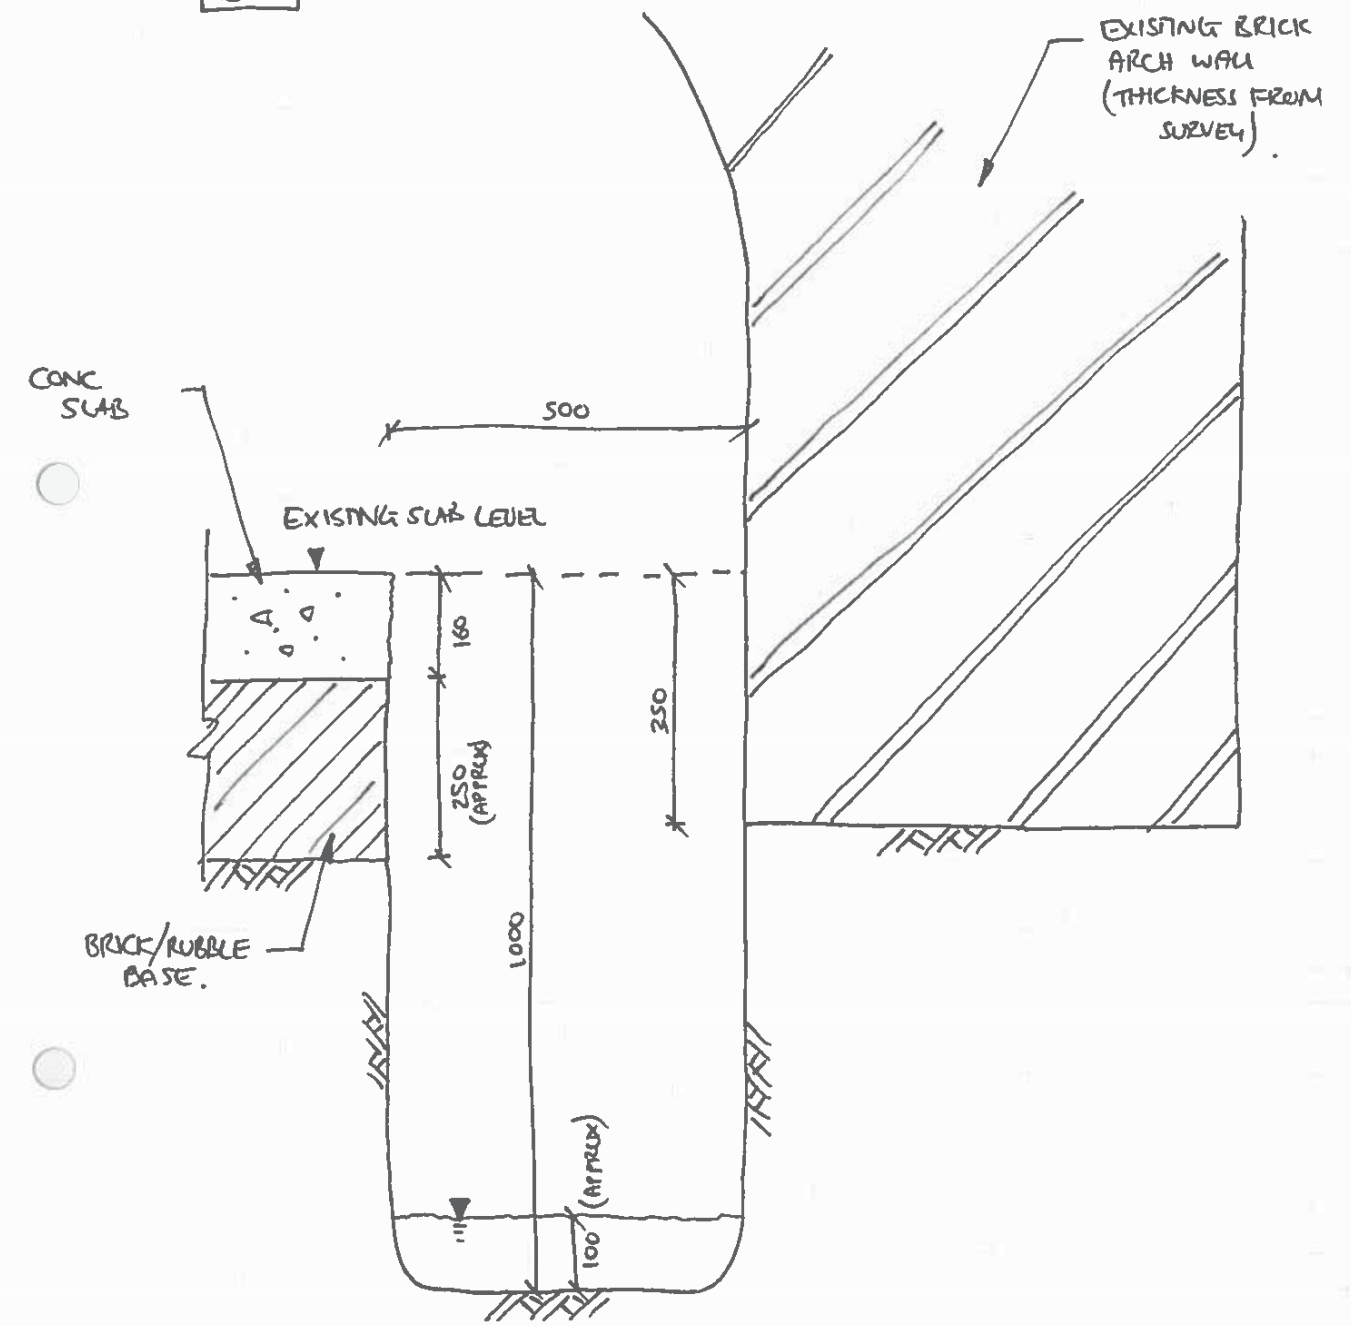
HOPE + ANCHOR TRIAL PIT (B22)
 1:10 @ A4.

1.2 Trial pit exposed load bearing masonry arch wall bearing directly on clay approximately 350 mm below existing slab level (location B22).

Water was observed in the base of the trial pit approximately 900 mm below existing slab level.

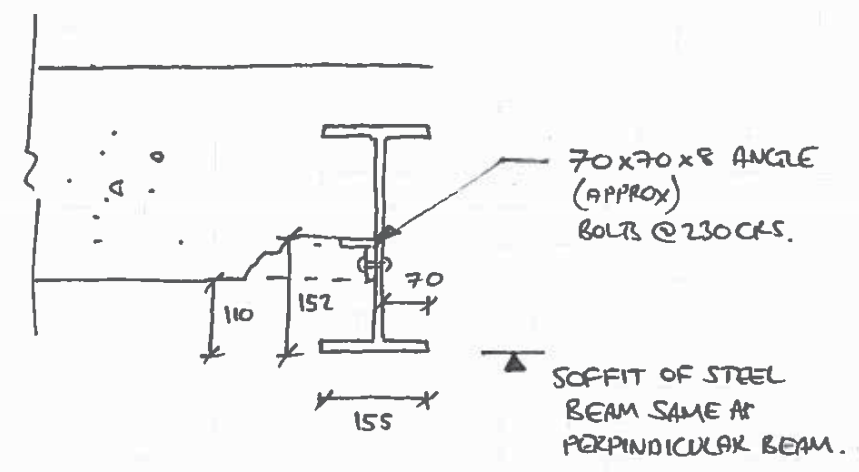
SECTION THROUGH FLAT ROOF BEAM
 1:10 @ A4

2.5 Steel beams supporting flat roof. Steel angles connected to the beam flange supports a concrete slab (filler joist concrete slab assumed). Beam bottom flange has suffered significant corrosion.

2.6 Corrosion of flat roof beam bottom flange.
