**STRUCTURAL REPORT ON THE CONDITION OF THE EXTERNAL WALLS TO NO.99 CAMDEN
MEWS LONDON NW1 9XA**

3.0 Summary

The inspection was carried out by Michael Eatherley on Tuesday 13 January 2015 accompanied and assisted by Mr Stephen Weiss and Michael Brundle, the Architect.

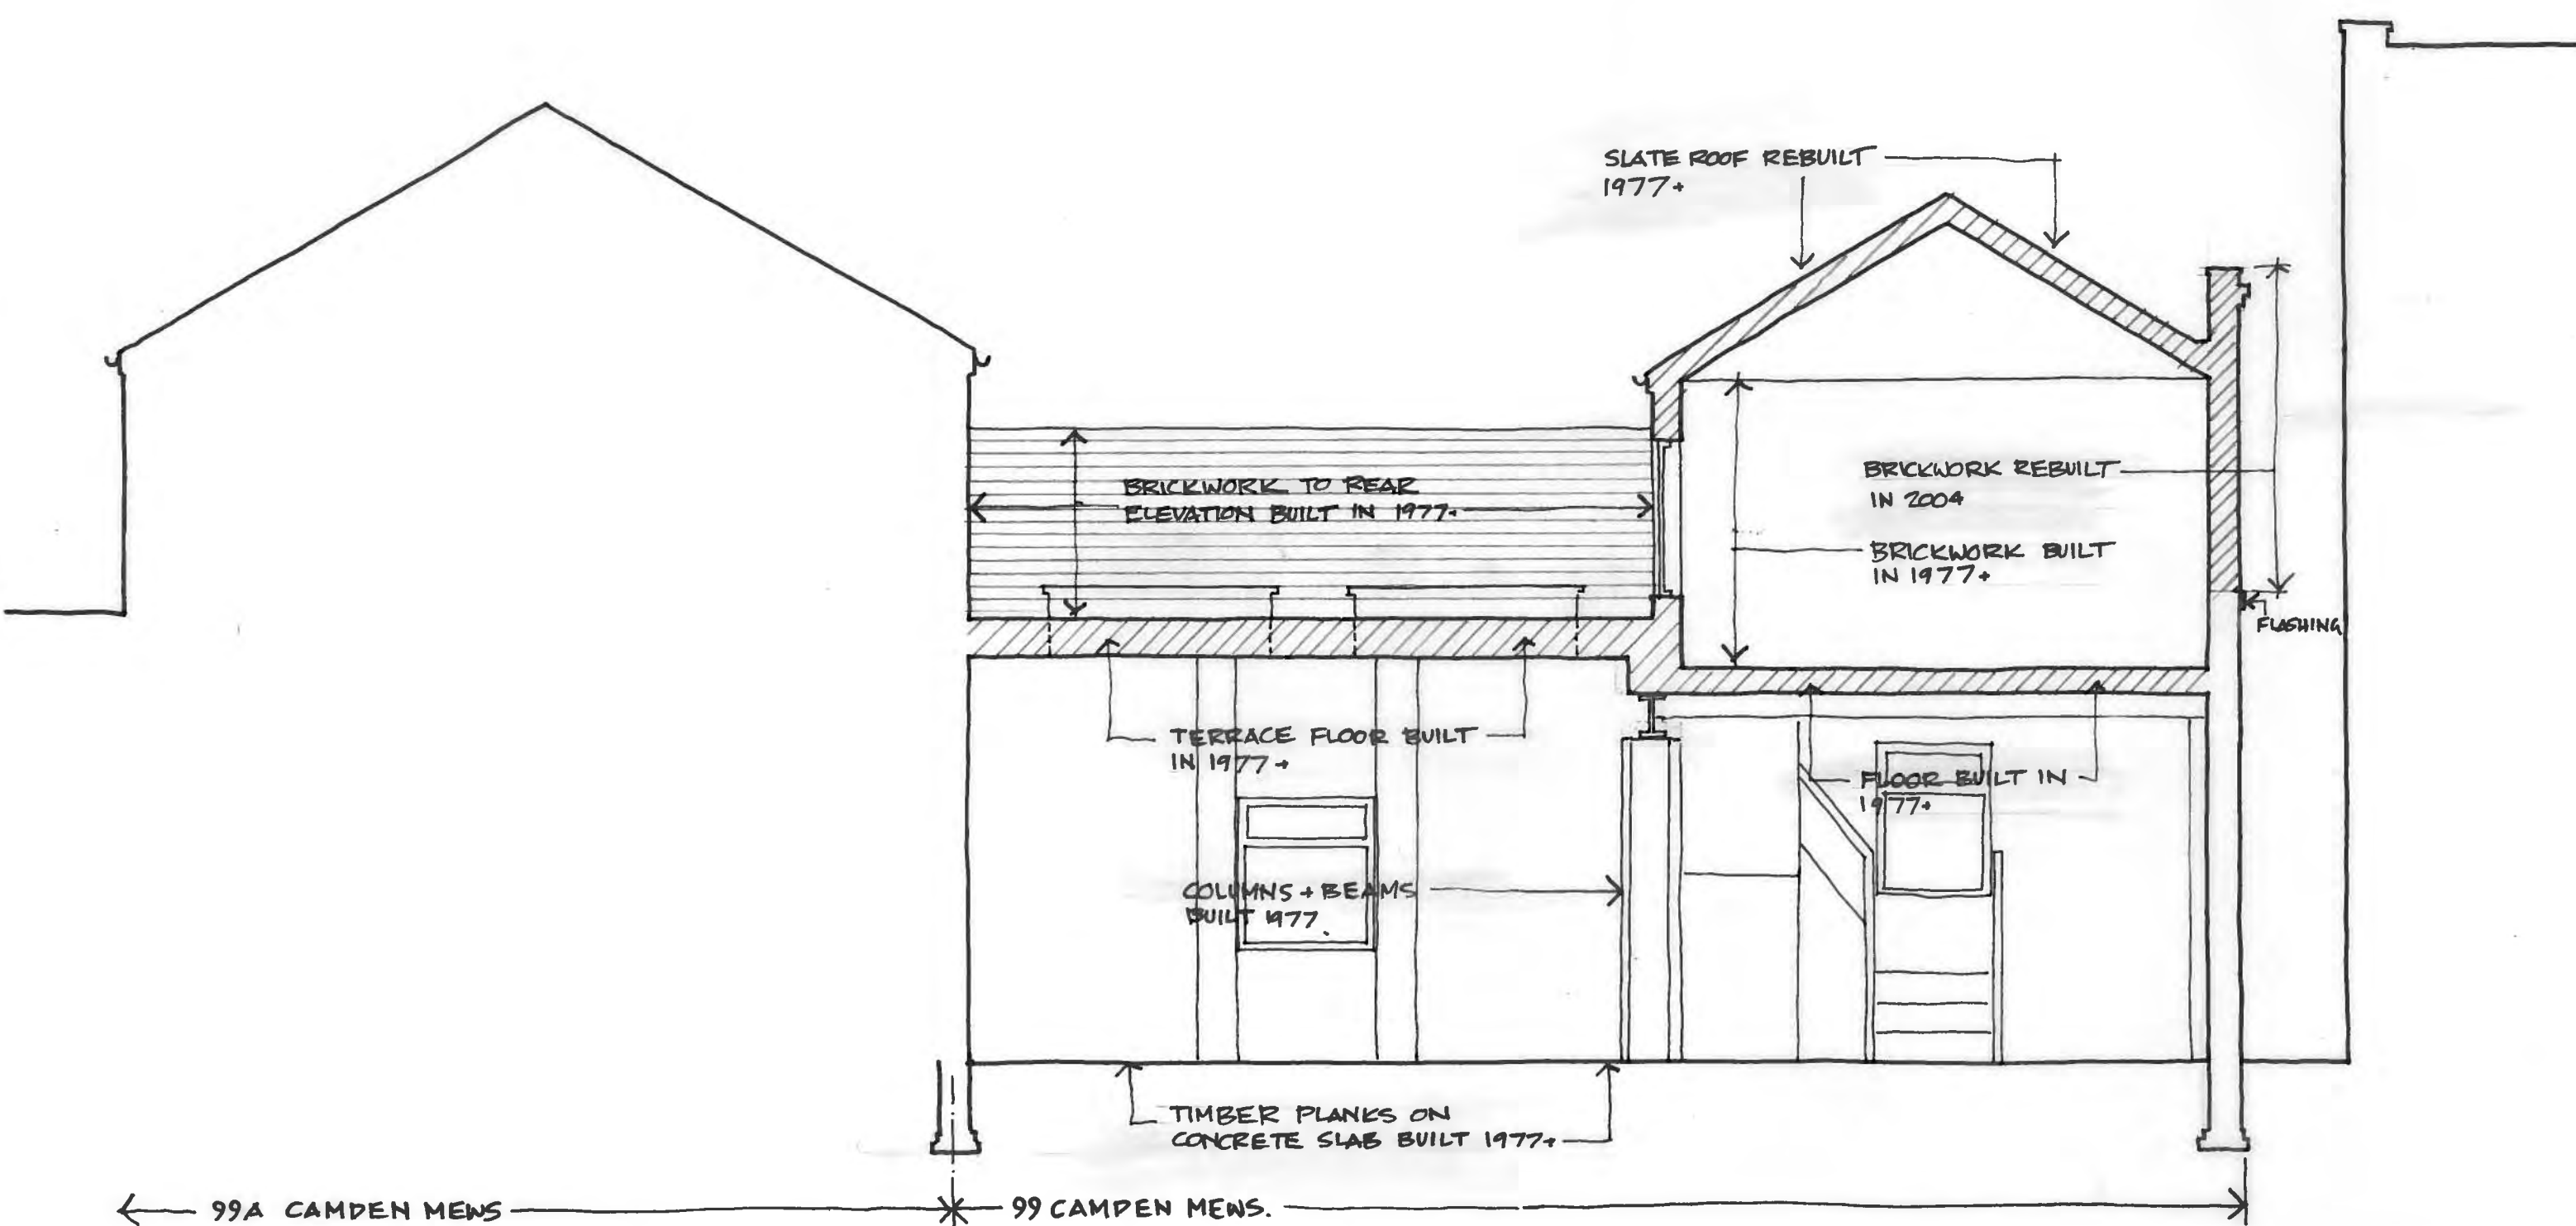
DRAWING. DIFFERENTIATING BETWEEN
19TH CENTURY AND MODERN BUILT FABRIC.
SHOWING CURRENT CONDITION
99 CAMDEN MENS 1:50 @ A3.
DRWG No W-12-004.

The single stock brick wall in Flemish bond of rather poor quality has been much altered since its original construction. The unstable upper part and a lower area loosened by subsidence at the northeast corner were rebuilt in 2007. The horizontal dividing line between the original wall and the new wall above has a line of flashing covering a step in the brickwork. The step is the result of 60 -70 mm bowing out in the middle of the lower wall and the straight modern part above. External steel ties have been installed at three levels as a means of reinforcing the corner brickwork at the back.

Photos from the Party Wall Agreement of 1991 indicate that at some time the front wall continued to the northeast and the presence of corbels at mid height along the flank wall suggest that in the past there must have been a single storey store to the north. The lower part of the wall is very damp that is apparent both outside and inside. The wall has cracks at both ends and poorly repaired in inappropriate cement mortar. The form of the cracks suggests that there may have been slight continuing subsidence since the repairs were carried out.

This wall has large areas of modern intervention and is in poor condition. As it stands it has a limited long term future requiring constant remedial work. In order to provide a “sustainable future”, we consider that, for the proposed redeveloped house, it would be appropriate to demolish the wall, as far as possible saving and cleaning the bricks, and to rebuild on new foundations compatible with the proposed new construction behind. If required, the bricks may be reused and the wall rebuilt with the more accommodating lime mortar.
