Summary Of Structural Assessment And Strengthening Works Required

| project name<br>6 Denmark Street | | | |
| sketch title<br>Proposed Structural Details | | | date<br>20/11/2017 |
| project no<br>879 | sketch no<br>04-XX-LB-S-0001.0 | rev<br>01 | by<br>RK |

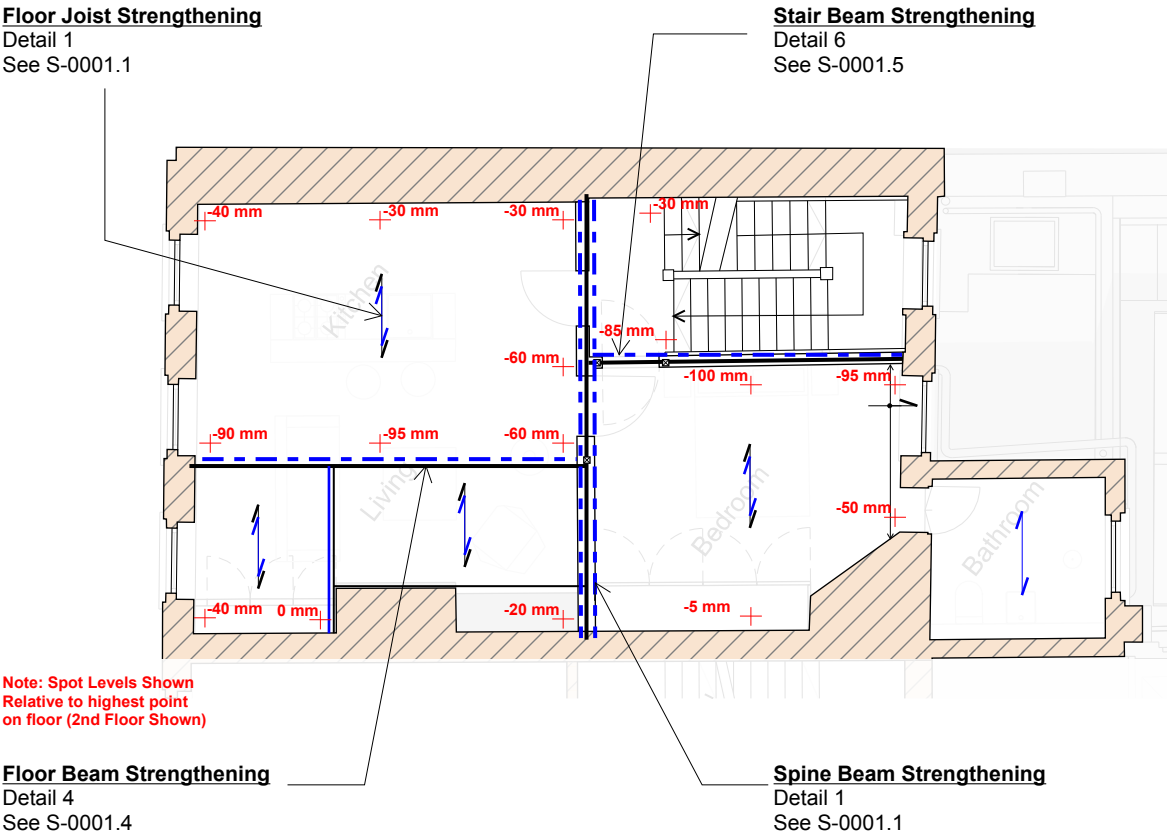
TYPICAL FLOOR PLAN 1ST TO 3RD

- The existing spine wall beam can not be justified to support the required residential loadings to current standards therefore strengthening is required.
- The existing floor joists require strengthening due to comply with current standards and allow for levelling of existing floors
- Generally all structural strengthening proposed will reduce deflections and movements within the building to protect the historic structure and materials from further damage
- Steel beams to bear onto padstones in masonry party walls

- The strengthening is required to allow the waste pipe from the proposed kitchen island unit to run through the floor zone. The island unit is required to avoid any damage to historic wall finishes
- The service run for the kitchen waste pipe will effect a maximum of 3 joists and the spine beam at each level
