BASEMENT PHOTO RECORD

GROUND FLOOR - EXISTING, STRIP OUT & PROPOSED

FIRST FLOOR - EXISTING, STRIP OUT & PROPOSED

SECOND FLOOR - EXISTING, STRIP OUT & PROPOSED

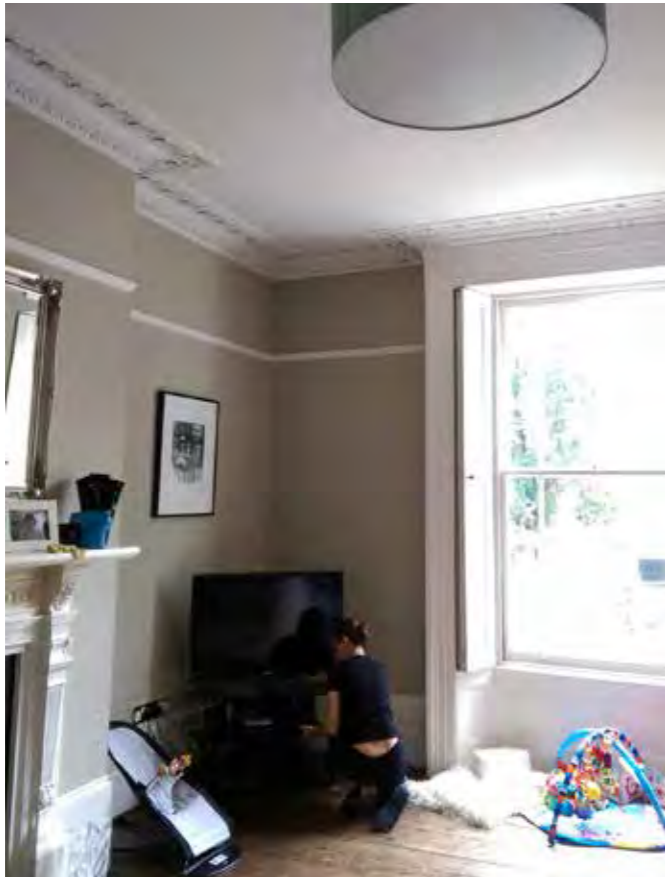
26.1 - Example of similar shutter box in a primary room

Below is an example image alongside some drawings of the type of shutter box similar to what would have been in the primary room of the first floor.
