The Hope Project

Appendix H - Drainage Strategy Report

January 2018 (Rev.02)

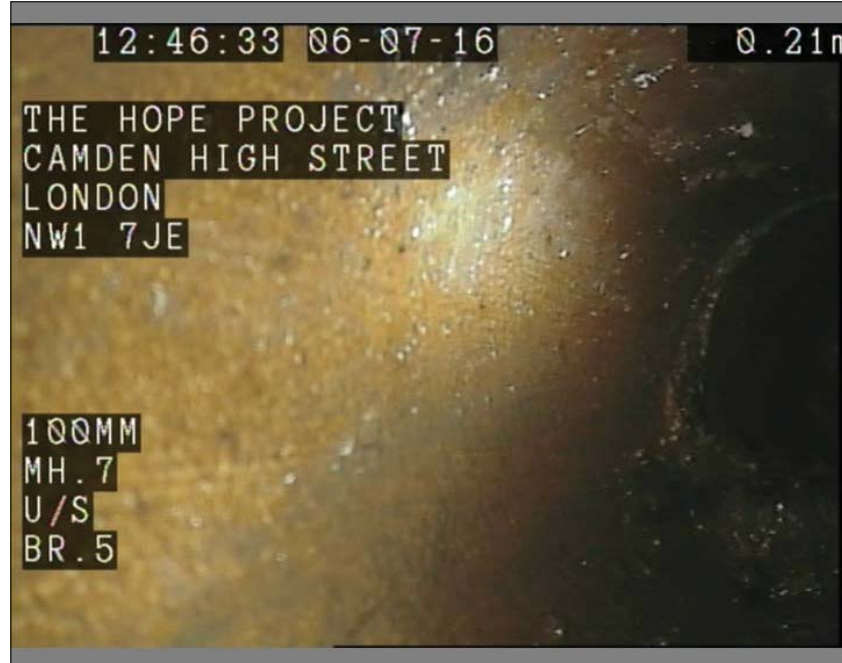
Photo: 23\_23\_147\_A.JPG  
0.21m, Attached deposits, encrustation at joint, from 4 to 7 o'clock, 20% cross-sectional area loss

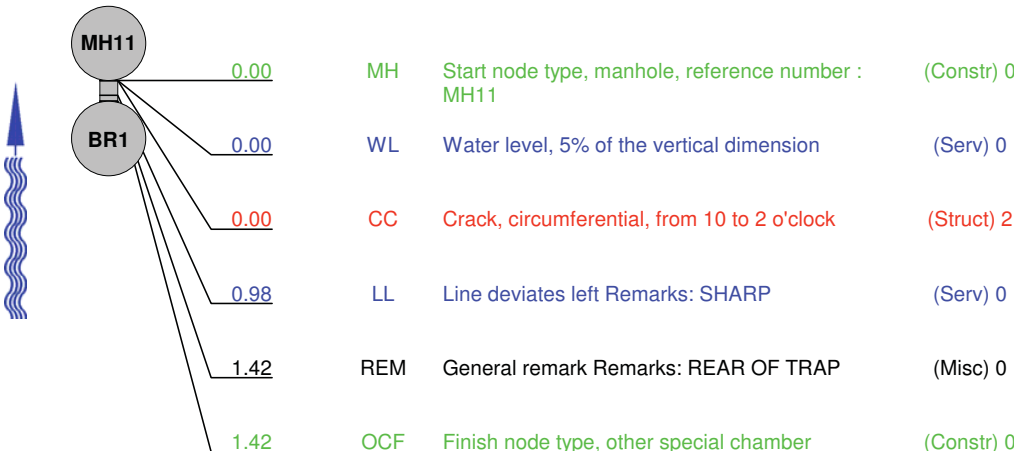
1:500	Position	Code	Observation	Grade
<b>Depth: 1</b>				
	MH11	0.00	MH Start node type, manhole, reference number : MH11	(Constr) 0
	BR1	0.00	WL Water level, 5% of the vertical dimension	(Serv) 0
		0.00	CC Crack, circumferential, from 10 to 2 o'clock	(Struct) 2
		0.98	LL Line deviates left Remarks: SHARP	(Serv) 0
		1.42	REM General remark Remarks: REAR OF TRAP	(Misc) 0
		1.42	OCF Finish node type, other special chamber reference number: BR1 Remarks: REAR OF GULLY TRAP REACHED	(Constr) 0

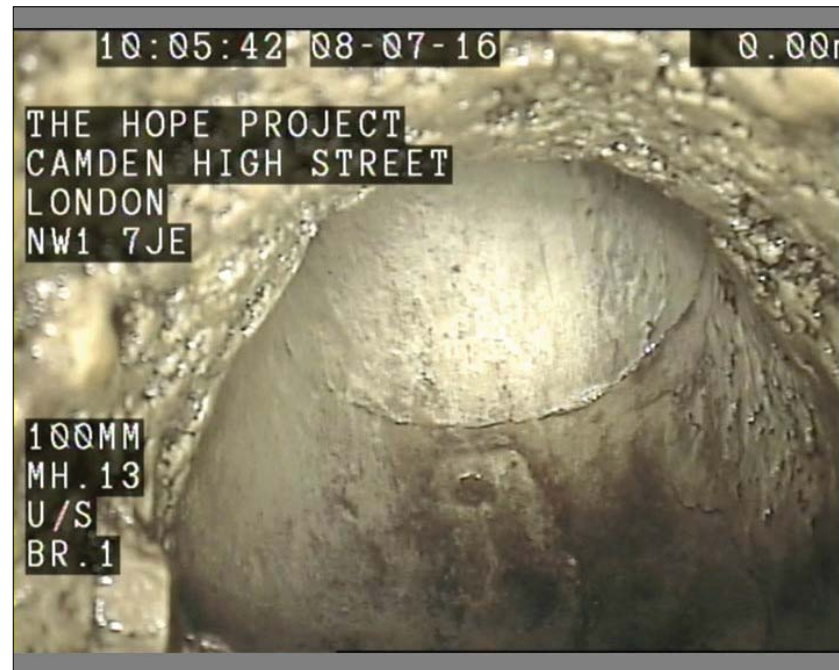
Photo: 29\_29\_193\_A.JPG

0m, Attached deposits, encrustation, from 9 to 2 o'clock, 10% cross-sectional area loss

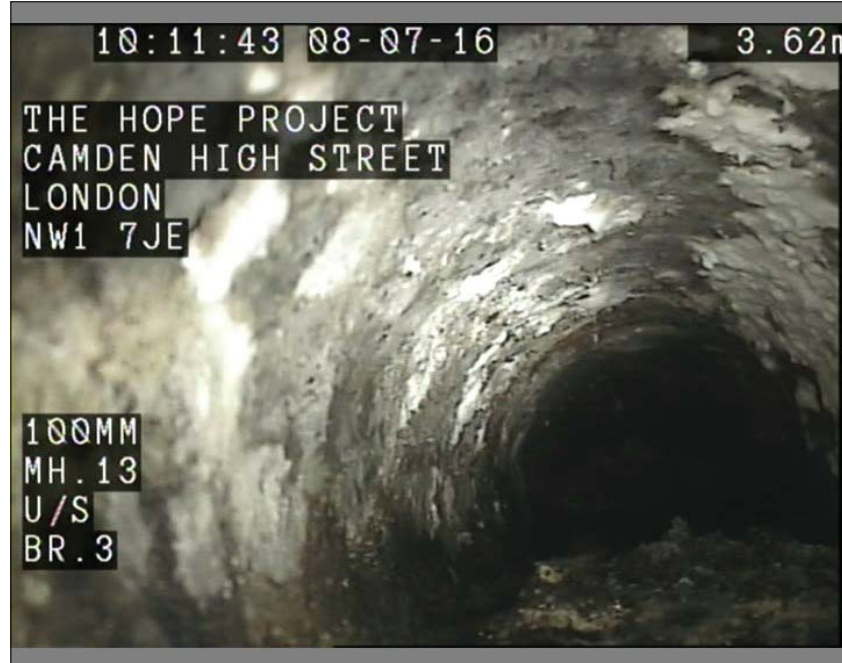
Photo: 31\_31\_205\_A.JPG  
3.62m, Settled deposits, coarse, 10% cross-sectional area loss

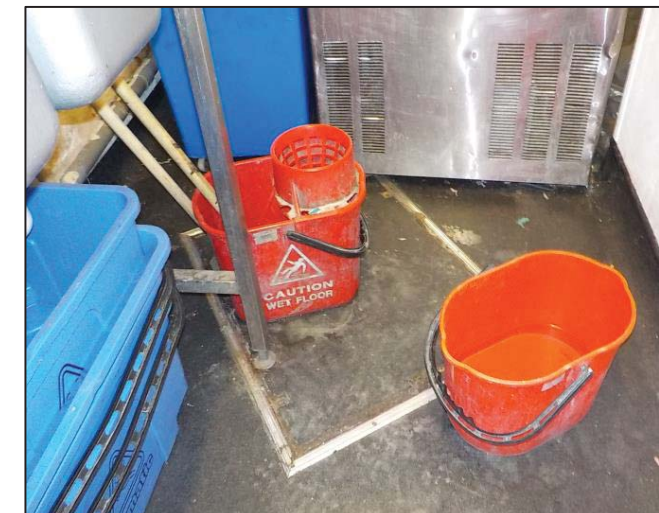
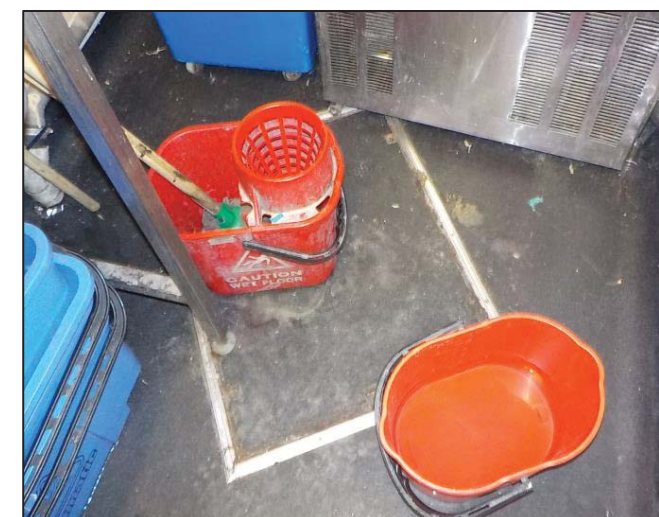
<b>Location</b>	Workshop Underground toilets		<b>Date</b>	7-Jul-2016	
<b>Manhole number</b>	MH9				
<b>Type</b>	OC				
<b>Cover shape</b>	RE	<b>Material</b>	CI		
<b>Cover Duty</b>	M				
<b>Cover Size</b>	570x740	<b>Clear opening</b>			
<b>Cover Condition</b>	Good				
<b>Shaft type</b>			<b>Size of Shaft</b>		
<b>Access</b>	N/A	<b>Access ok</b>	N		
<b>Entry type</b>			<b>Chamber size</b>		
<b>Chamber material</b>			<b>Other material</b>		
<b>Chamber condition</b>	9				
<b>Silt</b>	N	<b>Surcharged</b>	N	<b>Infiltration</b>	N
<b>Toxic</b>	N	<b>Rats</b>	N		
<b>Benching Condition</b>	9				
<b>Channel Condition</b>	9				
<b>Step irons/ladder</b>	9	<b>Cover Level</b>			
<b>Sewer type</b>	CO

<b>Comments</b>	Unable to raise
<b>Drawing</b>	<div style="border: 1px solid black; width: 200px; height: 150px; margin: 10px auto;"></div>

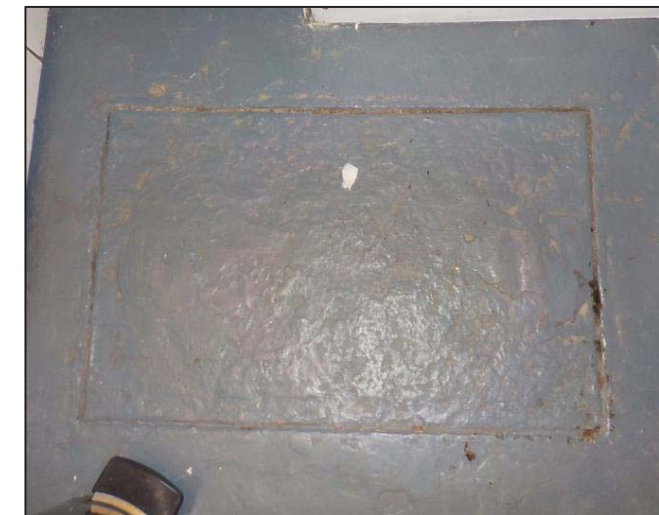
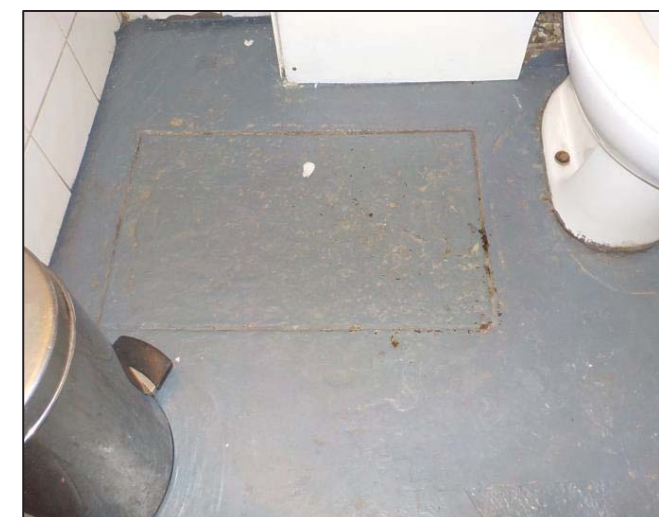
<b>Location</b> <i>Toilet Stairway</i>		<b>Date</b> <i>7-Jul-2016</i>	
<b>Manhole number</b> <i>MH10</i>			
<b>Type</b> <i>OC</i>			
<b>Cover shape</b> <i>RE</i>		<b>Material</b> <i>CO</i>	
<b>Cover Duty</b> <i>H</i>			
<b>Cover Size</b> <i>380x610</i>		<b>Clear opening</b>	
<b>Cover Condition</b> <i>Poor</i>			
<b>Shaft type</b>		<b>Size of Shaft</b>	
<b>Access</b> <i>N/A</i>		<b>Access ok</b> <i>N</i>	
<b>Entry type</b>		<b>Chamber size</b>	
<b>Chamber material</b>		<b>Other material</b>	
<b>Chamber condition</b> <i>9</i>			
<b>Silt</b> <i>N</i>	<b>Surcharged</b> <i>N</i>	<b>Infiltration</b> <i>N</i>	<b>Toxic</b> <i>N</i> <b>Rats</b> <i>N</i>
<b>Benching Condition</b> <i>9</i>			
<b>Channel Condition</b> <i>9</i>			
<b>Step irons/ladder</b> <i>9</i>		<b>Cover Level</b>	
<b>Sewer type</b> <i>CO</i>

<b>Comments</b> <i>Unable to raise</i>
<b>Drawing</b>

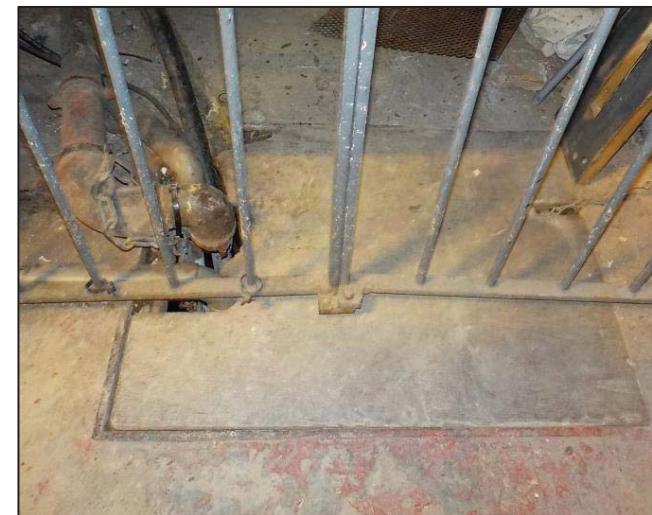
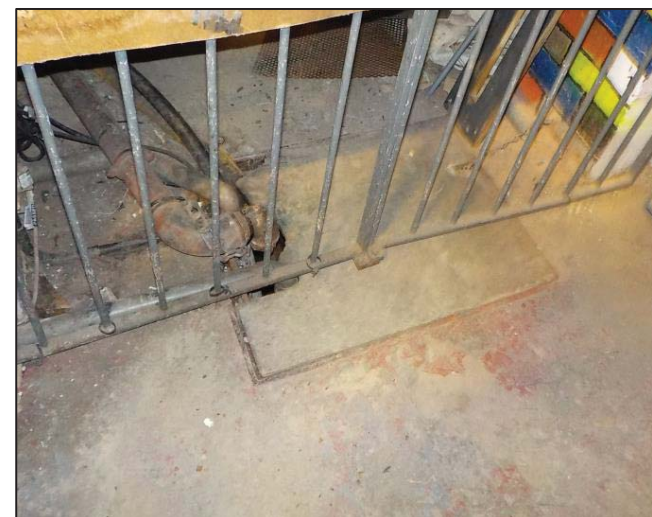
<b>Location</b>	<i>Underground</i>		<b>Date</b>	<i>8-Jul-2016</i>	
<b>Manhole number</b>	<i>MH12</i>				
<b>Type</b>	<i>OC</i>				
<b>Cover shape</b>	<i>RE</i>	<b>Material</b>	<i>CI</i>		
<b>Cover Duty</b>	<i>M</i>				
<b>Cover Size</b>	<i>550x770</i>		<b>Clear opening</b>		
<b>Cover Condition</b>	<i>Good</i>				
<b>Shaft type</b>	<b>Size of Shaft</b>				
<b>Access</b>	<b>Access ok</b>		<i>N</i>		
<b>Entry type</b>	<b>Chamber size</b>				
<b>Chamber material</b>	<b>Other material</b>				
<b>Chamber condition</b>	<i>9</i>				
<b>Silt</b>	<i>N</i>	<b>Surcharged</b>	<i>N</i>	<b>Infiltration</b>	<i>N</i>
<b>Toxic</b>	<i>N</i>	<b>Rats</b>	<i>N</i>		
<b>Benching Condition</b>	<i>9</i>				
<b>Channel Condition</b>	<i>9</i>				
<b>Step irons/ladder</b>	<i>9</i>		<b>Cover Level</b>		
<b>Sewer type</b>

<b>Comments</b>	<i>Unable to raise</i>
<b>Drawing</b>	<div style="border: 1px solid black; width: 200px; height: 150px; margin: 10px auto;"></div>
