# Kidderpore Summer House

Final Report December 2017

Report prepared for:  
Mount Anvil

**OBJECT:** Timber framed and clad. Cast, sectioned concrete columns. Terracotta tiled floor, all sited on a concrete base.

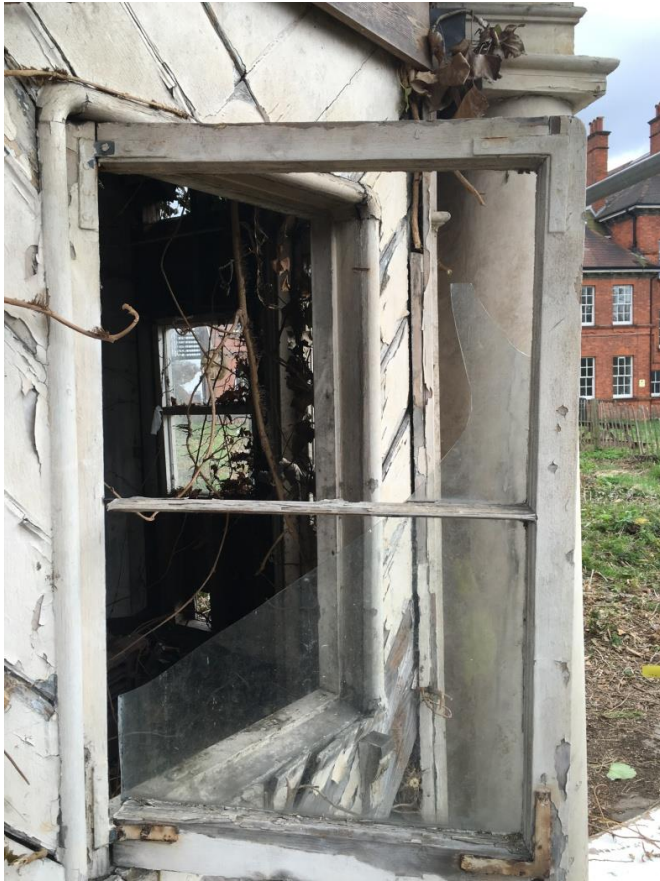
**Fig 9. Mouldings to front of frame**

The original window, in the left-hand panel to the portico, was a simple traditionally designed, single, opening casement window with one horizontal glazing bar (*fig 7*). The sill was extended and supported by brackets attached to the external boarding (*fig 8*). Rounded, planted-on mouldings were fixed to the front of the frame to extend it past the external cladding (*fig 9*). At the joint of these mouldings, between stiles and top rail, were quarter round blocks thus removing the sharp corner of the joint. The top rail of the casement had rounded corners corresponding to the rounded blocks (*fig 10*). The right window was clearly a crude, later replacement and had no redeeming features (*fig 11*).

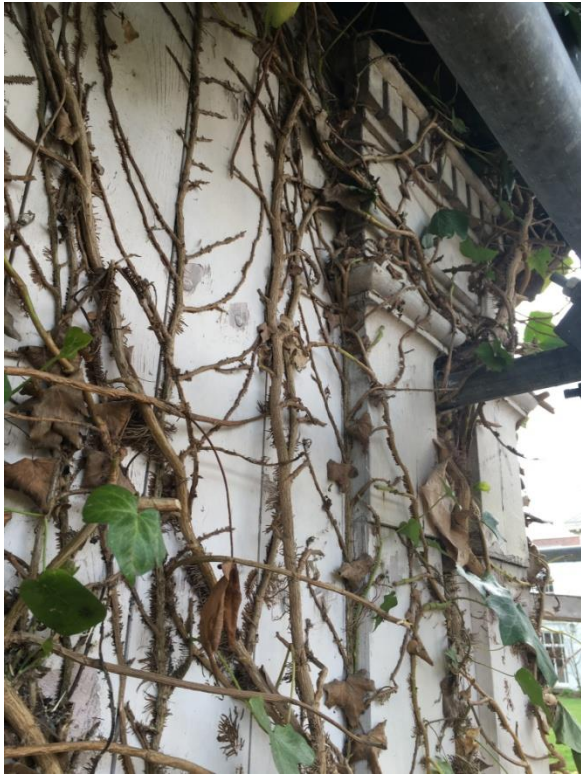
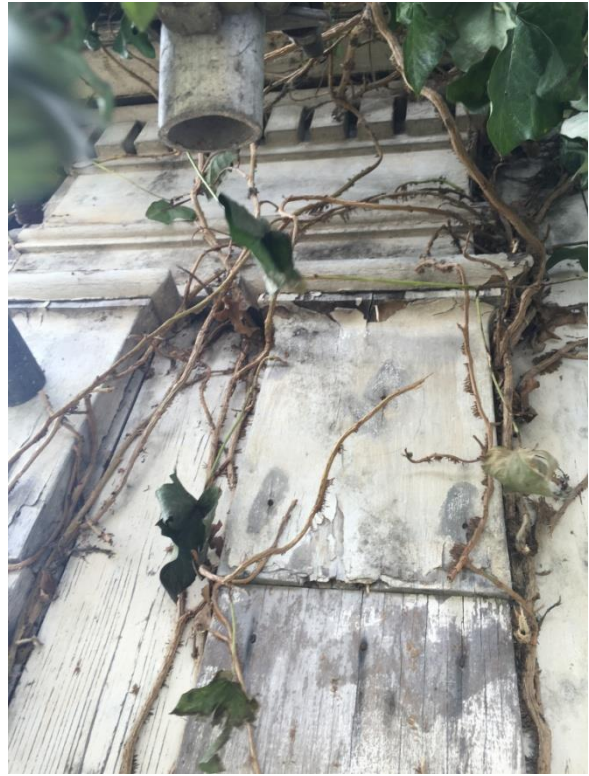
**Fig 14 &15. SW Pilasters**

These elevations were clad with three types of soft wood vertical boarding. TG&V, TG & beaded (TG&B) and plain tongued and grooved (T&G) boards (*fig 12&13*). The bulk of these elevations were clad with wide (6 inch) T&G boarding with the two rear, radiused corners clad in narrow (3 inch) TG&B boards. From the surveyed boards we were unable to conclude which style of boarding was original (if any) because of the sacrificial nature of timber cladding (*fig 14&15*). As stated before a pair of SW pilasters are the only significant feature on the front ends of the side panels.

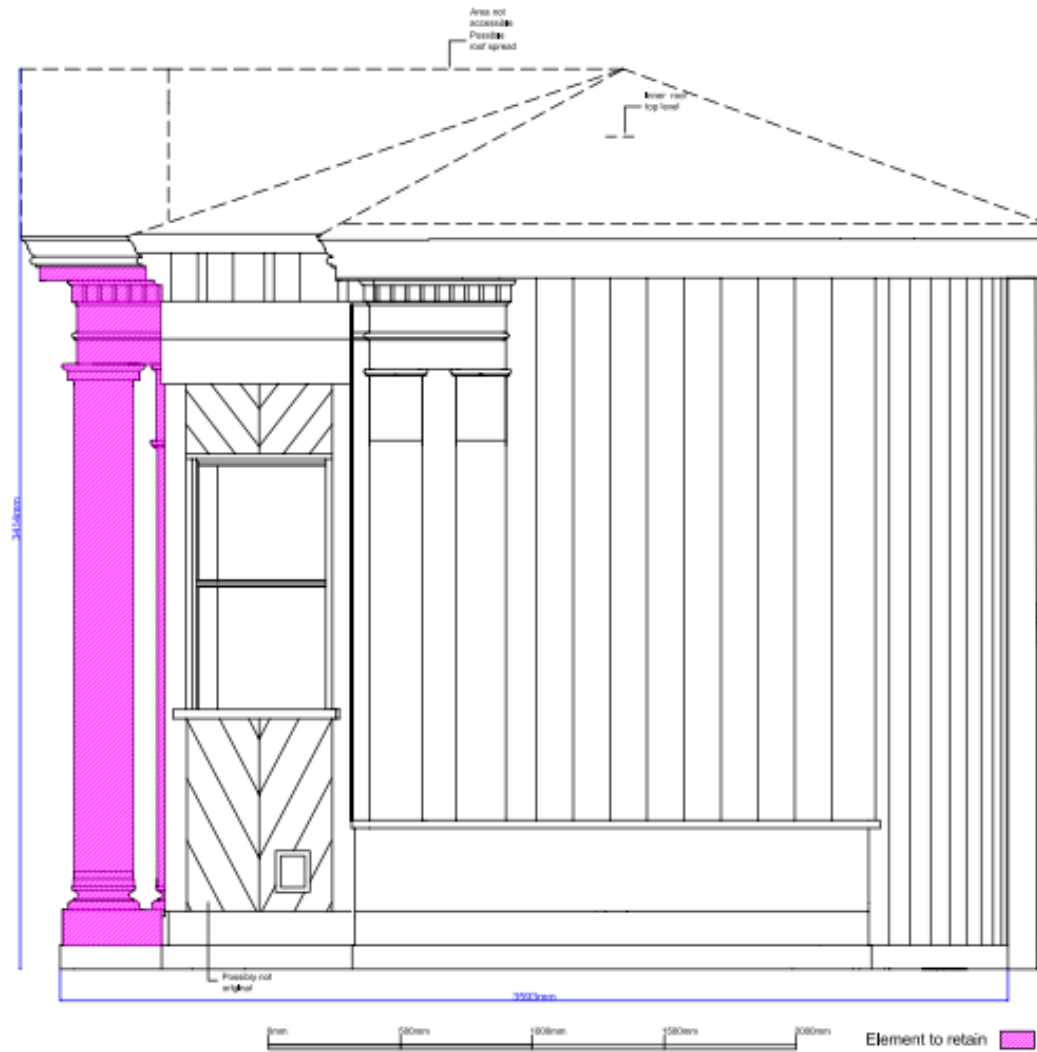
Dwg 03  
Scale 1:10 @ A2

The following drawings show the elevations of the Pavilion. The areas hatched in pink show the surviving elements of the Summer House that were made available to us after the controlled removal of all asbestos in the building. These elements have been coated in many layers of paint over its lifetime and will need to be carefully stripped to reveal the condition of the timber beneath before we can assess their condition. Under visual inspection and for the purpose of this report, it appears that the surviving material is in a good condition with only minor repairs required.

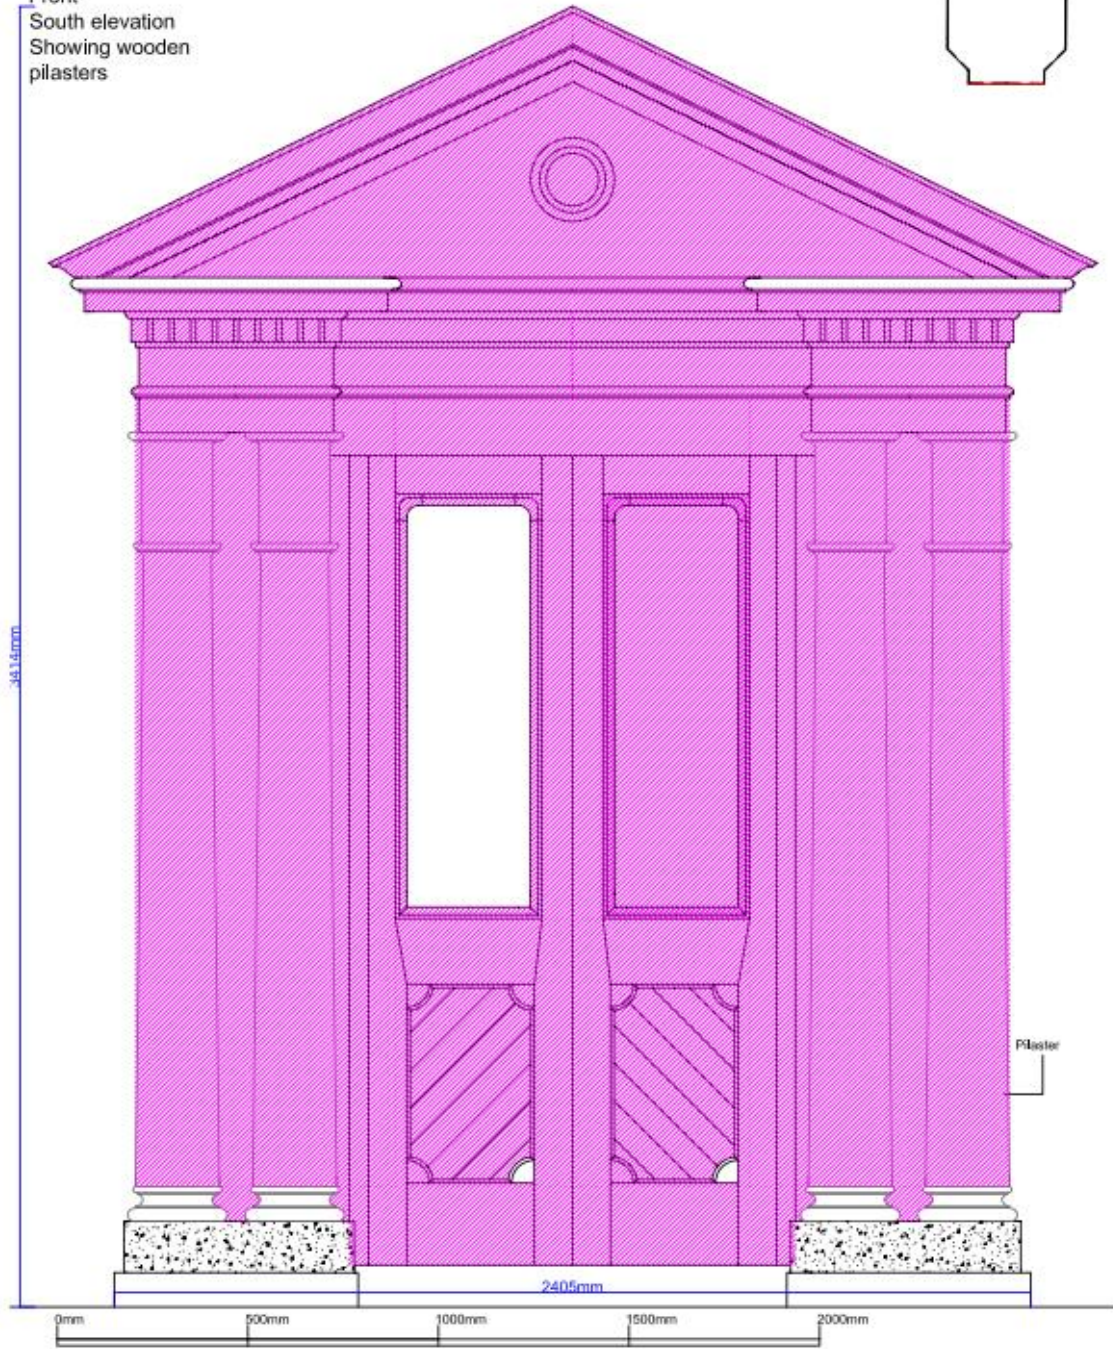
Dwg 02  
 Scale 1:10 @ A3

Kidderpore  
 Summerhouse  
 Front  
 South elevation  
 Showing wooden  
 pilasters

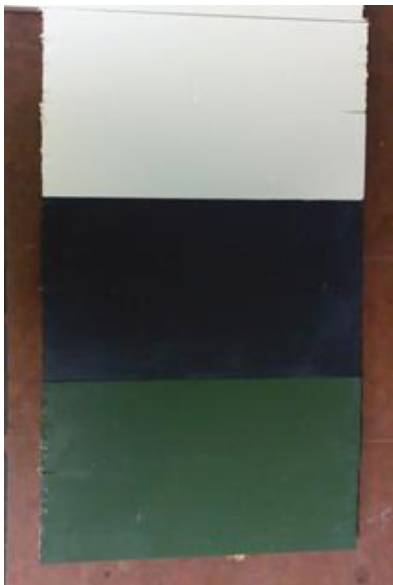
The Samples in Little Green, in order 1,3,2. Painted onto construction grade pine.

1. S6020-G30Y (Dark green) in Little Greene Tom's Oil Eggshell
2. Lead White EH 57 in Little Greene Tom's Oil Eggshell
3. Jack Black 119 in Little Greene Tom's Oil Eggshell (this is to represent the black found on the column base so we would propose using KEIM in this instance)

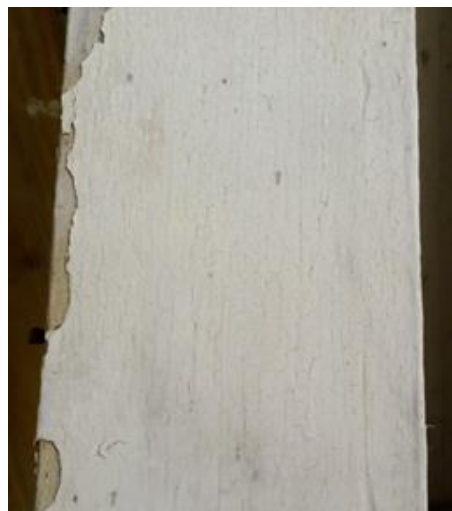
The existing paint scheme on the Summerhouse. Please note we would not recommend using this as a reference point, please read the paint analysis in Appendix 1.

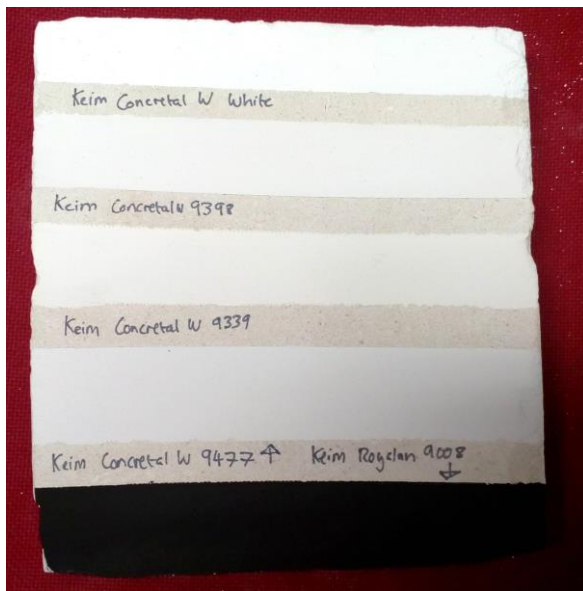
Samples of Keim painted on a piece of Portland Stone. Keim Royalan was chosen for the black colour because Concretal does not have a strong black in their colour range.
