ARBORICULTURAL ASSESSMENT REPORT

For:	Client:	Cunningham Lindsey (Maidstone)
	Insurer:	[REDACTED]
Site:	Policyholder:	[REDACTED]
	Risk Address:	54 Compayne Gardens, London, NW6 3RY
Refs:	OCA Ref:	63797
	Client Ref:	[REDACTED]
	Insurer Ref:	[REDACTED]

Arborist Name:	Thomas Peppiatt	Date:	25/07/2017
-----------------------	-----------------	--------------	------------

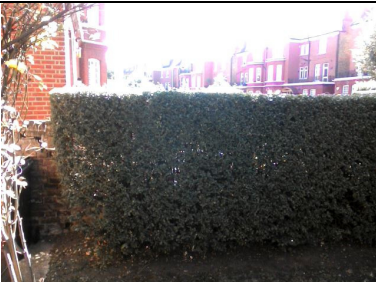
<p>H1 - Privet</p>	<p>H2 - Privet</p>

Tree No	Common Name	Age Class	Condition	Height (m)	Crown Spread (m)	Stem diam. (mm)	Dist to bldg. (m)	Pruning history	Recommendation	Tree work constraints	Notes	Owner address	Owner
H1	Privet	Mature	Fair	1.8	0.6	50	0.5	Trimmed regularly	No work required			54 Compayne Gardens, London, NW6 3RY	PH
C1	Rose (Climbing)	Mature	Fair	8	6	50	0.1	Pruned regularly	No work required			54 Compayne Gardens, London, NW6 3RY	PH
C2	Clematis	Mature	Fair	2.2	8	5	0.5	No significant past tree works	Fell close to ground level (approx 50mm)		On fence. Could be policy holders.	54 Compayne Gardens, London, NW6 3RY	PH
G1	Mixed Species Rose, Ivy, Holly	Mature	Fair	2	1.0	5	3.5	Pruned regularly	No work required			54 Compayne Gardens, London, NW6 3RY	PH
G2	Mixed Species	Mature	Fair	18	10	500	20	No significant past tree works	No work required		Woodland area, with Ash, London Plane, Lime,	Local Authority	LA
H2	Privet	Mature	Fair	1.8	0.50	50	0.5	Managed Hedge.	No work required			54 Compayne Gardens, London, NW6 3RY	PH

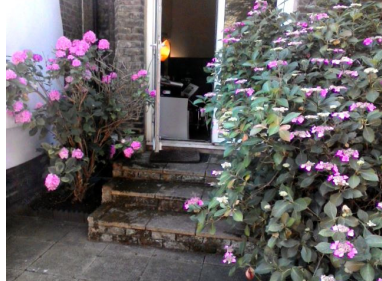
SG3 - Hydrangea

Tree No	Common Name	Age Class	Condition	Height (m)	Crown Spread (m)	Stem diam. (mm)	Dist to bldg. (m)	Pruning history	Recommendation	Tree work constraints	Notes	Owner address	Owner
H3	Privet	Mature	Fair	2.5	0.50	30	0.5	Managed Hedge.	No work required			56 Compayne Gardens, London, NW6 3RY	P3P
SG3	Hydrangea	Mature	Fair	2	2	50	0.5	Managed Shrub group.	No work required		X2 Hydrangea.	54 Compayne Gardens, London, NW6 3RY	PH
