CLIENT Venoru Ltd	
PROJECT 49 Marchmont Street, WC1N 2AN	
DRAWING CONDITION SURVEY REAR ELEVATION	
DRG. No 34	REVISION -
SCALE 1:50 @ A3 PAPER	DATE 11 Jan 2018

EXISTING REAR ELEVATION

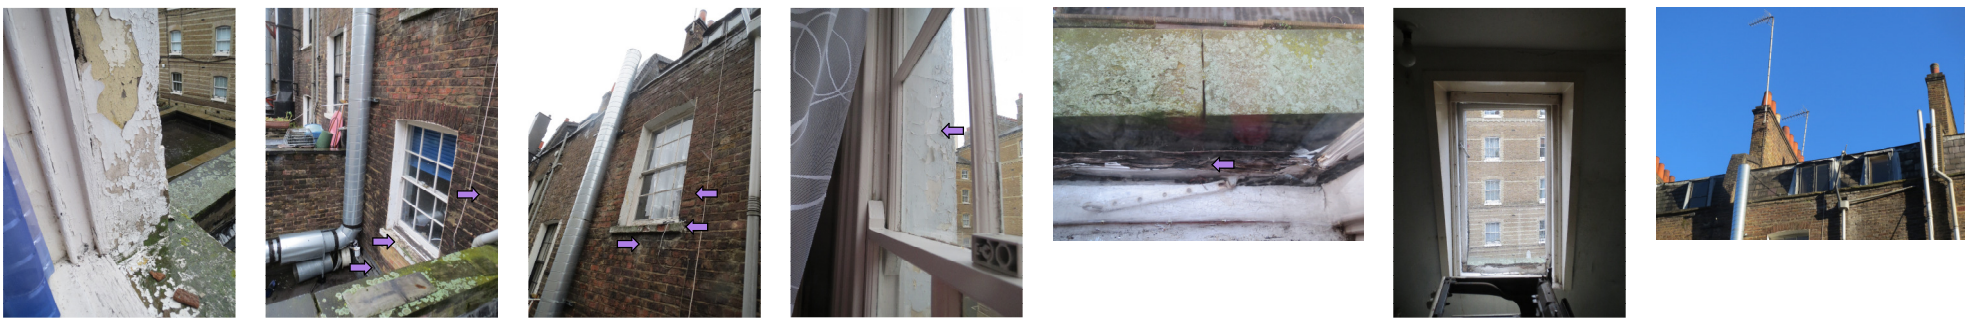
WINDOWS - condition of rendered reveals poor - render flaky and de-bonded allowing water ingress behind, sub sills - surface friable; external timber sills very poor, paint finish missing, rot to bottom rails - sanding back, filling and redecoration recommended
