SUMMARY - TIMBERS IN VERY POOR CONDITION IN FRONT AREA - ROOF EXPOSED TO WATER INGRESS

CLIENT Venoru Ltd.	
PROJECT 49 Marchmont Street, WC1N 1AP	
DRAWING CONDITION SURVEY fourth (attic)plan	
DRG. No 31	REVISION -
SCALE 1:50 @ A 3 paper	DATE 12 jan 2018

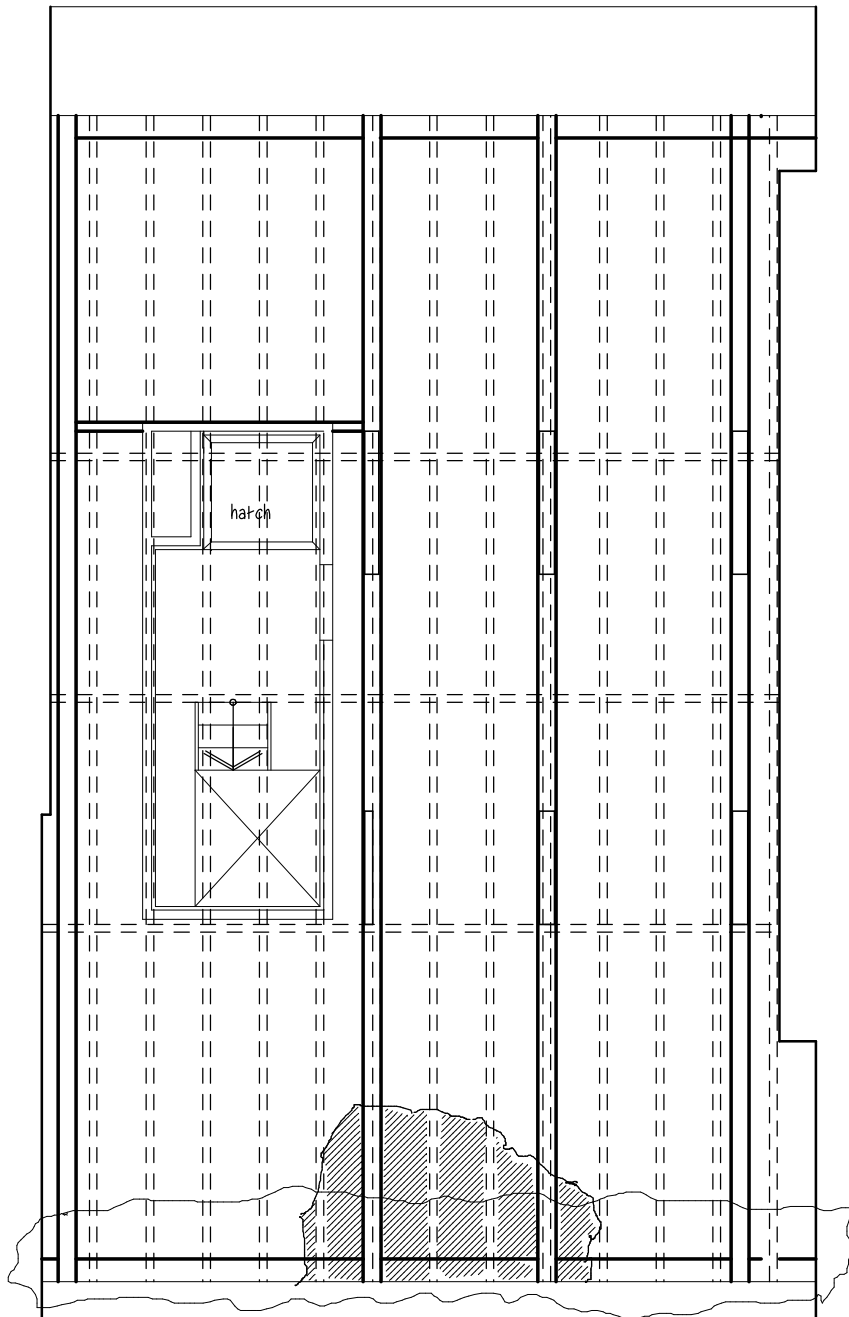
FRONT (EAST) PARAPET GUTTER PLATE IS IN A CRITICAL CONDITION - SATURATED AND ROTTEN - IT COULD BE AT THE POINT OF COLLAPSE - LONG TERM EXPOSURE TO WET IS SUSPECTED

PARAPET GUTTER BOARD IN CRITICAL CONDITION
