↑  
CONDITION SURVEY - GROUND FLOOR PLAN - entrance level

CLIENT Venoru Ltd.	
PROJECT 49 Marchmont Street, WC1N 1AP	
DRAWING CONDITION SURVEY ground floor plan	
DRG. No 27	REVISION -
SCALE 1:50 @ A 3 paper	DATE 12 jan 2018

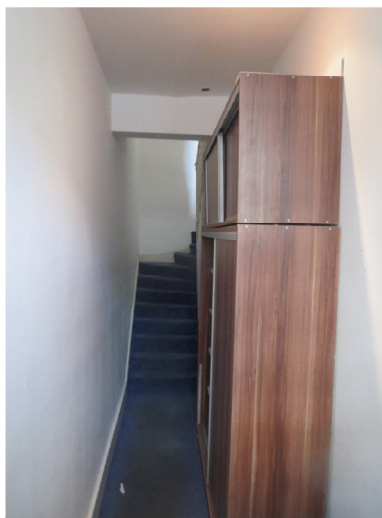
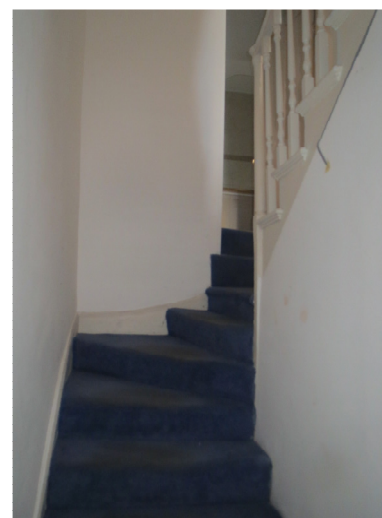
FRONT DOOR - ORIGINAL ELEMENT BUT MANY ALTERATIONS SUCH AS SECURITY LOCKS HAVE LEFT IT COMPROMISED

STAIRCASE - ORIGINAL ELEMENT - STRINGS WORN & PARTLY CONCEALED BEHIND WALL FINISH

UNABLE TO SEE CONDITION OF TREADS DUE TO CARPET ONCE CARPET REMOVED CONDITION TO BE ASSESSED APPEARS VERY WORN EVIDENCED BY DIP IN CENTRE

SPINDLES FAIR

HANDRAIL FAIR

NO ORIGINAL SKIRTINGS IN HALLWAY

WALLS PAINTED AND PAPERED - CONDITION WORN

MEZZANINE ROOM ENTIRELY TILED  
UNABLE TO DETERMINE CONDITION OF FABRIC
