CONDITION SURVEY - SECOND FLOOR PLAN

CLIENT Venoru Ltd.	
PROJECT 49 Marchmont Street, WC1N 1AP	
DRAWING CONDITION SURVEY second floor plan	
DRG. No 29	REVISION -
SCALE 1:50 @ A 3 paper	DATE 12 JAN 2018

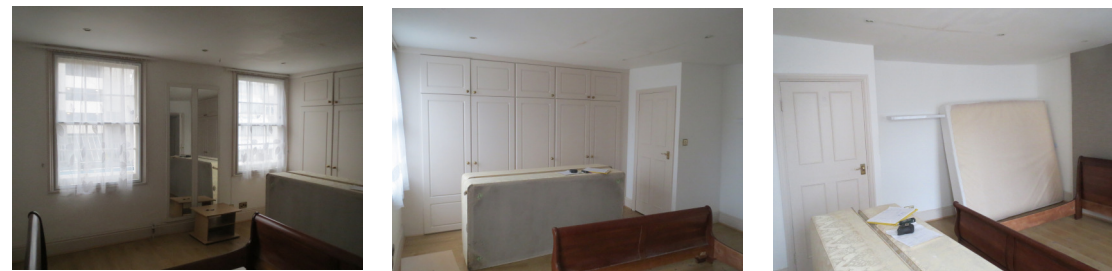
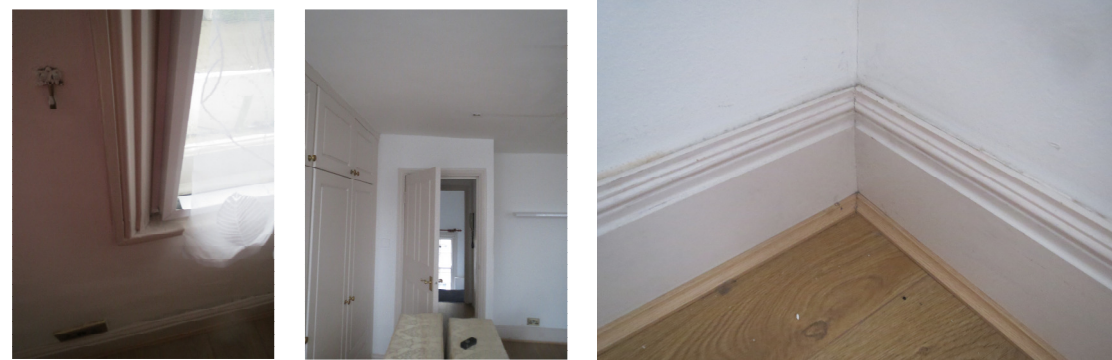
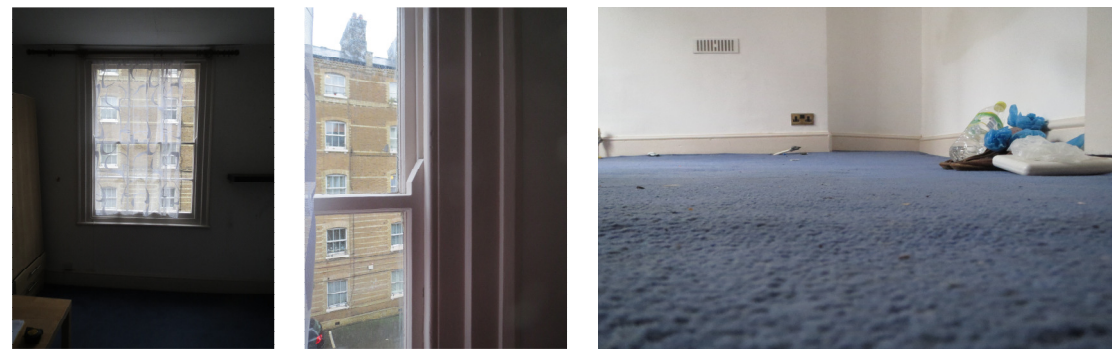
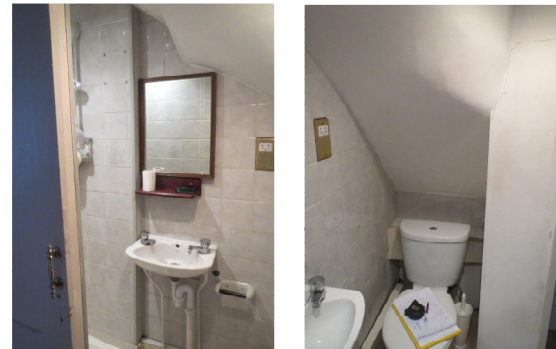
MODERN LININGS PREVENTED DETAILED INSPECTION

STAIRCASES ORIGINAL - DECORATION OF SPINDLES GOOD - CARPET POOR UNABLE TO SEE CONDITION OF TREADS

ARCH WINDOW OVER ATTIC STAIRS BLOCKED GLASS IN FRAME BUT COVERED OVER

REAR ROOM - DOOR D6 ORIGINAL BUT DEFLECTED - ARCHITRAVE COMPROMISED

PRONOUNCED DEFLECTION OF FLOOR TOWARDS NORTHEAST CORNER - REST OF FLOOR UNEVEN

CRACKS TO CEILING WEST TO EAST

FRONT ROOM

DEFLECTION OVER DOOR - CEILING DEFLECTS NORTH TO SOUTH DIPPING IN CENTRE OF ROOM
