PROJECT
49 Marchmont Street, WC1N 1AP

DRAWING
CONDITION SURVEY
third floor plan

DRG. No 30	REVISION -
SCALE 1:50 @ A 3 paper	DATE 12 jan 2018

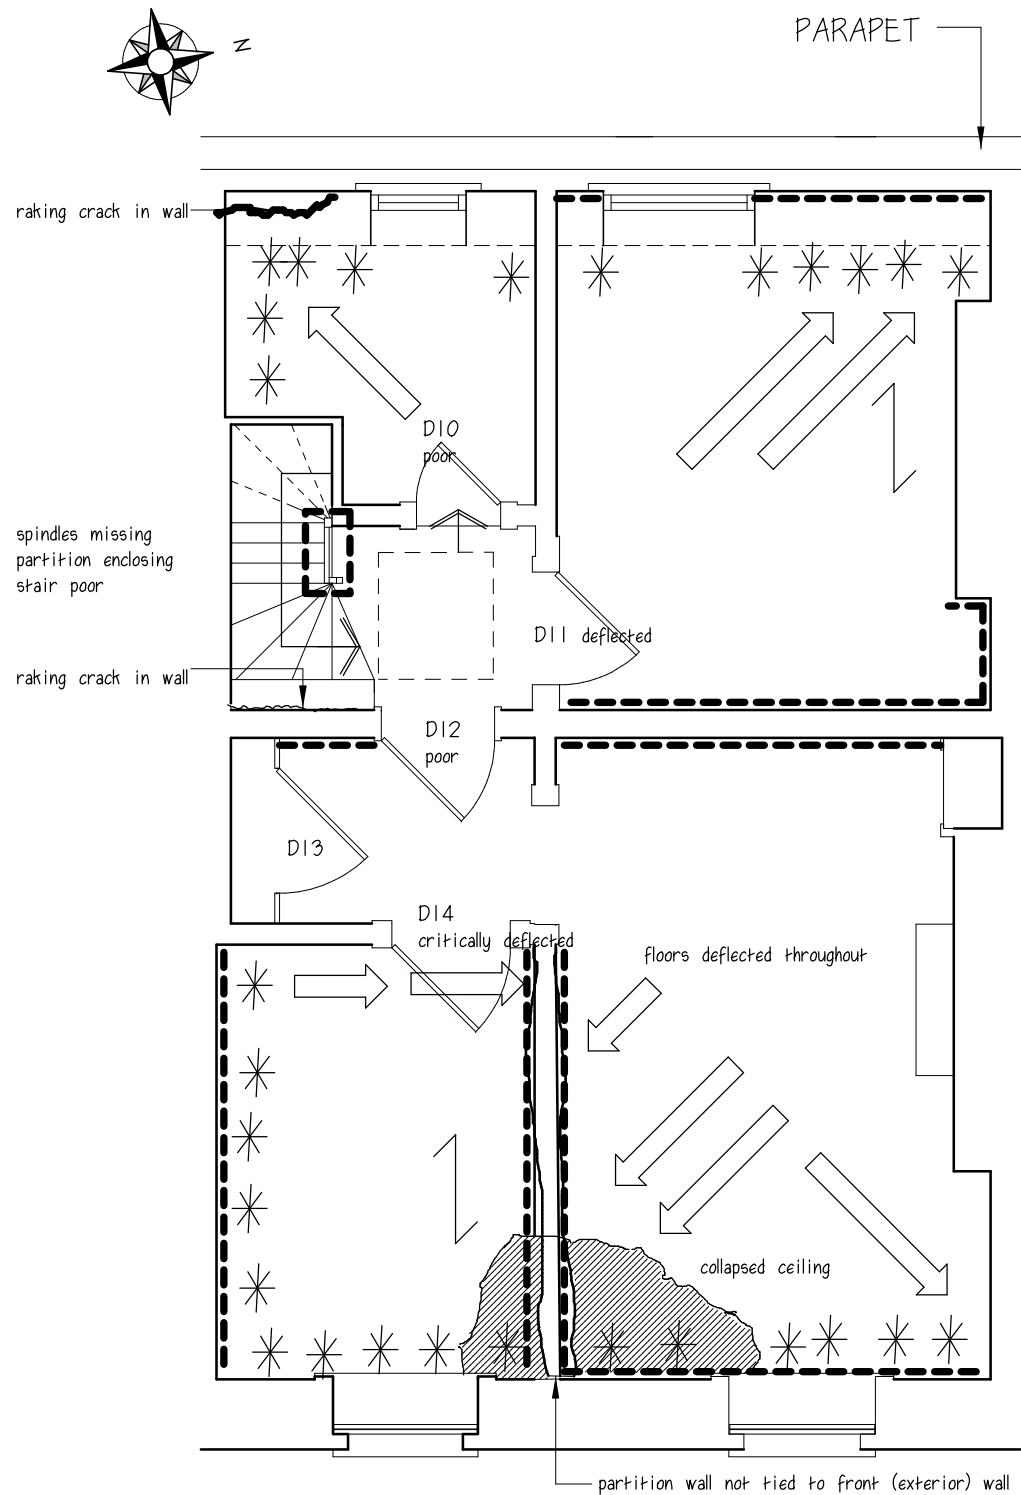
SUMMARY - OVERALL VERY POOR CONDITION - UNSTABLE AND ROTTEN - SERIOUS WATER INGRESS WITH SUBSEQUENT DAMAGE TO STRUCTURAL ELEMENTS

VERY STEEP AND DEFLECTING SLIGHTLY - MISSING SPINDLES
20TH CENTUREY PARTITIONS AND PIECING-IN OF TIMBER USED TO INFILL STAIR TO SEPARATE IT FROM BELOW
THE WORK IS UNPROFESSIONAL AND COMPROMISES THE ORIGINAL ELEMENT

A 1 M RAKING CRACK AT LANDING OF STAIRS

LATHER AND PLASTER PARTITION (RUNNING EAST TO WEST) DEFLECTING CRITICALLY AND TWISTING LATERALLY

HEAD OF DOOR D4 DROPPED 250MM AND HAS BEEN REPAIRED IN SITU

PLASTER HAS FALLEN AWAY EXPOSING LATHE - WHICH IS WET - THERE IS NO KEY BETWEEN THE LATERAL WALL AND THE FRONT FACADE MEANING THE WALL IS UNSUPPORTED

CEILING HAS POLYSTYRENE TILES IN PLACES WITH 20TH PLASTERBOARD ABOVE
THERE IS PARTIAL COLLAPSE IN SOUTH EAST CORNER ALLOWING VISUAL INSPECTION OF ROOF TIMBERS ABOVE
SEE CONDITION SURVEY ATTIC FLOOR DRAWING 31

WATER ENTERED THE BUILDING DURING THE SURVEY - WALLS ARE SATURATED ON EASTERN SIDE
PARTICULARLY WET UNDER SOIL AND VENT PIPE

MANY WALLS HAVE BLOWN AND ARE MISSING PLASTER SOME WALLS ARE BLACK - CONSISTENT WITH SMOKE DAMAGE
THERE IS AN ODOUR OF SOOT

SMALLER ROOM - SOUTH - HAS A CONTINUOUS RAKING CRACK TO SW CORNER
FLOORS DEFLECTING NORTH TO SOUTH
PLASTER WALLS ARE IN POOR CONDITION AND THERE IS EVIDENCE OF MOISTURE BUILD UP
ROT TO WALLS AND BLACK STAINING

CASEMENT WINDOW CRITICAL CONDITION AND READY TO COLLAPSE - TIMBERS ROTTEN AND GLASS LOOSE

LARGER ROOM - ROTTEN AND DAMP SLOPING WALLS
PLASTER BLOWN AND DAMP TO THE TOUCH
DOOR DEFLECTED SIGNIFICANTLY AND WILL NOT CLOSE - ARCHITRAVE COMPROMISED
FLOORS SLOPING IN SEVERAL DIRECTIONS - ORIGINAL WIDE BOARDS HERE IN GOOD CONDITION AWAY FROM WATER INGRESS

WINDOWS TO FRONT ARE IN VERY POOR CONDITION DUE TO LACK OF MAINTENANCE
BUT COULD BE REPAIRED BY A SPECIALIST AS THEY APPEAR TO BE SURVIVING ELEMENTS
WALLS UNDER WINDOWS ROTTEN

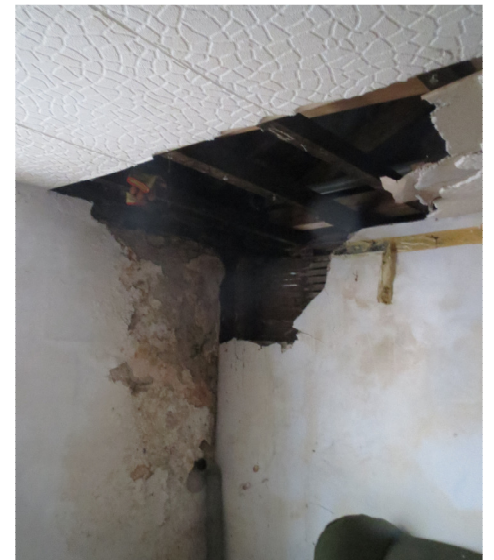
twisting to partition
