SURVEY OF SIGNIFICANCE ATTIC (4th) FLOOR PLAN

CLIENT Venoru Ltd.	
PROJECT 49 Marchmont Street	
DRAWING SURVEY OF SIGNIFICANCE FOURTH (ATTIC) floor plan	
DRG. No 23	REVISION -
SCALE 1:50 @ A 3 paper	DATE 29 Dec 2017

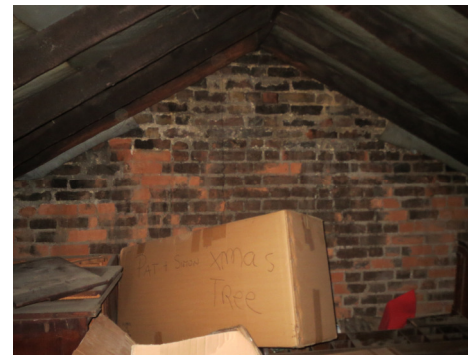
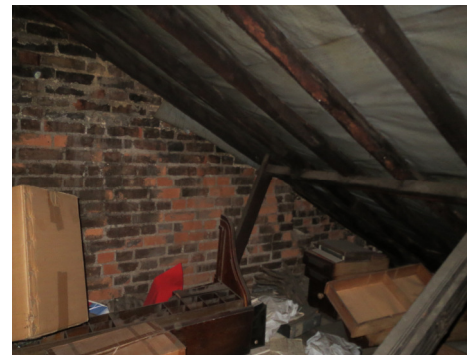
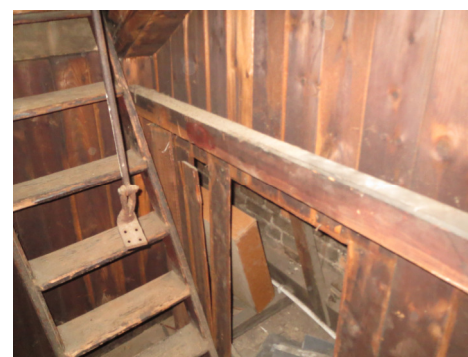
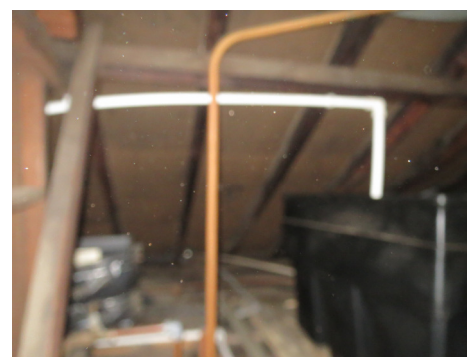
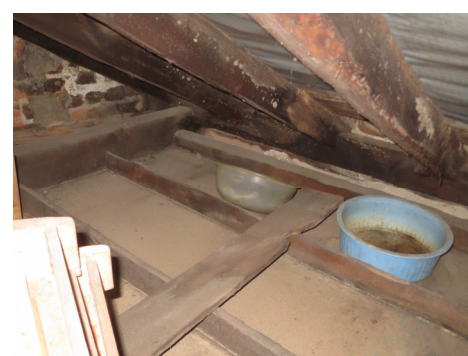
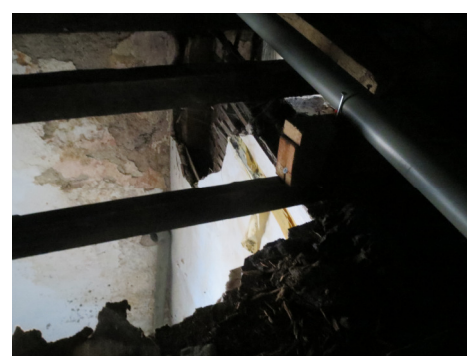
SURVIVING RAFTERS - UNPLANNED  
CEILING JOISTS ORIGINAL

TONGUE AND GROOVE LININGS TO LOFT ACCESS MAY BE EARLY JOINERY

LOFT HATCH NON-ORIGINAL

SEVERE DAMAGE TO CEILING JOISTS AT FRONT ELEVATION

BRACES AND TRUSSES ORIGINAL

NEW ROOF FELT

SEVERE WATER INGRESS TO FRONT AREA - PARTIAL COLLAPSE

ORIGINAL WALL PLATE SATURATED AND ROTTEN - SEE CONDITION SURVEY

OVERALL CONDITION FAIR - BUT AREA OF SEVERE DAMAGE
