10a Great Ormond Street
Planning reference 2016/0402/L
Planning Condition 4b

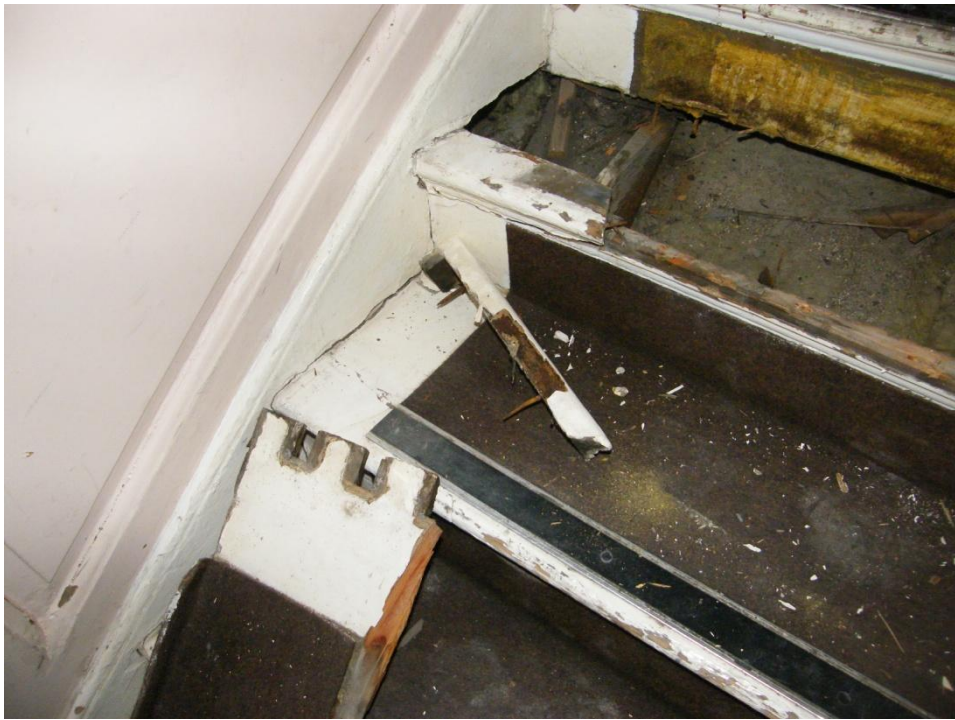
There were four treads on the first two flights where the single piece softwood board has split laterally. The defect has occurred as the irregular triangular blocking pieces have dropped slightly due to historic deflection in the framing below.

This has resulted in a loss of intermediate support to these four treads resulting in the wood splitting under load.

Where this defect has occurred the top surface of the blocking piece has been raised by adding a thin soft wood packer and the tread board replaced on a like for like basis.
