ADDENDUM TECHNICAL REPORT

Crawford Reference: SU1703328

**Mr Alasdair Graham
23 Rochester Square
London
NW1 9SA**

SUBSIDENCE CLAIM

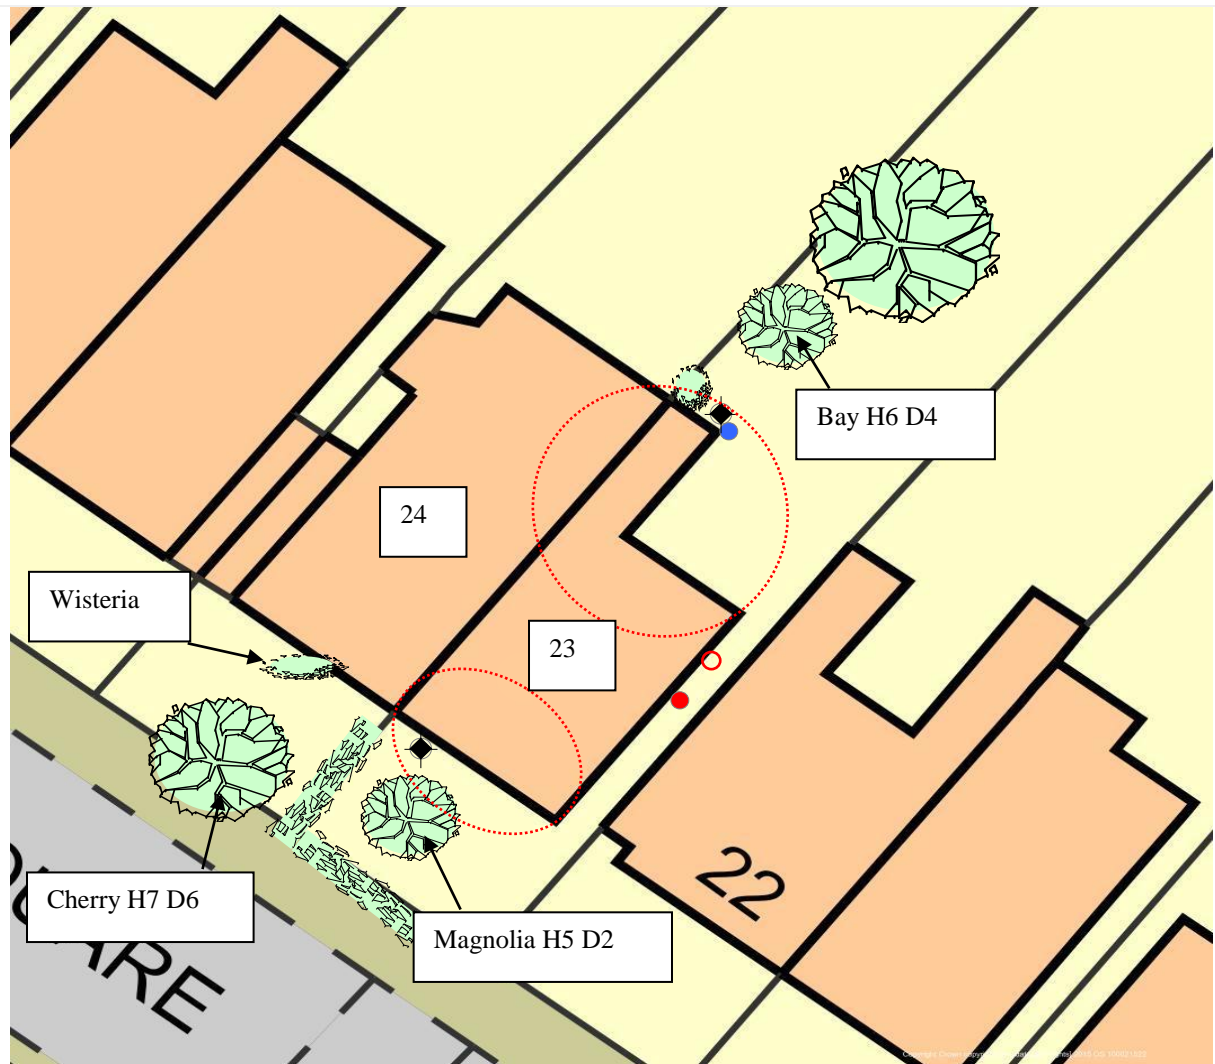
Site Plan

A trial hole was excavated to expose the foundations - see site plan for location and the diagram below for details. Trial Hole 1 revealed a brick footing with no projection founded at a depth of 0.25m below ground level which bears onto a brown slightly sandy silty clay.
