Landmark Trees

ARBORICULTURAL IMPACT ASSESSMENT REPORT FOR:

33 Belsize Avenue
London
NW3 4BL

Ref: KSR/33BLS/AIA/01a

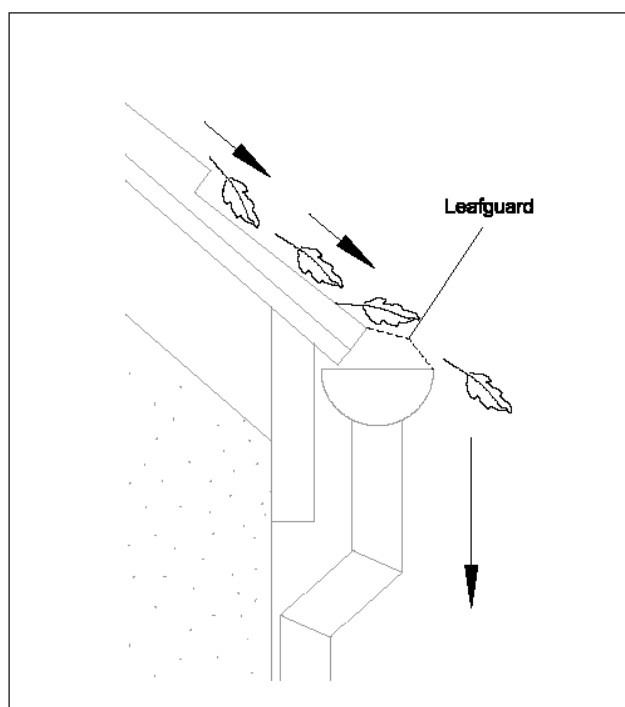
- 6.3.4 Nuisance deposition can be further mitigated with routine maintenance, light pruning / deadwooding and the fitting of filtration traps on guttering (see Figure 5 below).

Figure 5: Filtration traps, as shown above, could be fitted on the gutters which can easily be maintained at 2-3m above ground.

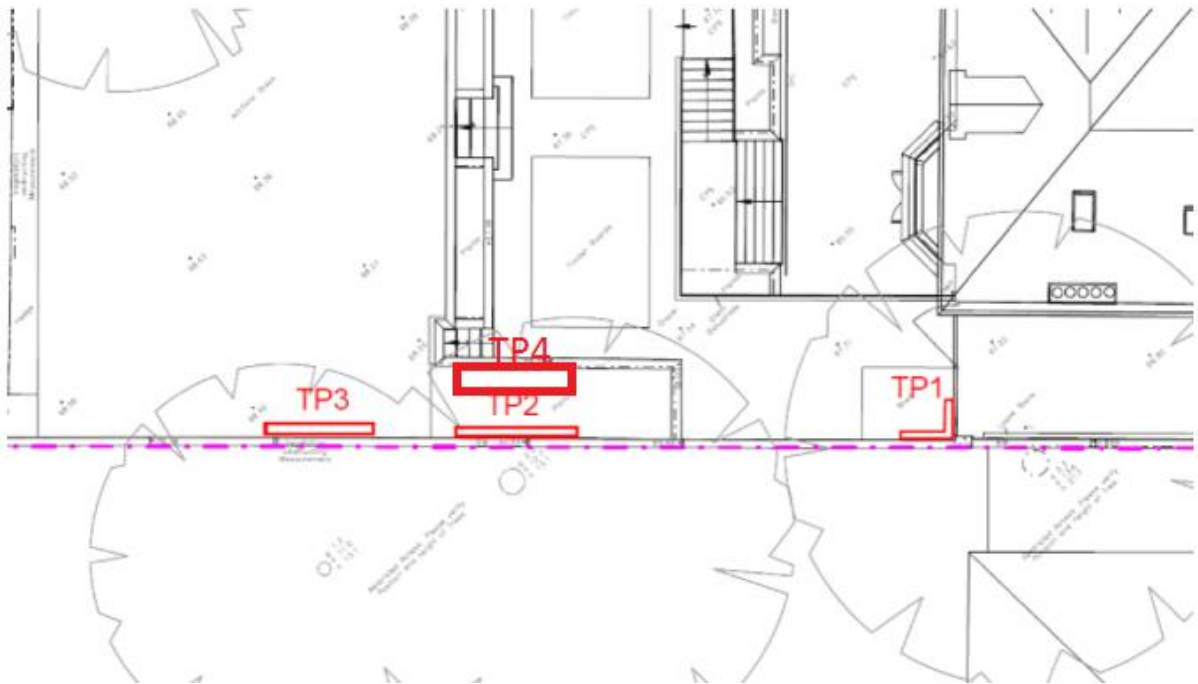
Site overview

Trial Pit 1 was not excavated after consultation.
Trial pit 2 was halted due to the large root at 700mm below surface level and trial pit 3 was added in closer to the centre of the property.
