St Giles Circus  
26 Denmark Street  
Zone 2 works

Listed Building Consent  
2015/6937/L

Structural works to roof, gable wall and chimney Review

Rev 00  
9<sup>th</sup> February 2018

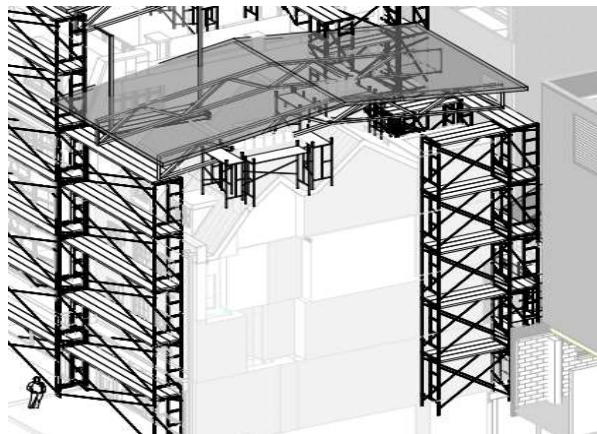
Figure 1.

An independent scaffold will be erected in front and to the and rear of 26 Denmark Street with a temporary scaffold roof above to protect the internal fabric of the Grade II listed building and to gain safe access whilst the works are undertaken.
