Subject SU1703328 (client ref), Client: Crawford & Co, Customer: Mr Graham, Auger ref: 74134.1.USI - MM

SITE INVESTIGATION

23 ROCHESTER SQUARE

Insured: Mr Graham
Client's Ref: SU1703328
Auger's Ref: 74134.1.USI
Visit Date: 11/10/2017
Report Date: 12/10/2017
Author: DO
Checked By: MM

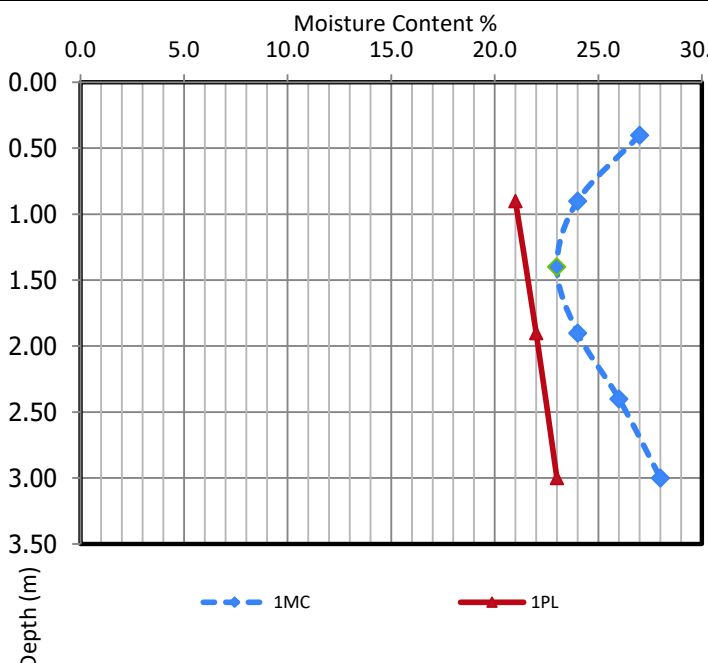
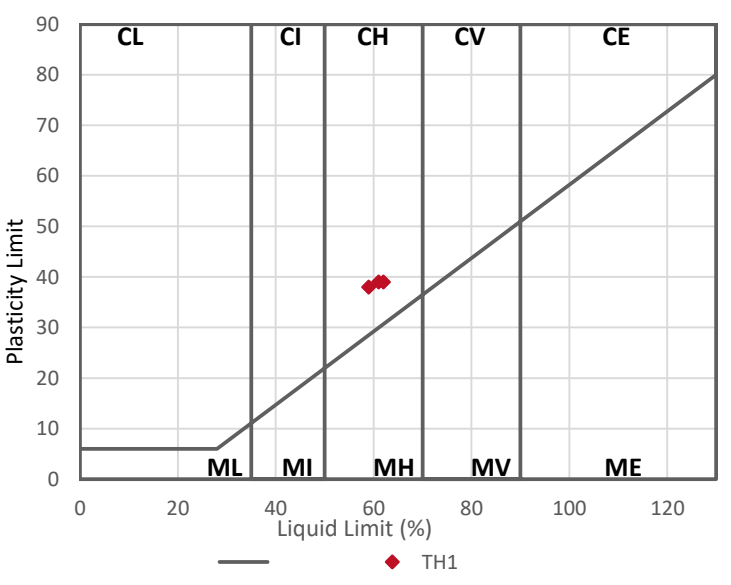
PLASTICITY CHART FOR CASAGRANDE CLASSIFICATION
BS 5930:1999+A2:2010

| TH Trial Hole | Sample Type | Depth (m) | Moisture Content % | Liquid Limit % | Plastic Limit % | Plasticity index % | Passing .425mm % | NHBC Chapter 4.2 | Remarks |
|---|---|---|---|---|---|---|---|---|---|
| TH1 | D | 3.00 | 28 | 62 | 23 | 39 | 97 | MEDIUM VCP | CH High Plasticity |
