Arboricultural Appraisal Report

Subsidence Damage Investigation at:

23 Rochester Square
London
NW1 9SA

CLIENT:	Crawford & Company
CLIENT REF:	SU1703328
MWA REF:	SUB171121-1892
MWA CONSULTANT:	Andy Clark
REPORT DATE:	04/12/2017

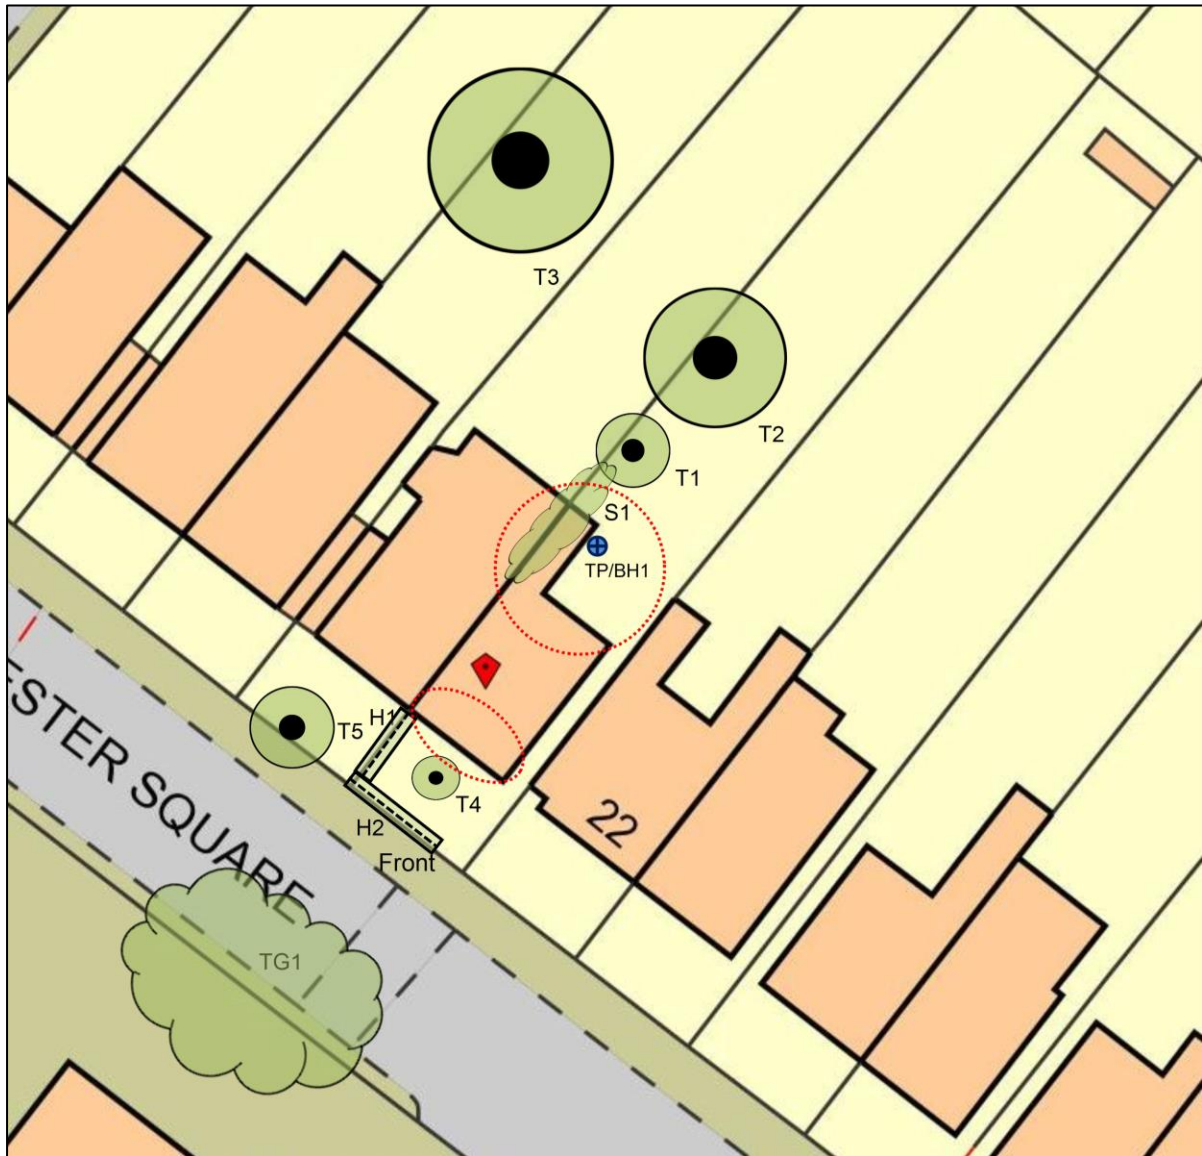
SITE PLAN

Roots were observed to a depth of 1.6m bgl in TP/BH1 and recovered samples have been tentatively identified (using anatomical analysis) as Salicaceae spp.; the origin of which will be T3 Weeping Willow as the only Salicaceae spp. nearby, suggesting the influence of this tree on the soils below the foundations to the rear of the property.

If an arboricultural solution is to be implemented to mitigate the current damage and allow the soils beneath the rear of the property to recover to a position such that an effective repair solution can be put in place, we recommend that T1 Bay, S1 Ivy and T3 Weeping Willow are removed.
