REPORT

on trees in relation to

7 South Villas, London, NW1 9BS

on behalf of PBA Consulting
for Plum Underwriting
via: Carmichaels
ref: 58703602437

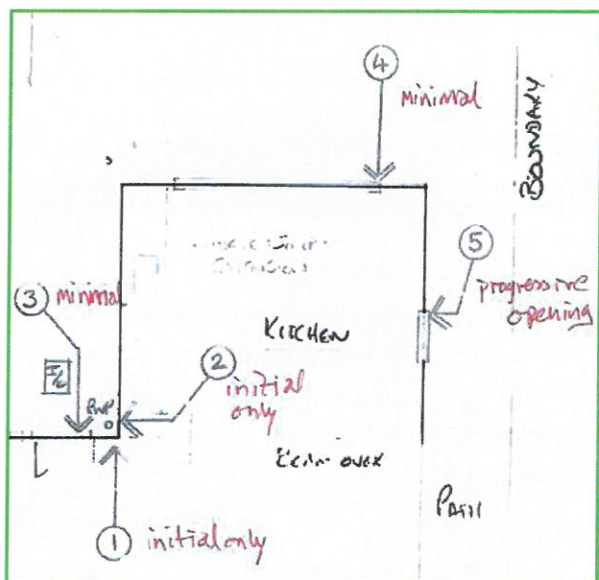
The root identification indicates that vegetation near the property (willow 2) has developed roots close to or under the footings. Questions therefore arise over how such vegetation could be managed in order to reduce soil drying near the footings.
