The Lodge  
Flaxman Terrace  
Camden

Heritage and Design and Access Statements,  
Condition Survey and Schedule of Repairs

8 February 2018

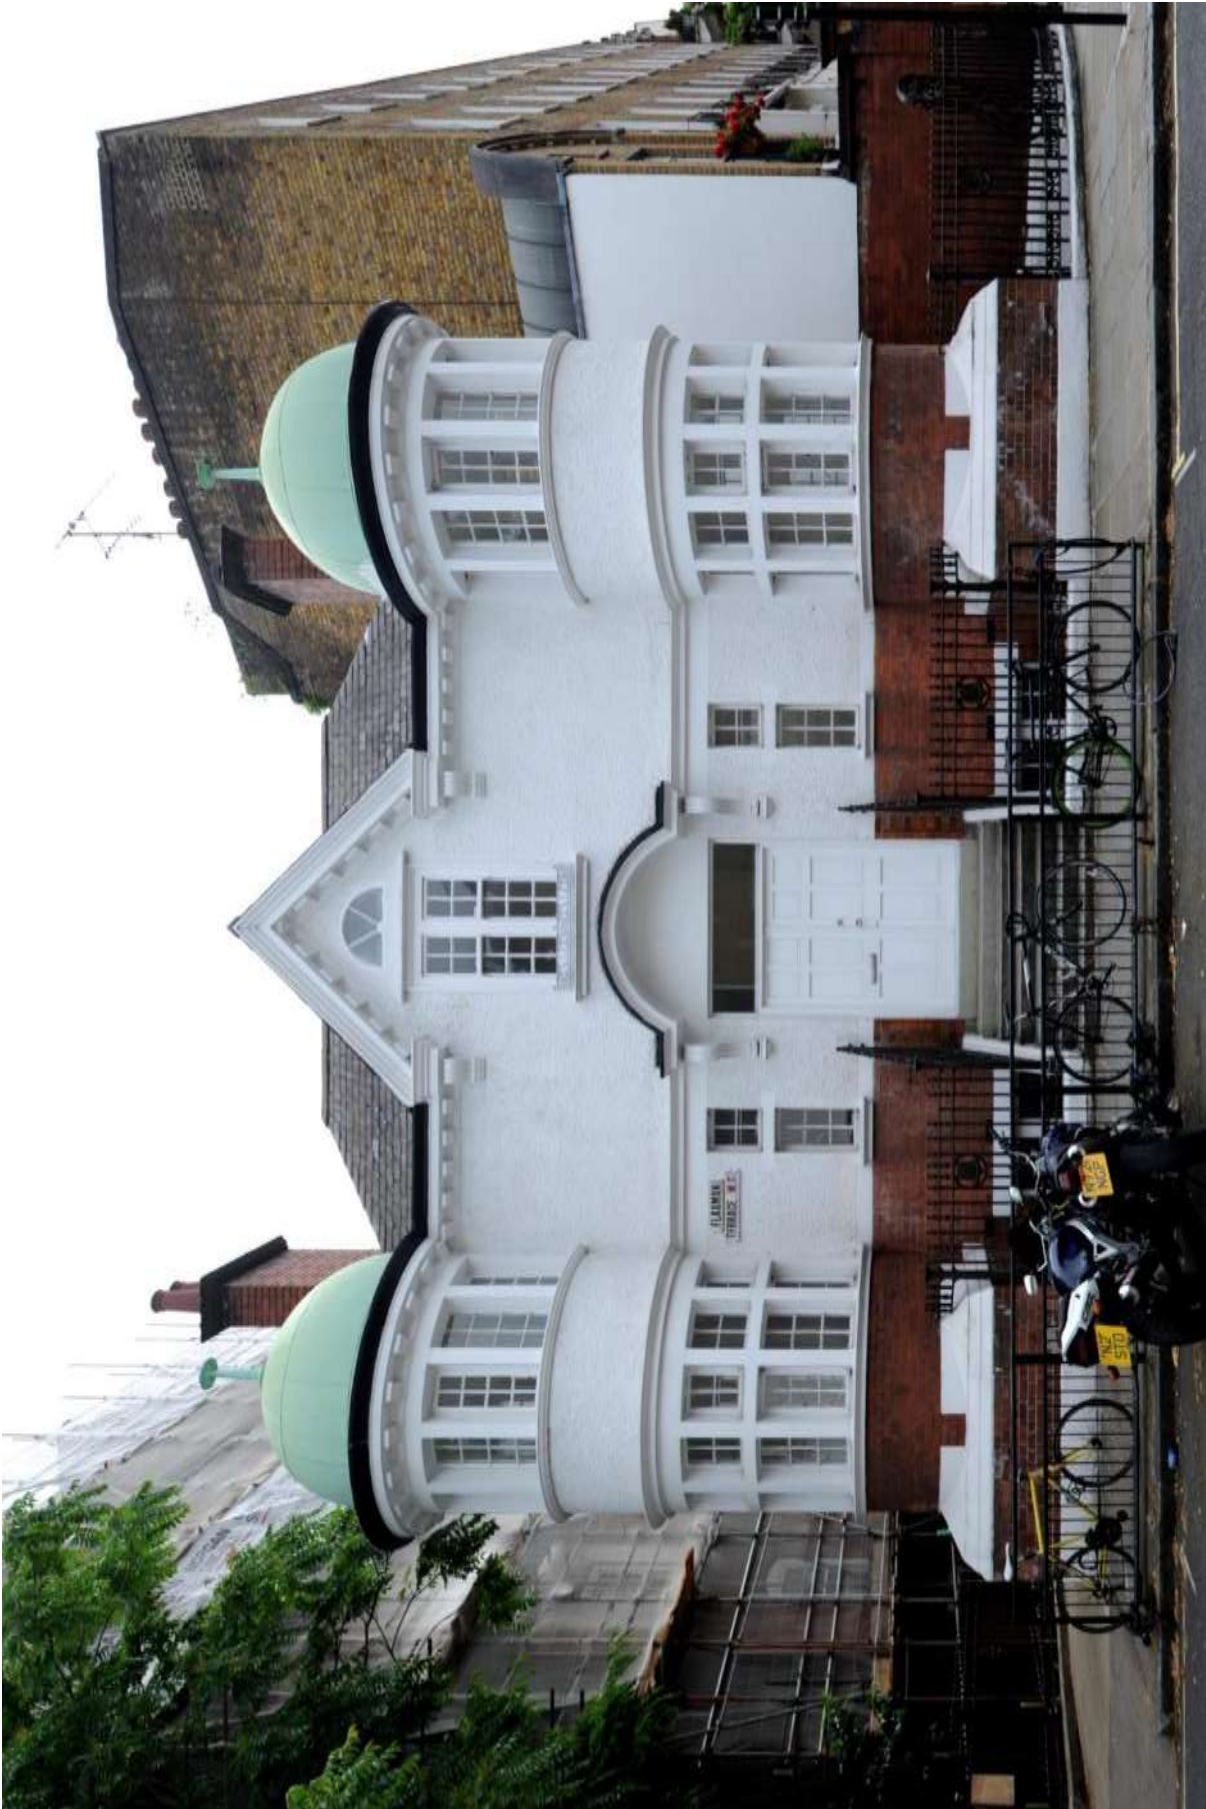
Fig 3 The Lodge from the west

The wall is generally satisfactory apart from the dampness at the bottom of the two light wells flanking the entrance steps (Figs.14 & 15). Originally there was a single area on the west side of the building but at a date after 1992 new brick walls were built under the steps to create an external room accessible from the north lightwell. These walls may be contributing to the dampness in the earlier brickwork by by-passing the

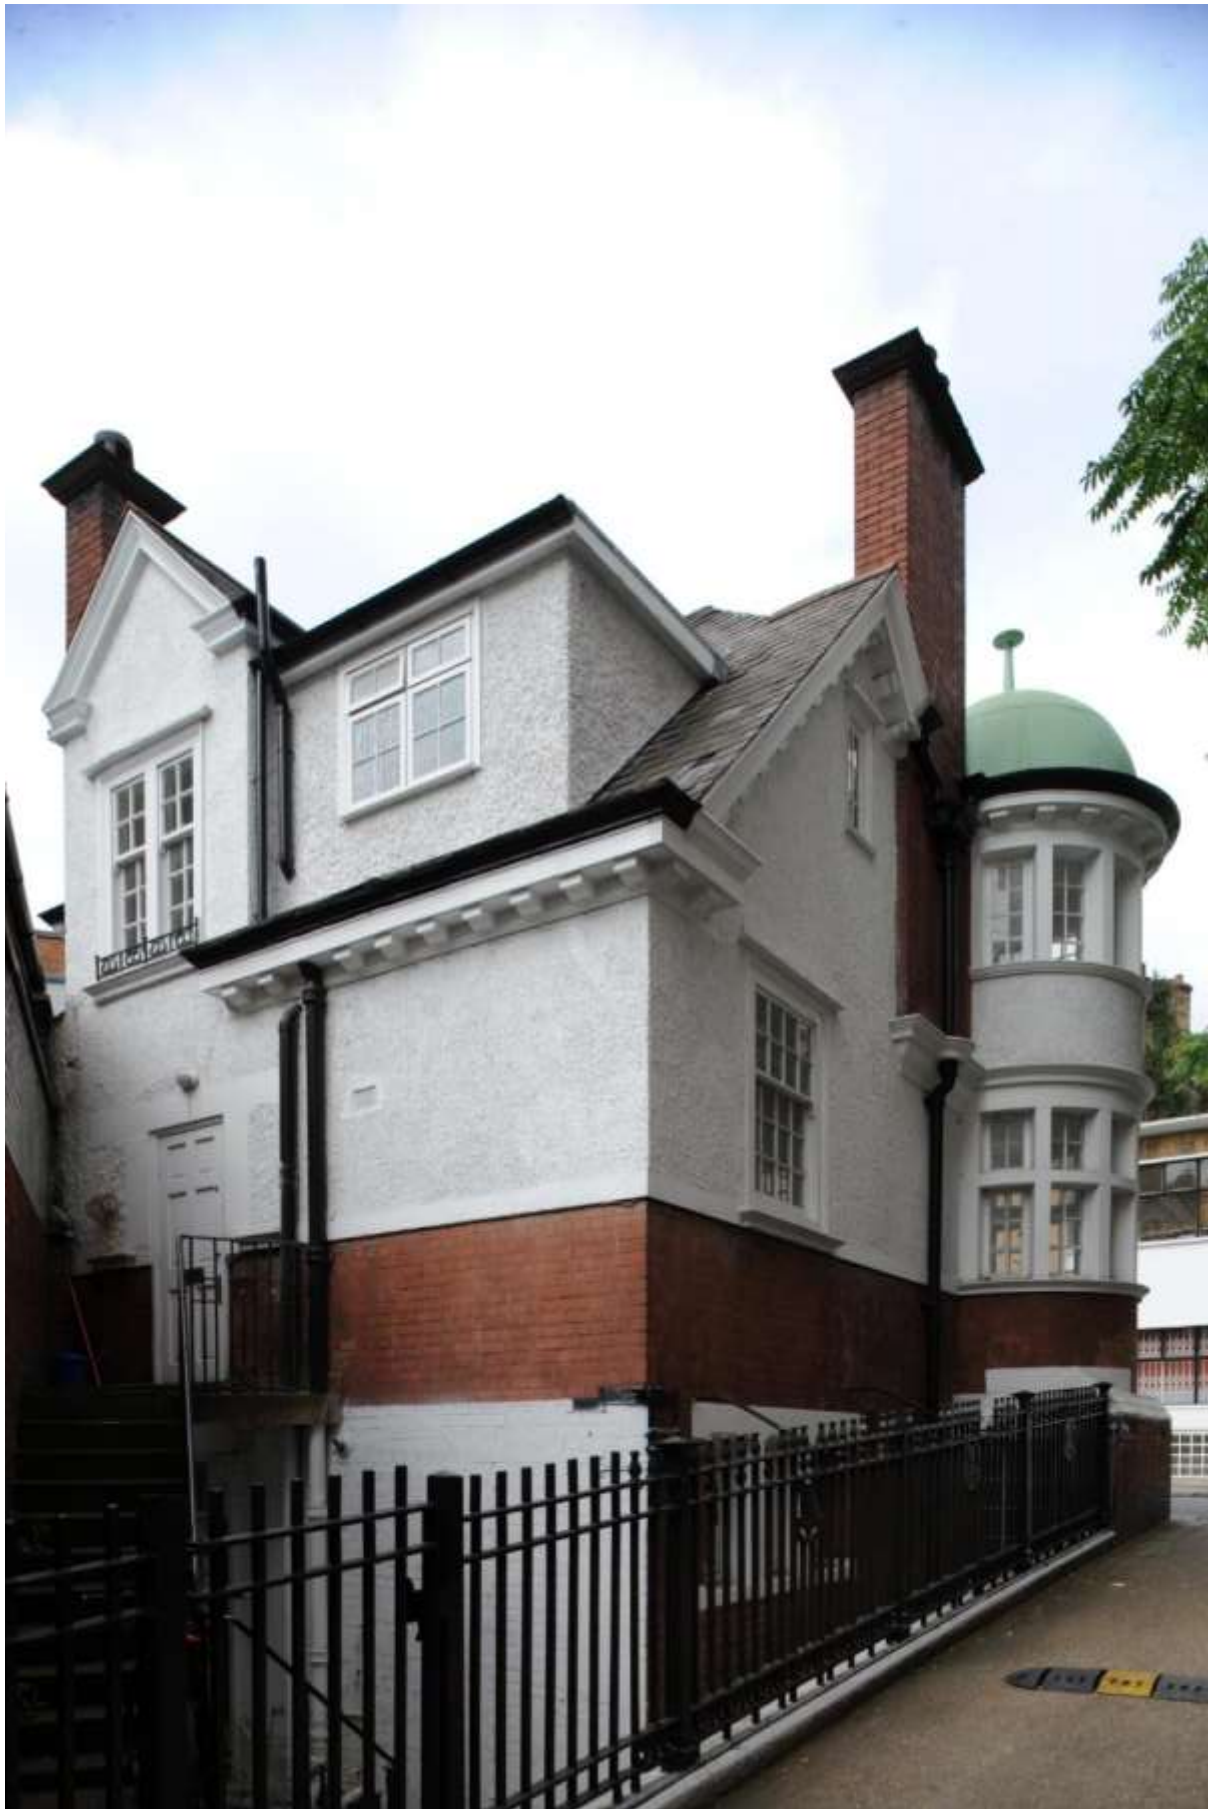
The brickwork in the basement storey has been painted white in the 1990's or even more recently (Fig.4).

Fig 4 The Lodge from the north-east

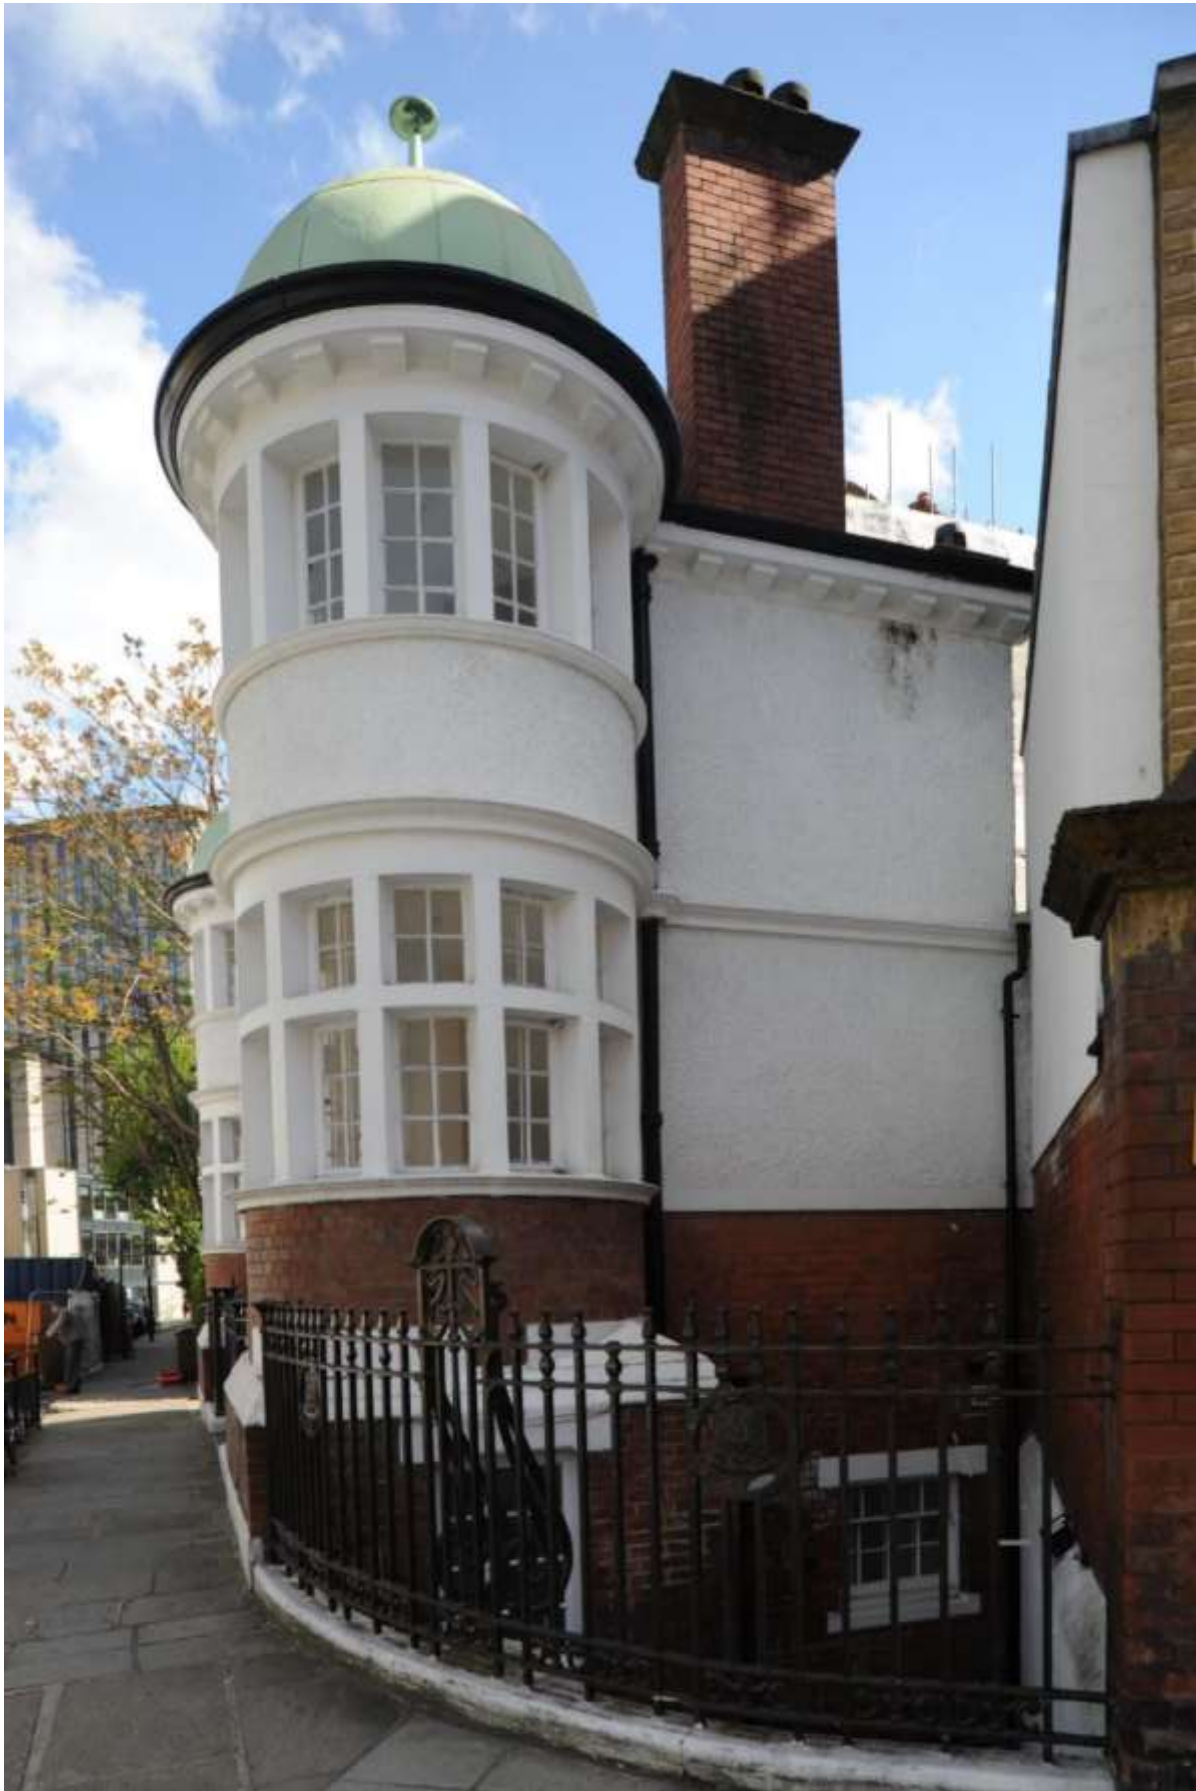
Brick stack with a concrete cap containing three flues and two clay chimney pots (Fig. 5)

- The pointing on all faces of the stack is deteriorating.
- There is a 15mm wide crack for the full depth of the concrete cap on the west side a s second 15mm wide crack on the south side of the cap (Fig.11).
- The condition of the flaunching is not known because it cannot be seen.
- The western chimney pot is missing.
- The condition of the lead flashing and gutter at the base of the stack cannot be ascertained because they are not visible. On the evidence of the leadwork elsewhere on the roof it will be nearing the end of it useful life.

Fig 5 The Lodge from the south

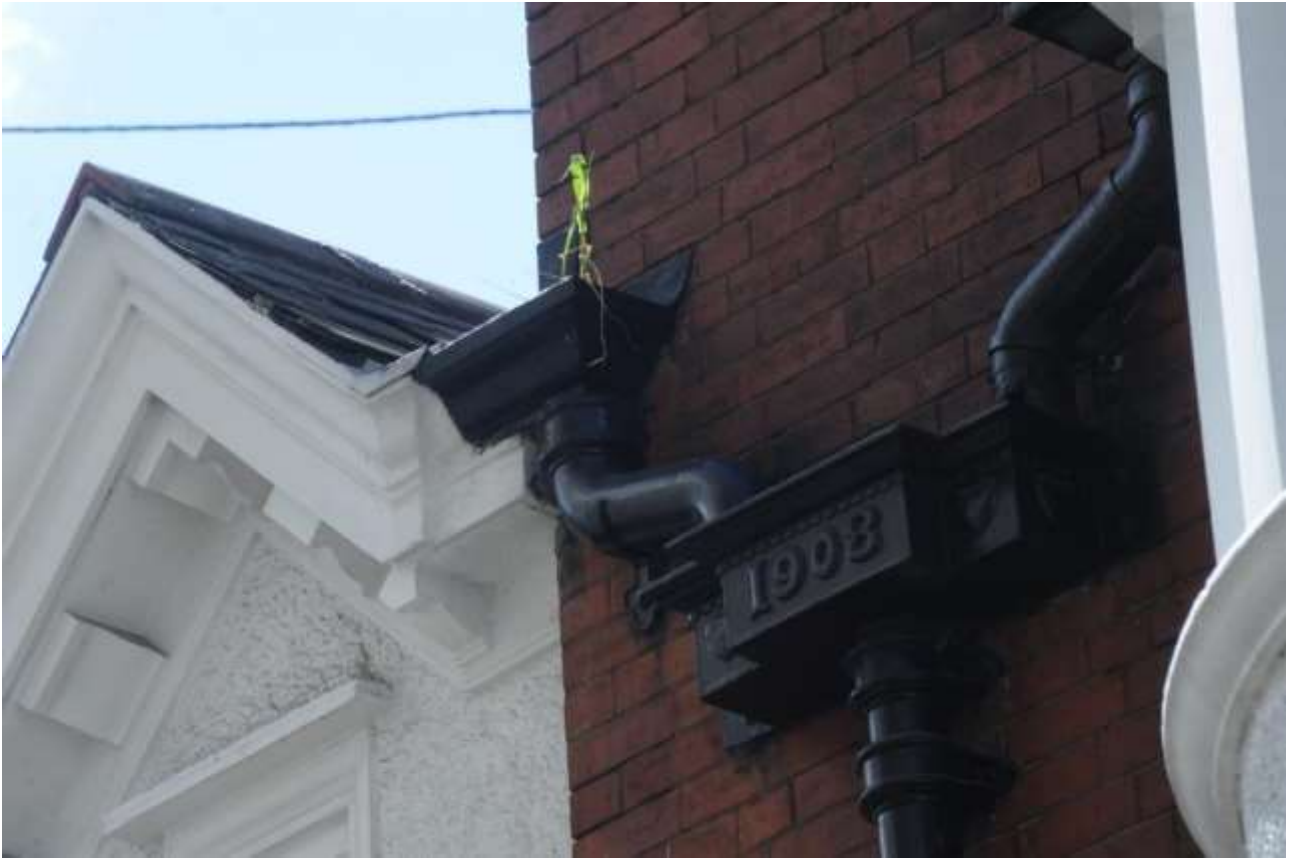
Downpipe R1 is a nom. 100mm circular painted cast iron pipe terminating in a shoe which discharges onto the decking in the north area (Fig.50). At the top of the pipe is a painted cast iron hopper head with the date 1908 into which pipes from the north-west tower gutter and the lead gutter on the east side of the north chimney stack (Fig.6).

Fig 6 The rainwater hopper dated 1908 on the north elevation

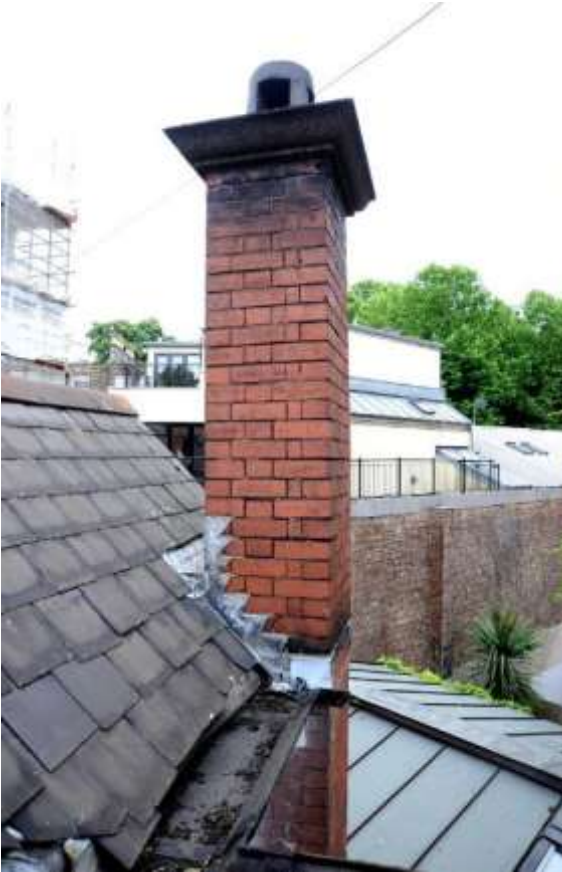
Brick stack with a concrete cap containing a single flue and a clay chimney pot (Fig.12).

Fig 12 The east chimney stack

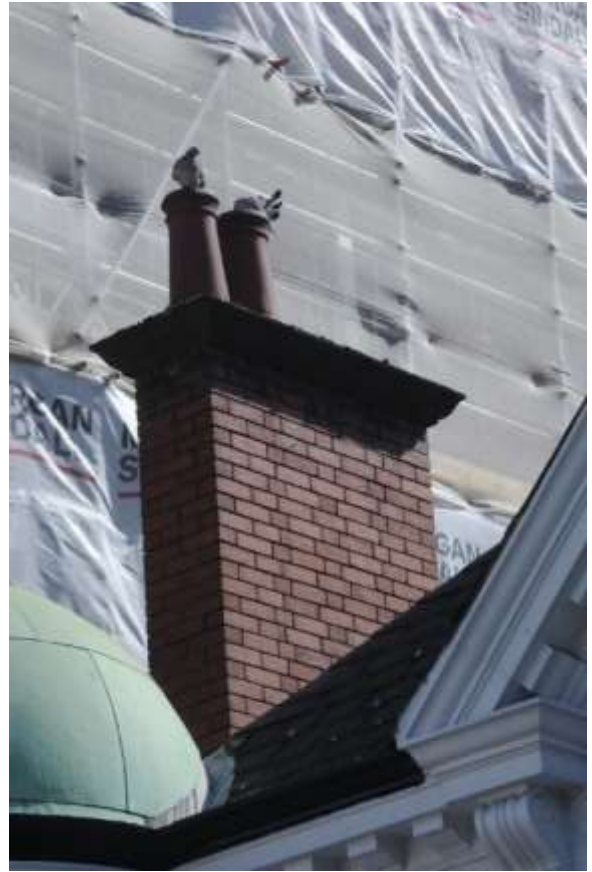
Brick stack with a concrete cap, containing four flues and two clay chimney pots (Fig.13).

Fig 13 The north chimney stack

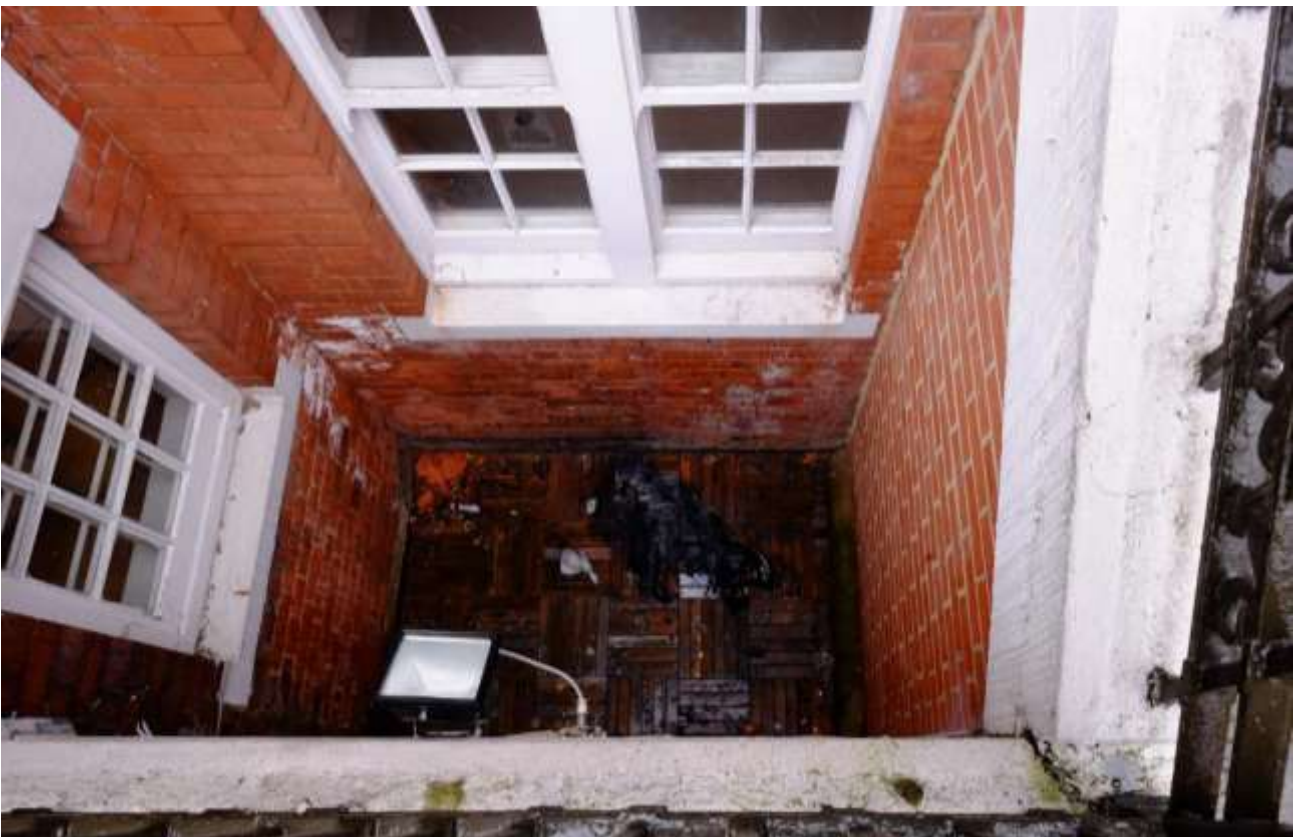
Fig 14 The north lightwell on the west side of The Lodge

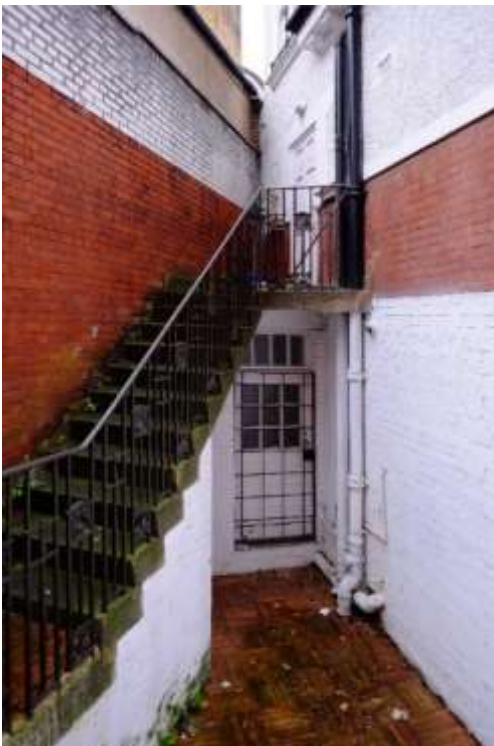
Downpipe R2 is a nom. 100mm painted circular cast iron pipe which changes to a plastic pipe about 600mm above ground level (Fig.18).

Fig 18 The rear doors and external stair in the east area

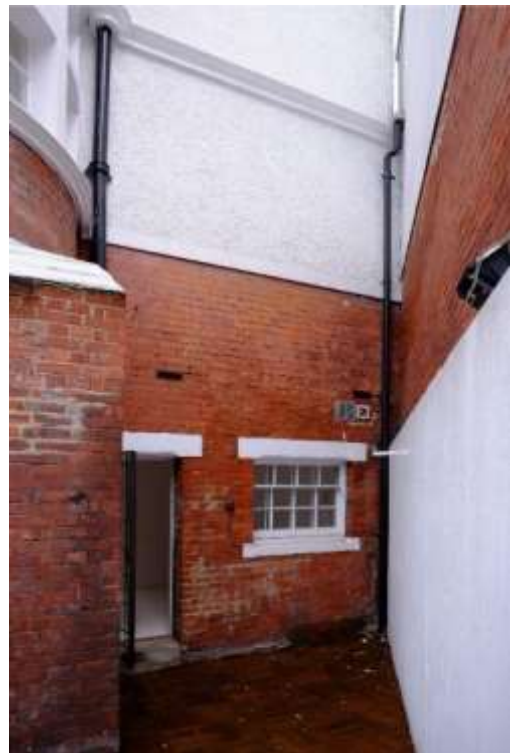
Downpipe R3 is a nom. 68mm diameter circular black plastic pipe which discharges into a gutter in the south area (Fig.19). It removes water from the glazed roof installed in c.1992 over the rear of the ground floor room.

Fig 19 The south area

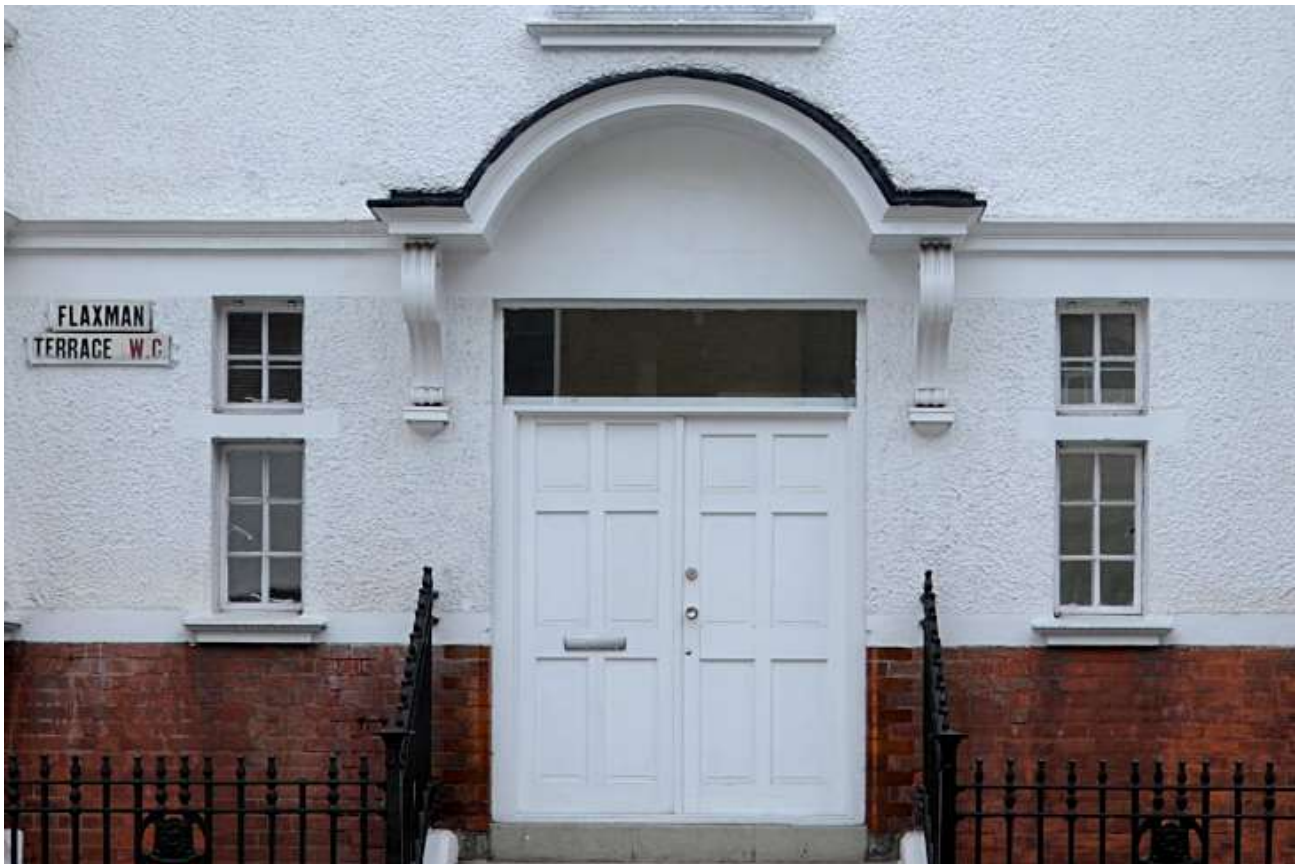
3.1.5.1 Door D1 is a modern painted panelled double timber door and frame and a clear glazed fanlight above (Fig.20). The door leaves are fitted with 1.5 pairs of steel hinges, an aluminium letter box, a pair of metal knobs, 2 no. surface mounted vertical bolts and 2 no. surface mounted horizontal bolts on the inner face, a deadlock with a pair of keyhole escutcheon plates and a Yale type lock with a thumb turn on the inner face. It is thought that originally the entrance door was a single panelled door with sidelights and a fanlight similar to the 19<sup>th</sup> century doors of homes in Gordon Square.

Fig 20 Door D1

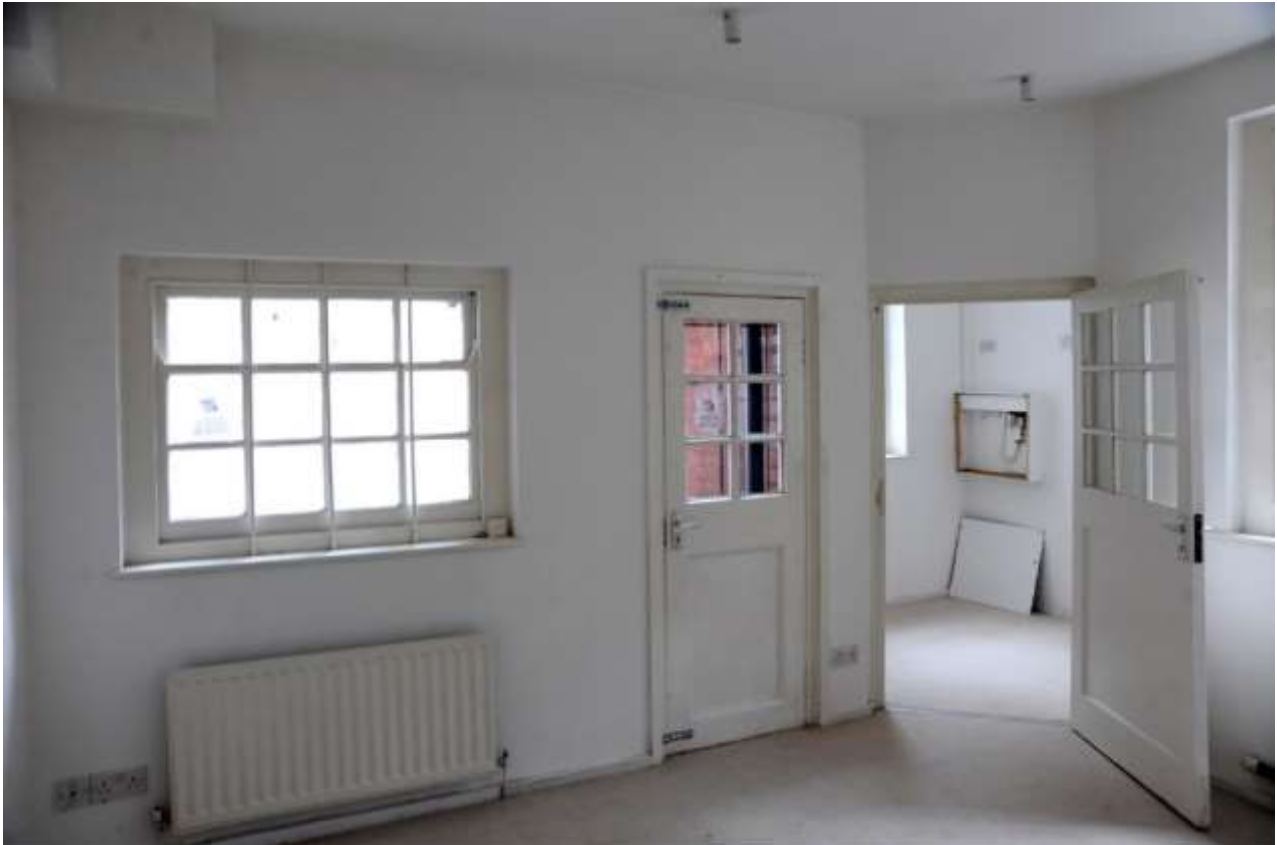
3.1.5.5 Door D13 is a modern painted timber half glazed door and frame with six glazed lights Fig.39). The door is fitted with a pair of aluminium lever handles, a sash lock and on the inner face two horizontal bolts. Externally is a coated steel security gate with the deadlock missing. The timber door is in a satisfactory condition.

Fig 39 The south wall and door to the south-west tower at basement level

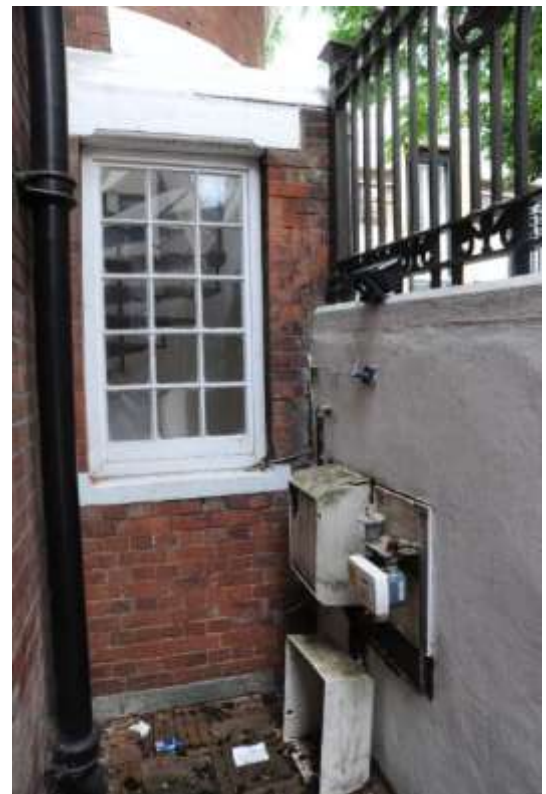
Fig 50 The north area and north-west tower

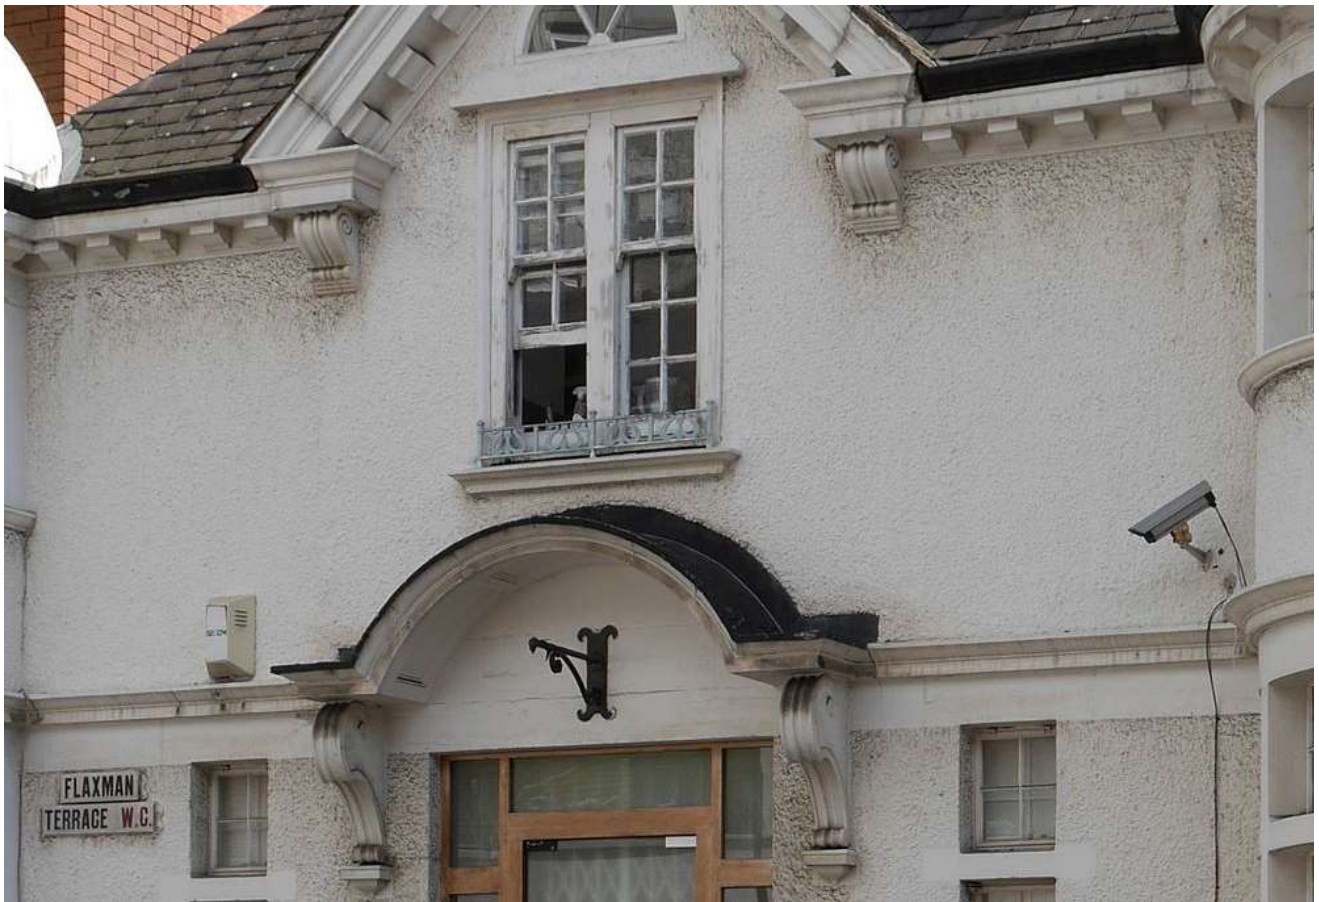
- An original wrought iron bracket to support a lantern over door D1 visible in earlier photographs (Fig.51) has been removed by a previous owner.
- Repoint the panel of brickwork adjacent to the north balustrade of the entrance steps with a lime mortar matching the strength of the original mortar.

Fig 51 The original bracket for a lantern above door D1 in 2013
