35 TEMPLEWOOD AVENUE, NW3
EXISTING FABRIC ASSESSMENT/
REINSTATEMENT METHODOLOGY
FEBRUARY 2018

35 TEMPLEWOOD AVENUE, LONDON, NW3

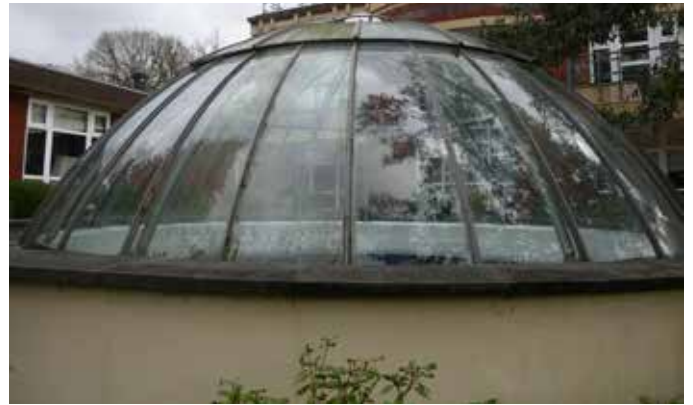
4. Exterior view of the glazed dome

In terms of the glazing to the dome, the existing glass is not original, this having been replaced with laminated panels which in some instances are delaminating. It is therefore intended that existing glazed panels will be replaced with new clear georgian wired panels to replicate the original installation.

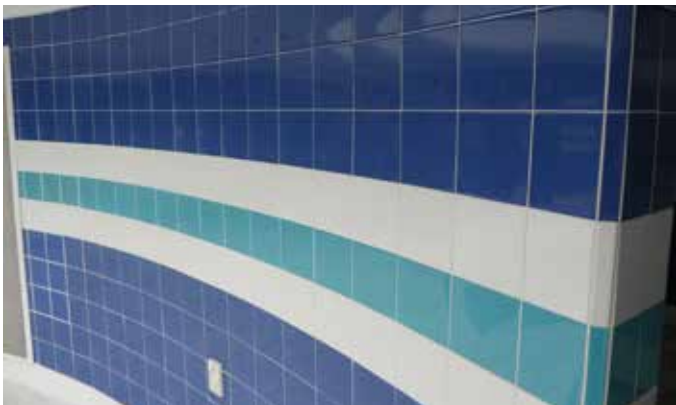
11. Detailed view of the wall tiling

None of the existing blue and white glazed ceramic wall tiling is original as evidenced by comparison of the original tiling shown in the image below and the tiling that exists currently. It is therefore intended to remove all the existing ceramic tiles and replace with new glazed ceramic tiles to match the original colour scheme and arrangement.

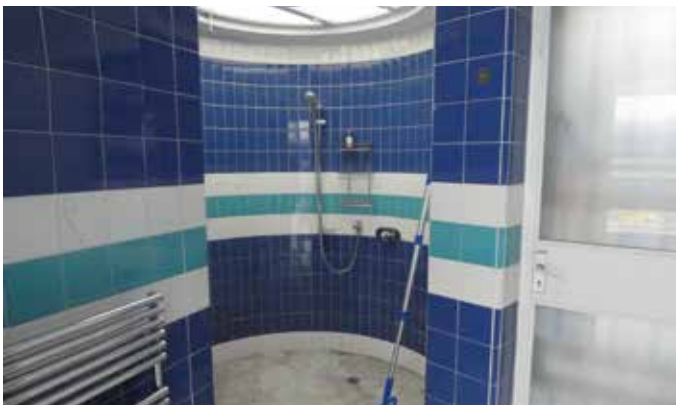
13. Interior view of the shower area

None of the existing fixtures and fittings within the pool building are original, or of any significance, evidenced by the image below showing the original fixtures within the shower. It is therefore intended to replace the existing fixtures and fittings with new.

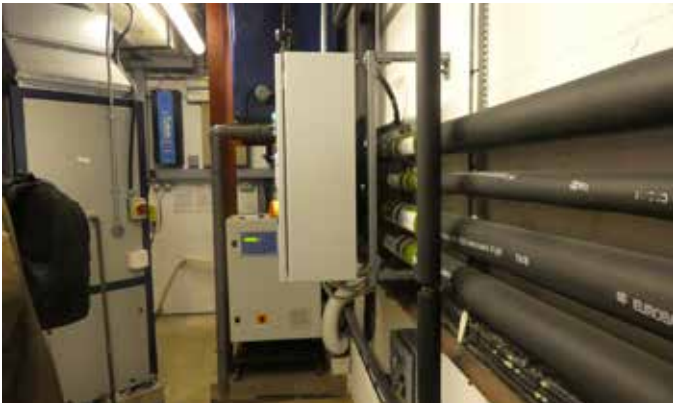
15. Existing Pool Plant

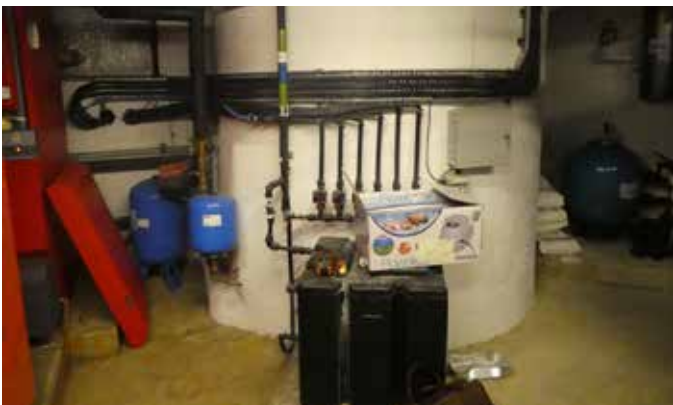
16. Existing Pool Plant
