Heritage Statement

Internal Structural and Fabric Repairs, 28 Russell Square

March 2018

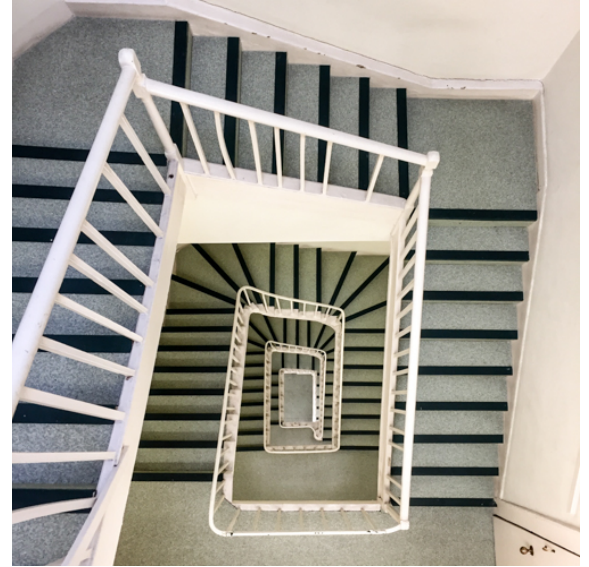
Image 4, View of Rear Staircase

The approach used to the repair of the rear small staircases is identical to the main staircase. The upper flight is of timber framing and has suffered considerable distortion and some previous efforts at repair by installing a boxed out downstand and timber support. However, this boxing out repair has been ineffective structurally and is also considered to be detrimental to the significance of the staircase. The proposal is to remove this timber framed boxing, and to install a new slender steel beam with a cranked profile to match the staircase profile. The intentions are that this new steel beam will be an honest and reversible intervention to repair the staircase structure, which is currently suffering from serious and ongoing structural problems caused by the one off movement within the supporting walls of the upper storeys.

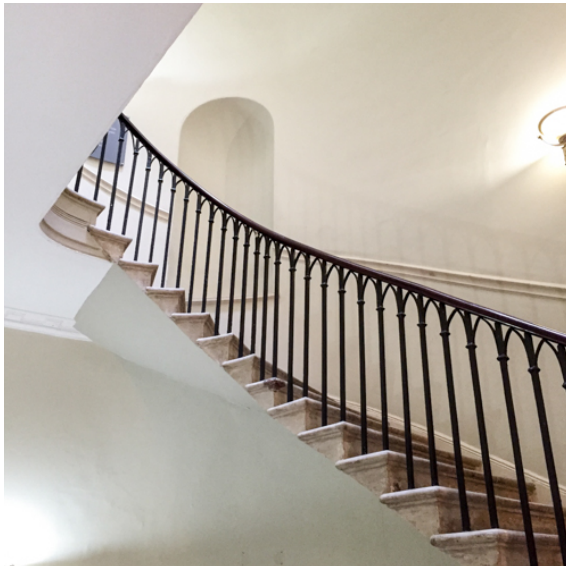
Image 3, View of Main Staircase

second floor level. However, this stair has suffered significant deformations and requires repairs.

The approach used to repair the main curved stone staircase has been to replace the existing repair mortar between the existing stone joints with a natural hydraulic lime mortar putty that is rammed into the joints. It is intended that this new mortar will be installed throughout all of the staircase joints and provide a sustainable long term solution that deals with the effectiveness of the wall distortions caused by the inappropriate removal of the lower ground walls within the house, and also possible issues created by the use of other repair mortars used previously. The top step of the upper flight requires a more localised repair, possibly using resin bonded steel dowel bars through the stone and keying into the upper landing structure which is of timber framing. The precise form of these repairs will be the subject of detailed investigation once access and support scaffolding has been installed. However, it is intended that any repairs will not adversely affect the appearance of the upper tread, which is badly separated from the main flight at present.
