30 Euston Square

*Fire protection for the heritage rooms of
the Royal College of General Practitioners*

**Design and Access Statement
Incorporating a gazetteer of doors**

March 2018

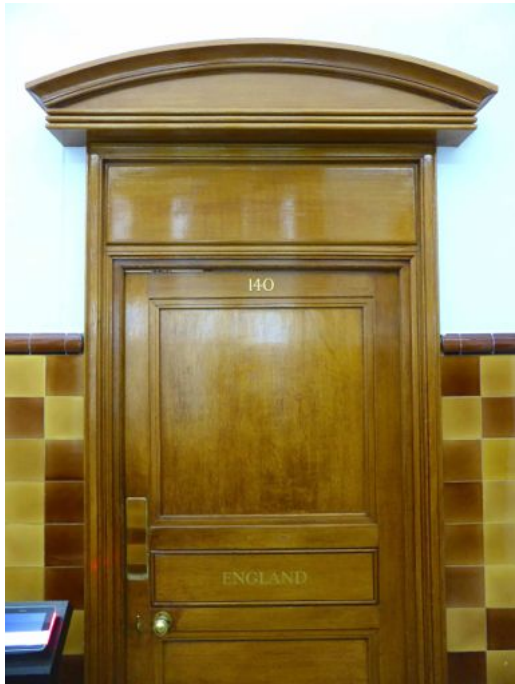
Fig.16 Pedimented frame with overpanel

The entry door requires perimeter work to reinstate a close fit to the frame as part of achieving fire compliance. Original ironmongery is particularly important to the door. Any decorative works to the doors must ensure that the ironmongery is handled extremely carefully.

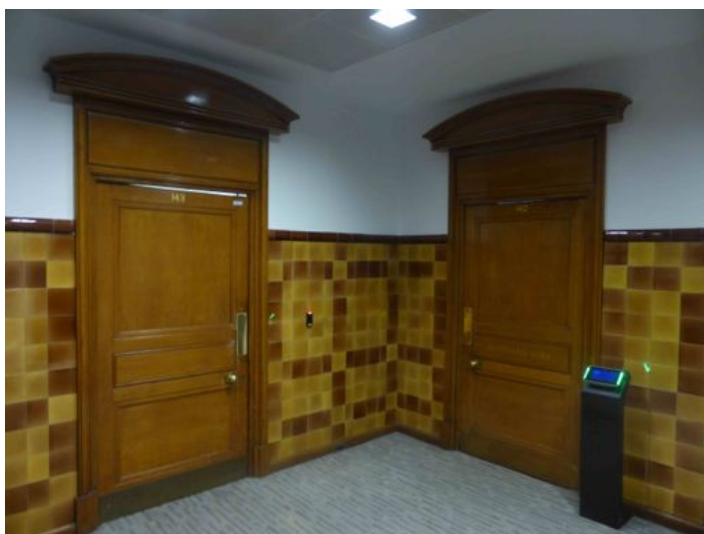
Fig. 27 Oak Scotland Alba door 6 to the right in context with door 7 within a fire compartmented lobby

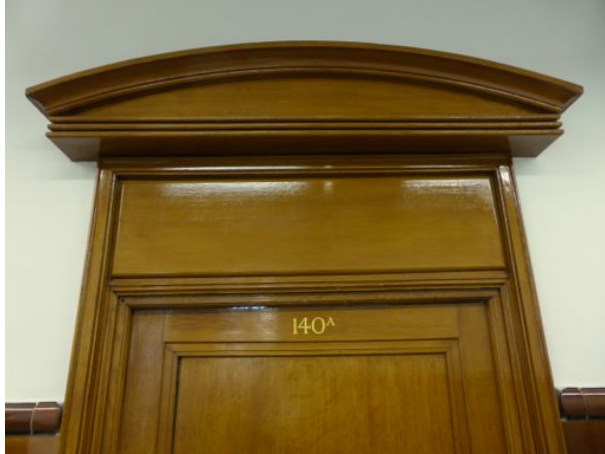
Fig. 29 Arched pediment to minor boardrooms, note signwritten numbers (and room names)

Noted in the listing are well presented pedimented entry doors, ref. Gazetteer comments on the individual room. Externally the varnish is overly reflective but has not affected the colour of the oak in the same detrimental way as the interior of the doors. Any future redecoration works to the corridor (or any necessary repair work to inadvertent damage) needs to have in place a specification for refinishing the doors. Corridor-side ironmongery should also have the lacquer over the polished finish removed so that an authentic patina of use can moderate the overt difference visible between the new and old handles. The gaps to the doors requires attention for Fire safety reasons.

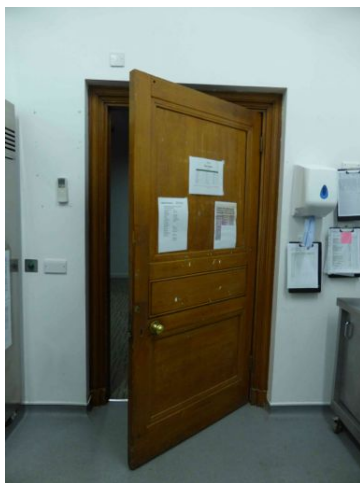
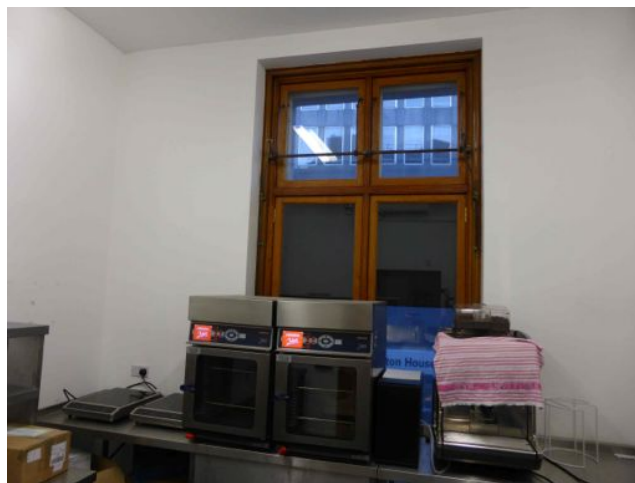
The Servery door is in good condition (Fig. 21), albeit a heavily used door given the Servery use, a new locking mechanism has created interventions into the leaf however this is part of the extended life of the door and inevitable. Issues of fire seals and hinge suitability apply as with the other minor boardrooms.

Figs. 30, 31 interior of Servery door (pedimented to lobby), no other features of significance remain within the room
