Area 6. PAR area to the east of the concrete path by pond.	Restoration works

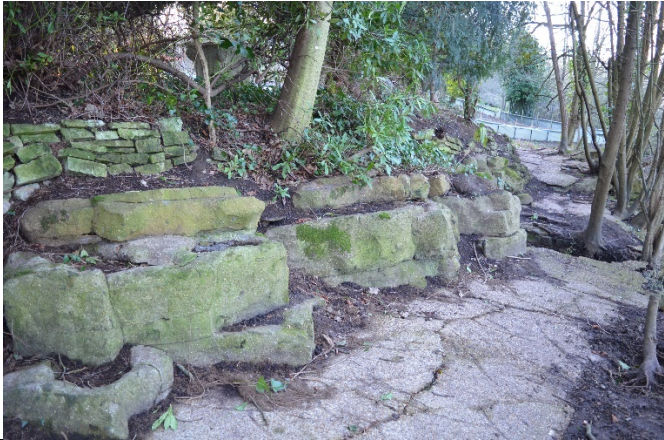
<p>6a. Tree no 2960 (at the north end of area 6).</p> <p>Pulhamite outcrop is built into the bank with plant pockets with natural vertical fissure through the centre of the outcrop.</p> <p>There is a loose lump of brick burr sitting adjacent to outcrop.</p>	<p><i>The edges of the PAR will be defined by drawing back soil that covers the top and edges.</i></p> <p><i>Loss of PAR to the north end, due to cracking and surface loss, will be consolidated.</i></p> <p><i>Ivy growth is evident and will be treated with herbicide. Local trees will be managed for root growth control.</i></p> <p><i>Retain and store loose burr section unless an area of missing material is found.</i></p>
