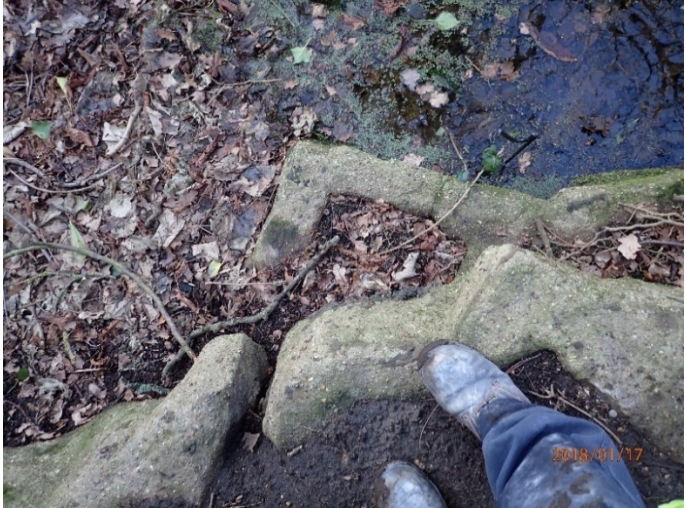
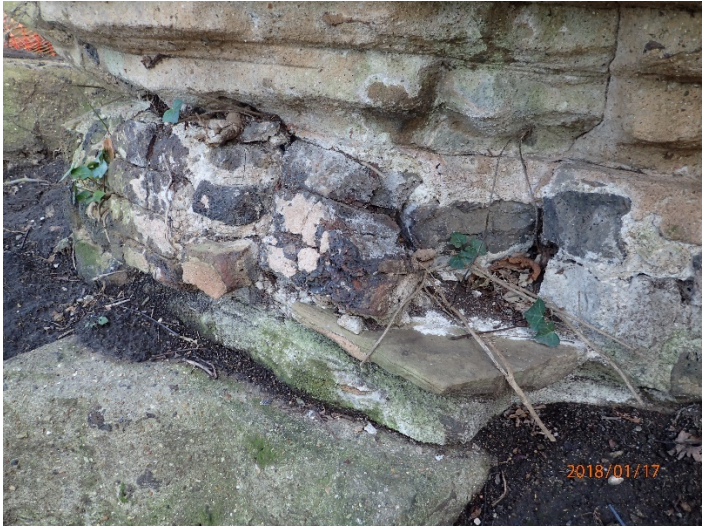
<p>Note the area between tree no 2974 and tree no 2972, i.e. between areas 4a and 4b: may require some gentle excavation to see if any PAR is buried and to define the limits of the two large outcrops (4a and 4b).</p>

There is some PAR adjacent to the path and there is a collection of bricks and rubble down at the water line.

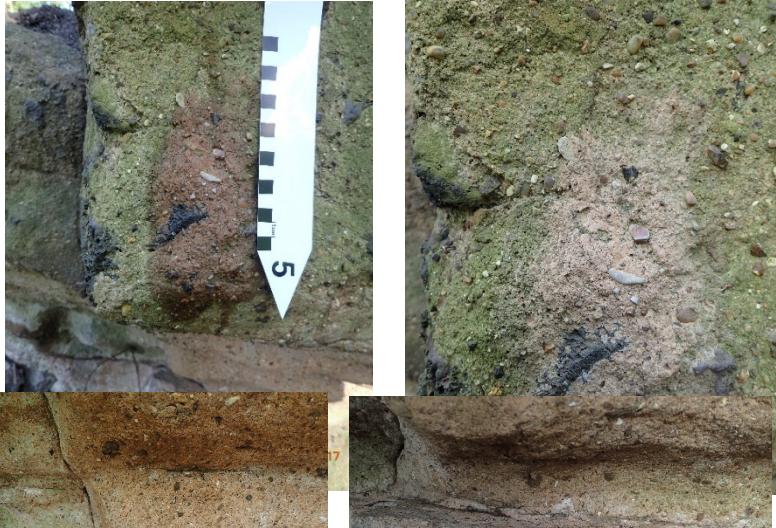
There is some evidence of both slate and sandstone slabs being used as the basis for the cantilevered sections, but generally such areas are not exposed, and the PAR coating is not lost so it is hard to determine the exact nature of the construction of the cantilevers.

Surface texture is variable between strata and this is mainly a function of the quantity and size of aggregates in the mortar. This is an intentional design variation to emphasise the difference in the geological strata. As a rule, the finer softer recessed beds will have less aggregate and the more projecting strata heavier and larger aggregate content. This characteristic reflects the qualities of hard rock strata (with larger aggregates) and softer more eroded strata with finer aggregates.
