Tree inspection & Decay detection Report

Lombardy poplar tree

10 Fitzroy Park
London
N6 6HU

Tree No.: 1 **Species:**
Populus nigra 'Italica'
(Lombardy Poplar)

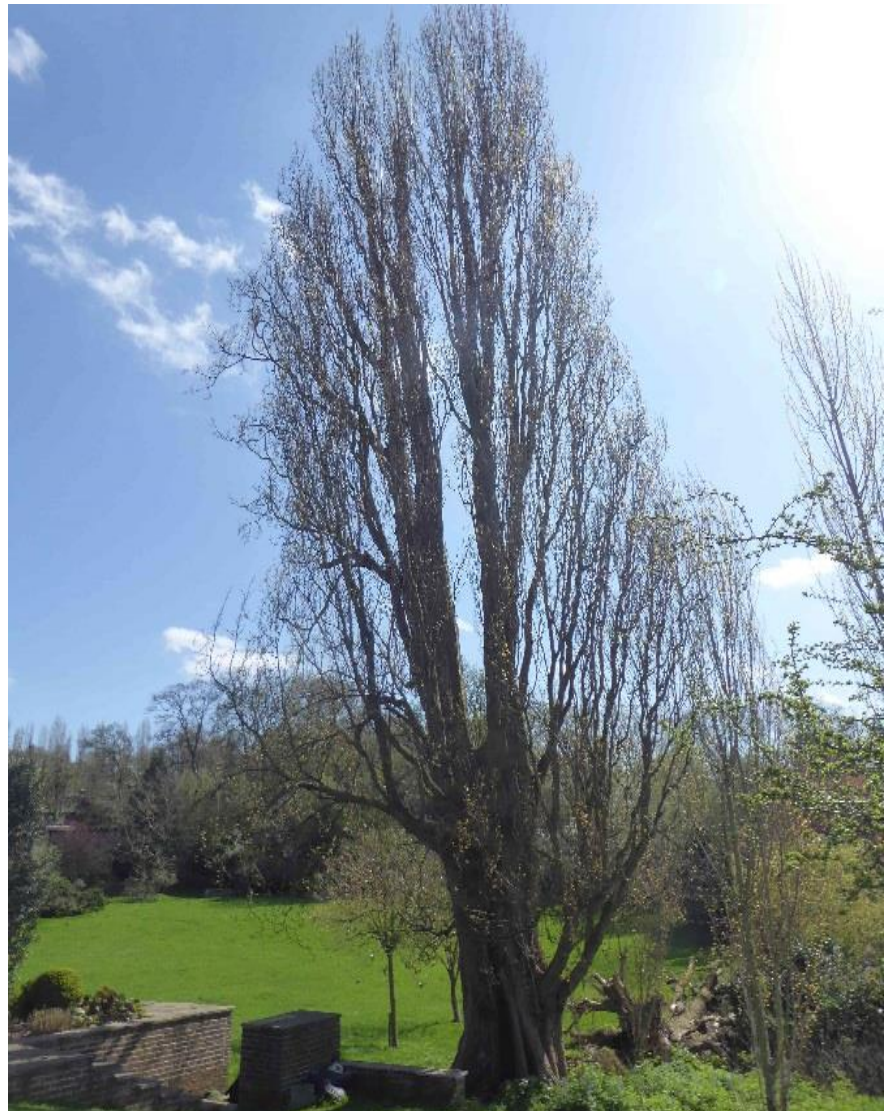
Structural Condition: Poor.

- Buttresses / buttress roots - Major adaptive growth / strong development.
- Crown reduction - Historic.
- Deadwood - Major.
- Decline - Suspected.
- Epicormic growth - Crown.
- Leaning trunk - Minor.
- Root decay - Suspected.
- Suppressed crown - Major.
- Unbalanced crown - Major.

Surveyor's Note: Unbalanced crown due to neighbouring tree which failed recently.
Sounding mallet test - hollowing suspected in buttresses to the north and 'rib' to the west (by mp4)
Root decay suspected following historic topping.

Fell tree to ground level due to poor structural condition, with deteriorating wood condition in stem and base and probable root decay – works recommended to remove risk of tree failure on to neighbouring property and recreational features near the tree
