SUMMARY OF PROPOSED WORKS

CLIENT Venoru Ltd	
PROJECT 49 Marchmont Street, WC1N 2AN	
DRAWING PROPOSED FOURTH FLOOR (ATTIC) PLAN FOR PLANNING PURPOSES ONLY NOT FOR CONSTRUCTION	
DRG. No 14	REVISION C
SCALE 1:50 @ A3 PAPER	DATE 4 April 2018

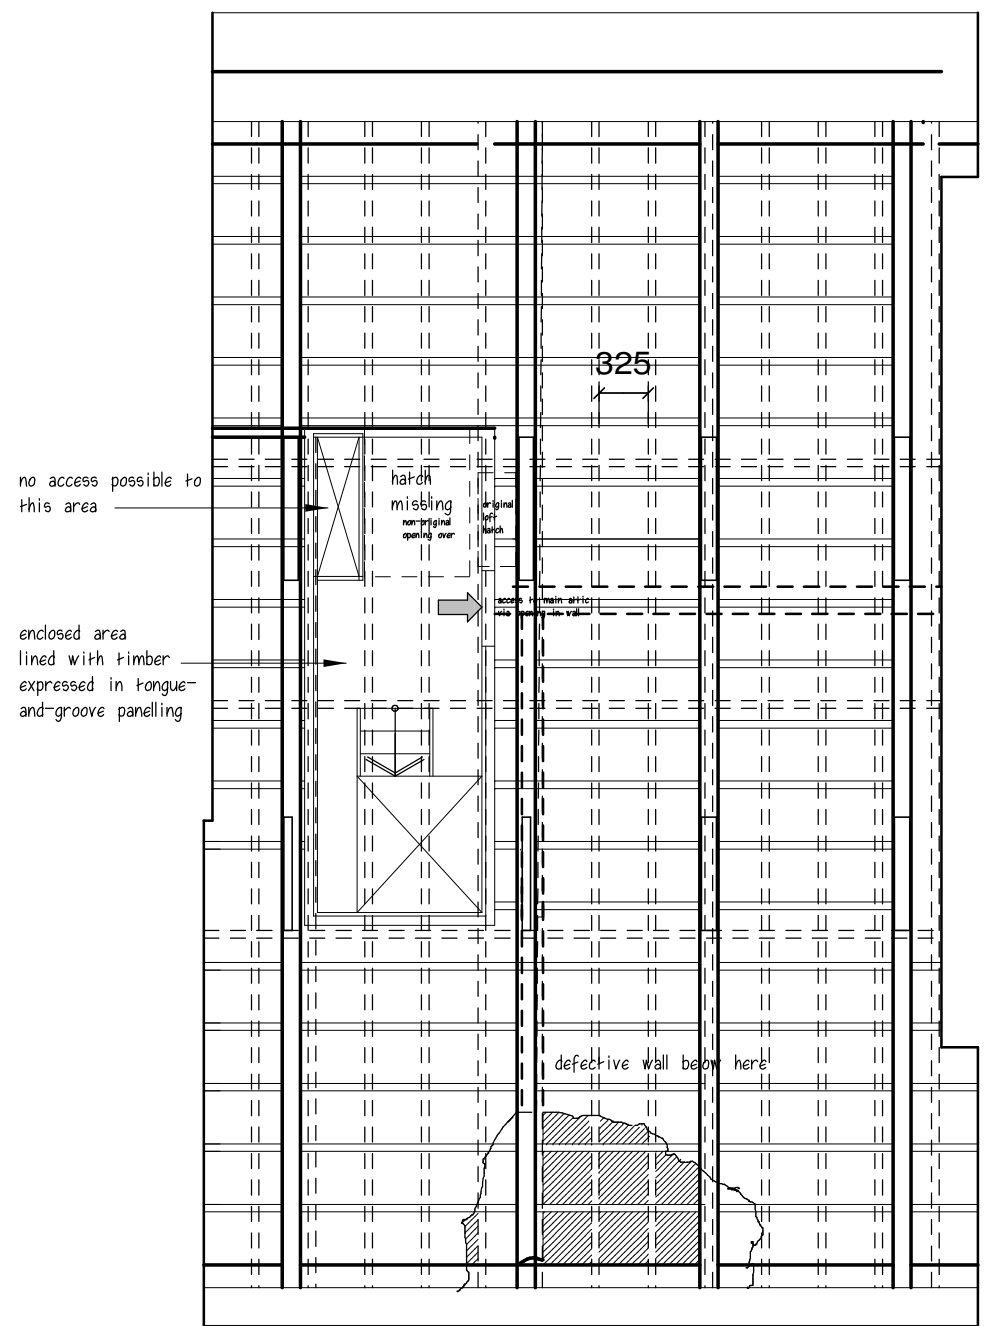
PROPOSED ATTIC (4th) FLOOR PLAN

1. Intermediate ceiling joists
 Many of these are rotten and lack integrity especially at the eastern end where collapse has occurred
 these are to be repaired where possible using scarf joints or methods outlined to the right or new ceiling rafters to be placed alongside existing
2. Main trusses - see section also
 The bearing ends especially adjacent to the failed parapet gutter on the east elevation are rotten and defective
 The ends are to be carefully propped and new ends scarfed in - see diagrams adjacent to illustrate the typical approach
3. Rafters - have been inspected for rot and damage - whilst some may be beyond repair the intention is to retain as many original timbers as possible. They are to be left in situ
 However, long-term neglect, water ingress and continuous saturation have left many rotten at the bearing ends - of which many in a critical condition

GUTTER BOARD AT PARAPET
 (NB - Access not possible to west (rear) elevation because of window collapse)
 The gutter board has entirely failed and will need to be replaced entirely

ALTERATION
 The drop at the base of the slates and the lead gutter was inadequate and explains the water ingress ideally a drop of 150 mm from tile to gutter base is required therefore the bottom 2-3 rows of slates are to be sprocketed to lift the height between tile and gutter

DIAGRAM ILLUSTRATING AREAS OF SEVERE DAMAGE

Principle of repairs
 wherever possible timbers to be repaired with timber
 be it splints, or scarfed - only if structural engineer deems it necessary will
 fitch beams or steel plates be introduced.
 please see summary of approach to be taken exemplified in pictures and diagrams opposite

Where possible rafters are to be "doubled up" and loads borne by adjacent new timbers placed alongside them
 And or ends to be carefully replaced with scarfed timber inserts

The adjacent rafters will need to be temporarily propped, defective timbers cut away and replaced
 It is not clear if this can be done unless the roof is stripped and all defective timber cut out - when the rafters and trusses are being repaired too

THERMAL PERFORMANCE
 A new thermal layer is to be applied between the ceiling joists creating a cold attic
 - a hemp based thermal insulation with excellent breathability properties has been selected
 As the ceiling joists are quite shallow
 - loft extenders are to be fixed to the ceiling joists to extend vertically the area that can be insulated
 - to a min depth of 300mm

Timber scarfed to existing, wedged and bolted top to bottom
 Stainless steel fitch plates bolted into beam and bolted side to side
 Timber splints planted on either side and bolted through
