# Claim Assessment Report

**Our Reference:** IFS-LBG-SUB-17-0073223

**Risk Address:** 8 Brookfield Park, London, NW5 1ER

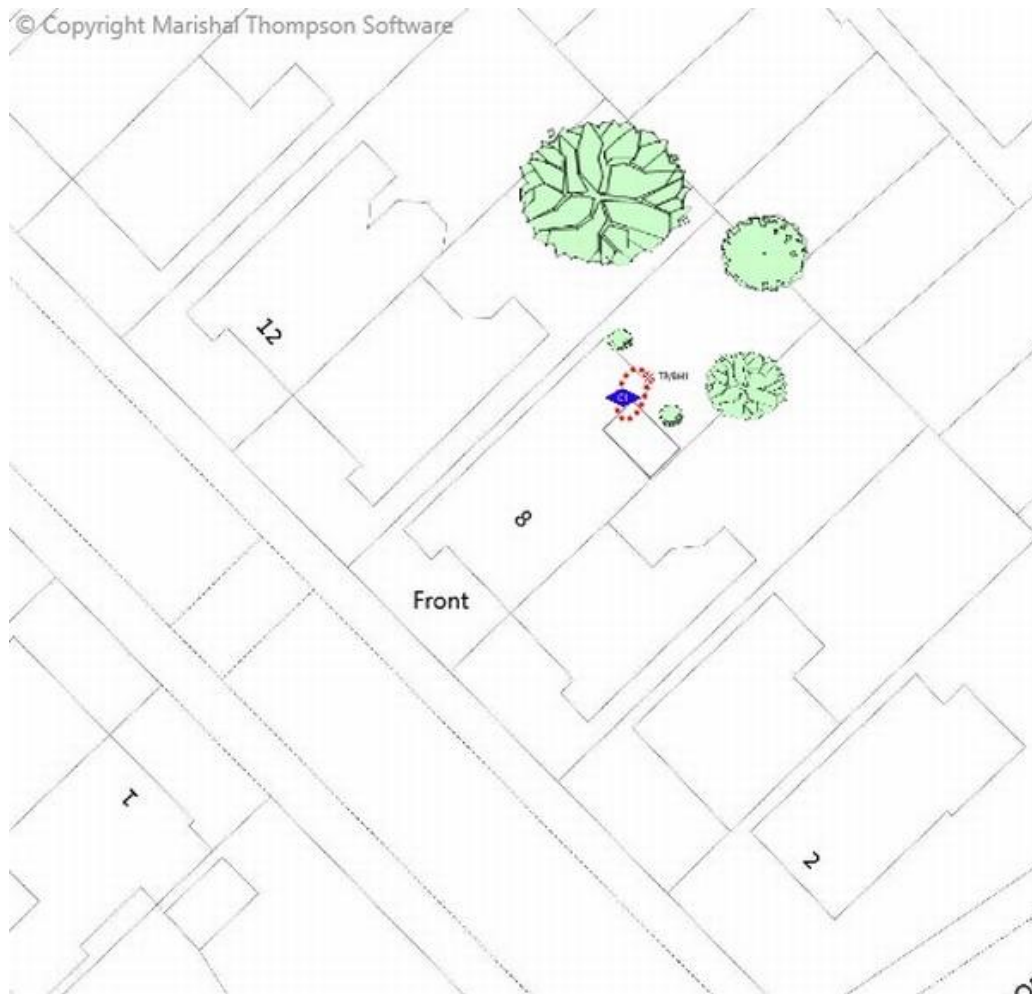
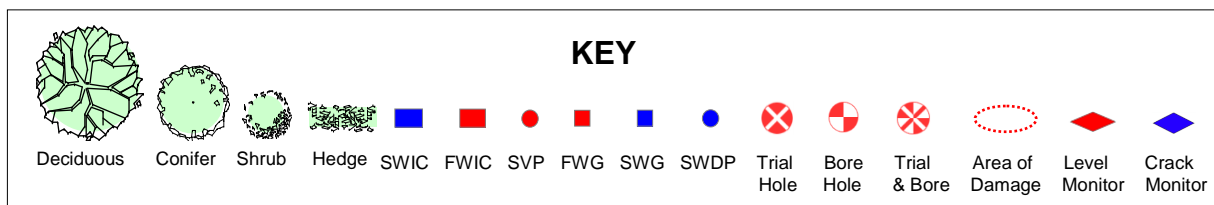
FIGURE 1 Site Plan

Foundation movement to the right corner of the extension in relation to vegetation in the rear garden results in the crack damage and distortion now evident.

The proximity of the trees suggests these are the most likely moisture extracting influence. Following removal of the trees the property can be repaired.
