St Giles: 7 Denmark Street

Timber Roof Structure: Condition & Repair

May 2018

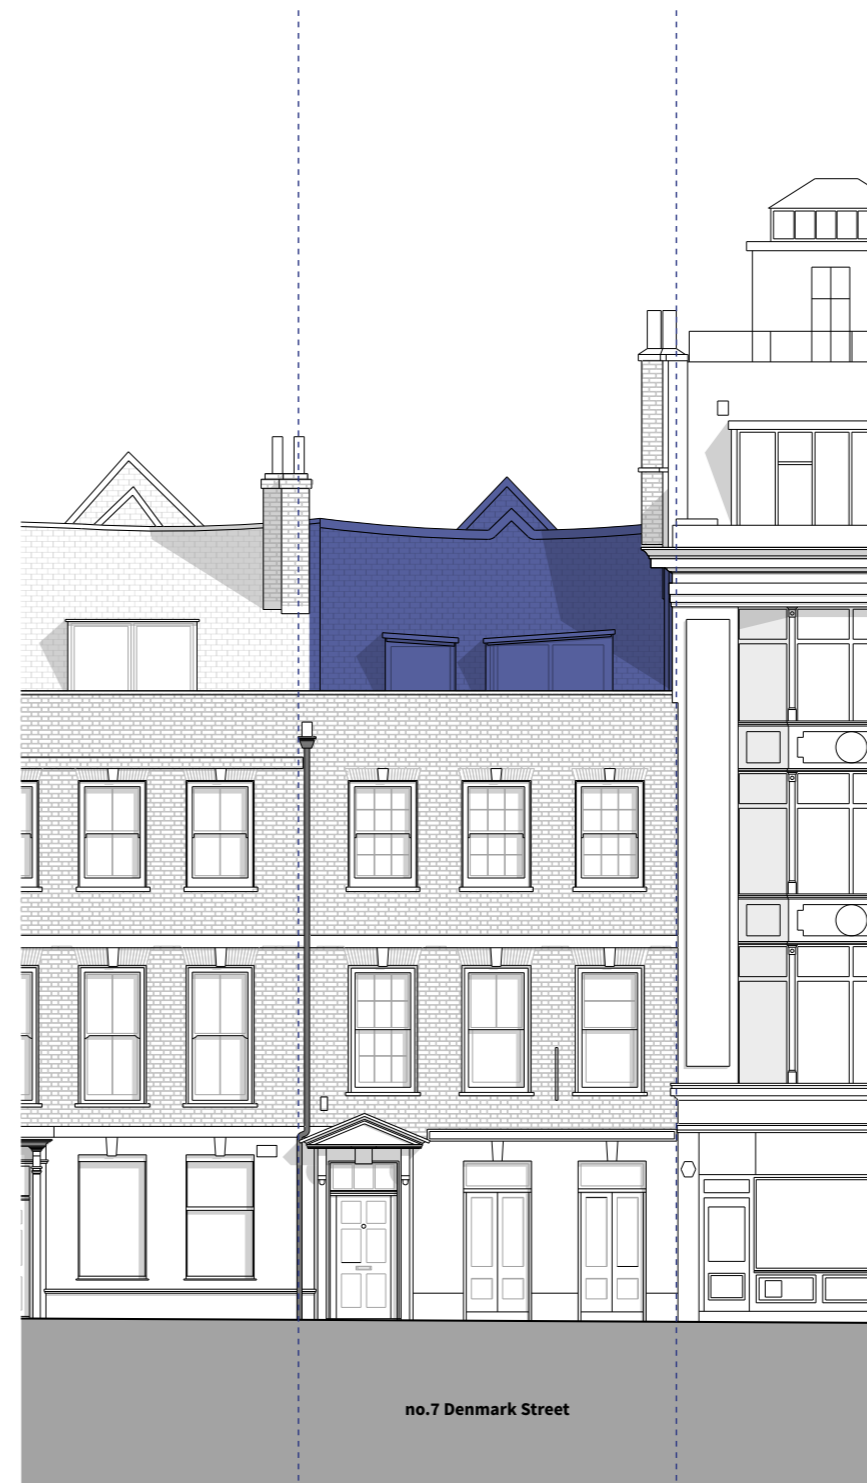
Comparing no.7 Denmark Street (righthand side of the adjacent image) and no.6 Denmark Street (lefthand side) highlights the amount of repair required to no.7.

The purlin, rafters and joists towards the front of the roof are all suffering from rot and severe deflection. Having examined the structure and historic fabric, and building upon the principles developed in the repairs of no.6. the following document outlines the intentions for the like-for-like repair of the original roof structure.

Scarfig of the exposed timber frame allows the repair for each individual rafter to be carefully thought through to ensure the signs of centuries of deflection and movement are mitigated.

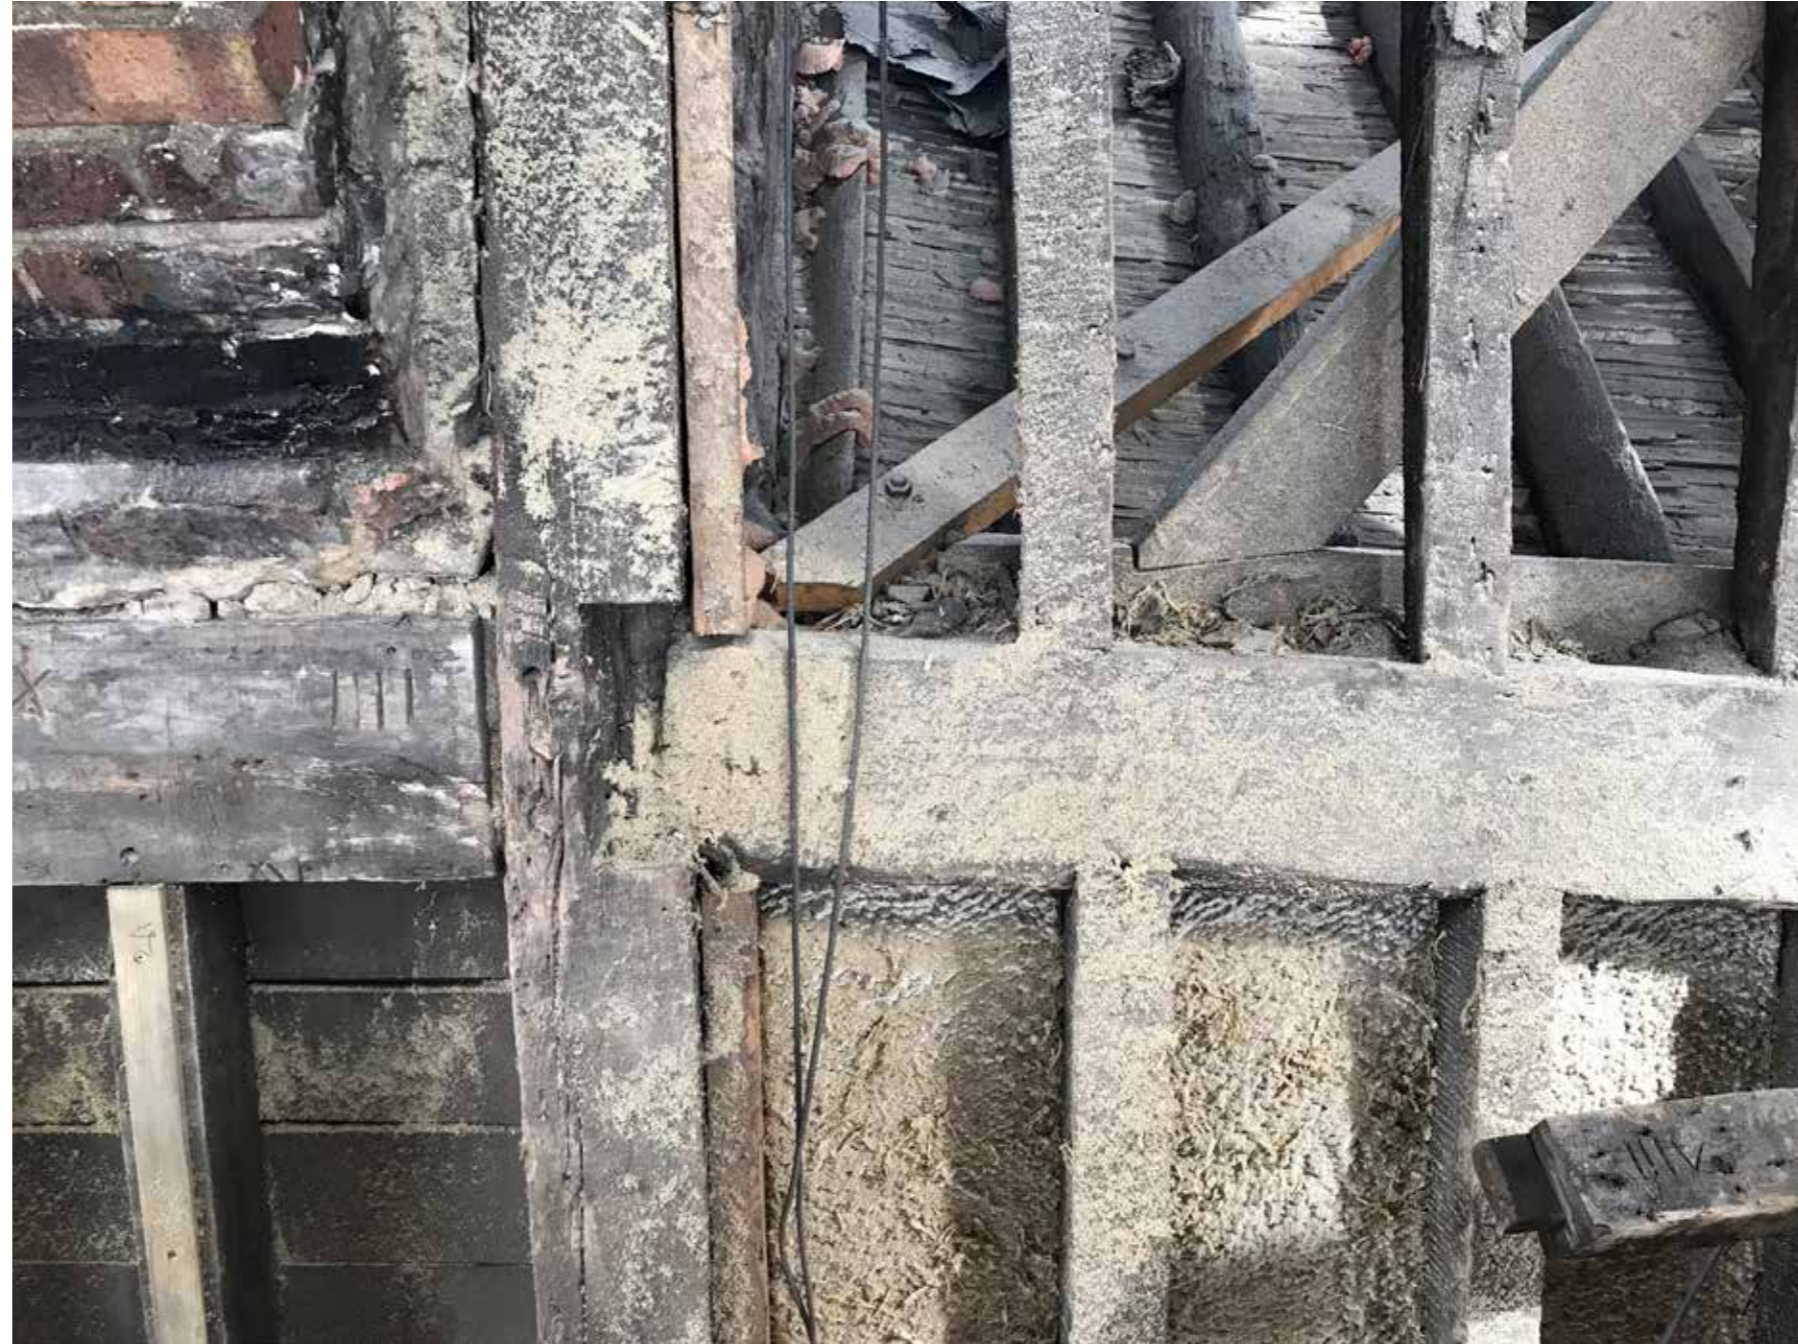
Comparing no.6 & no.7 even more closely, where they meet at the party wall, reveals how urgent the need for repair on the roof of no.7 is.

The level of deflection is so great that the purlin is being pulled from the party wall and distorting the rafters as it moves. Splits have occurred across a number of the timber members, decreasing the structural integrity of the roof. Later bracing, strapping and repairs are not solving the problem. Like-for-like repairs are required.

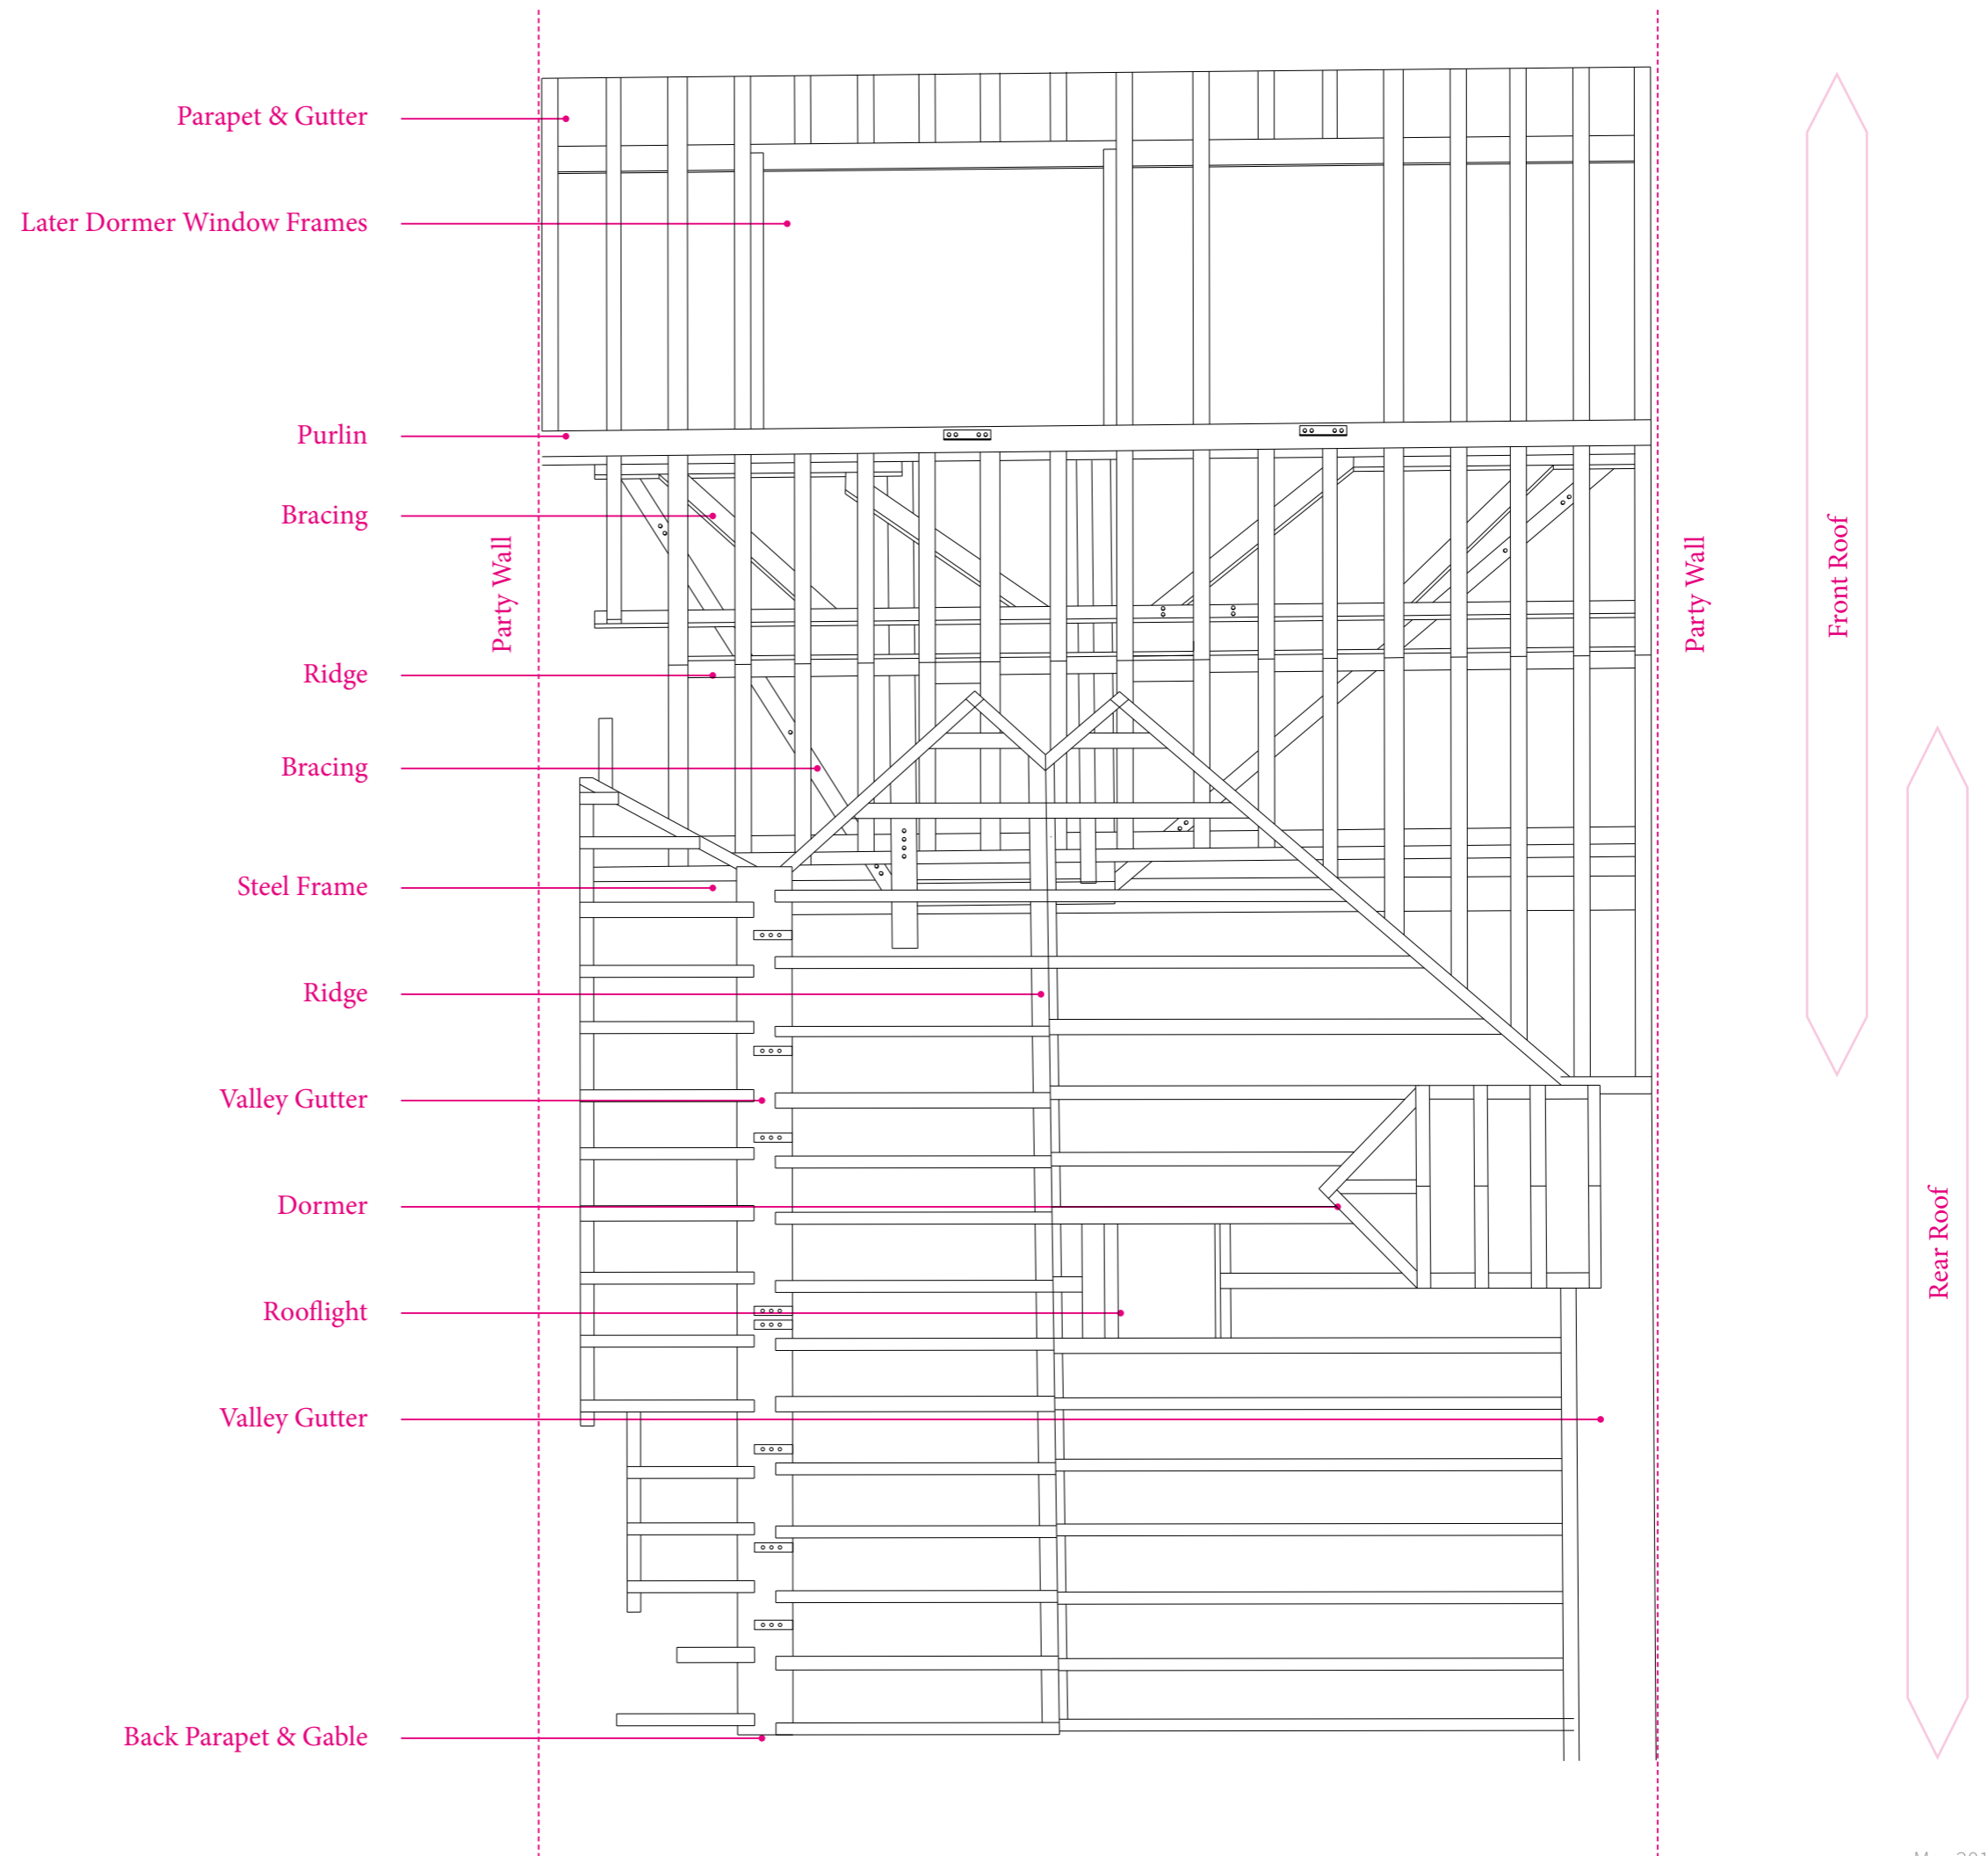
Plan of Present Roof Structure

Repairs to the roof generally exist in the void of the front roof pitch, providing the structure with greater lateral stability.

In places throughout the roof, strengthening works undertaken in the 19th and 20th centuries comprising steel cradles, plates and bolts stiffen the failing timber structure.

By replacing the front purlin, which is affecting the integrity of the entire structure, we could remove some of the redundant modifications to the roof while ensuring it doesn't continue to deflect further.

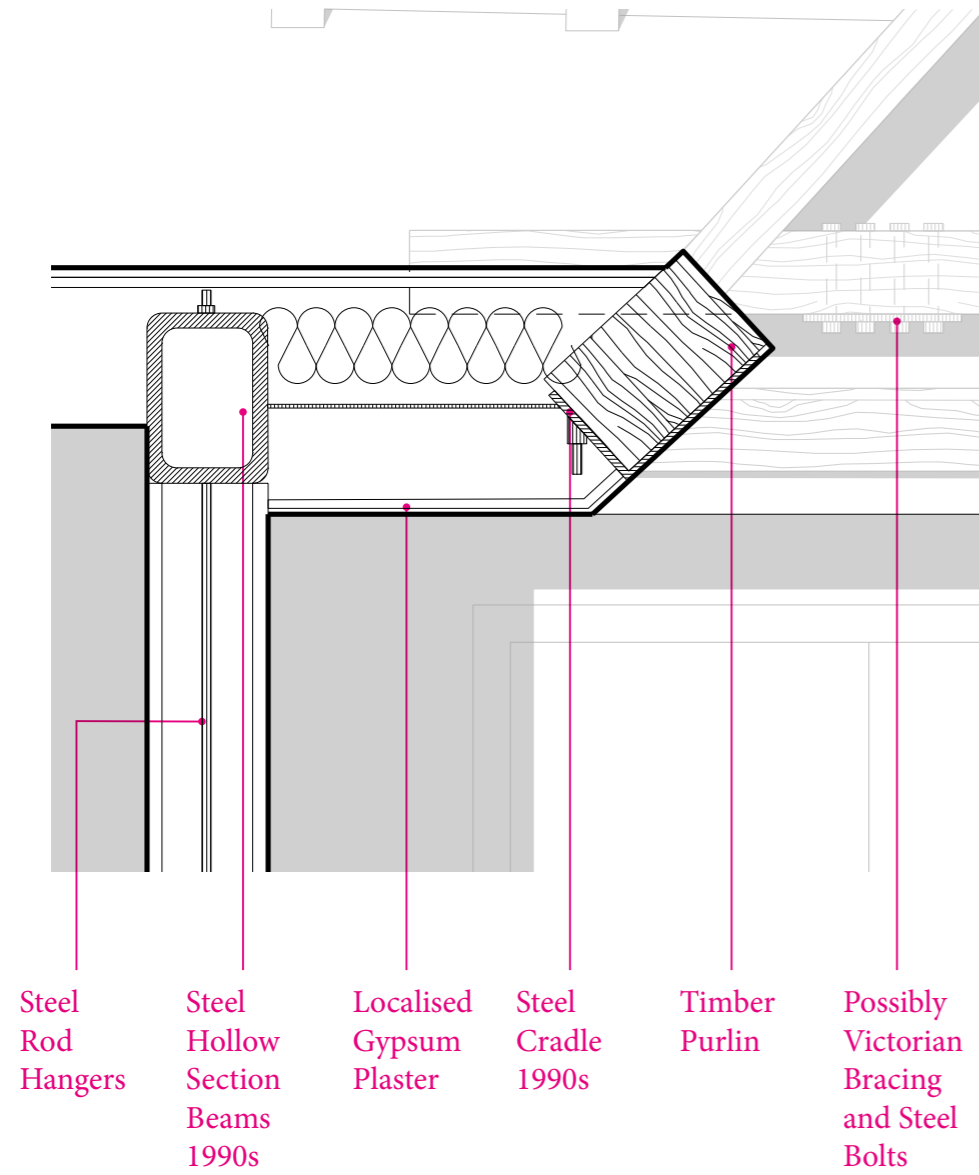
Existing Detail B

New timber bracing within the void of the front roof improves the stability of the structure. However, the current struts will no longer be needed once the replacement purlin is in place and existing rafters repaired

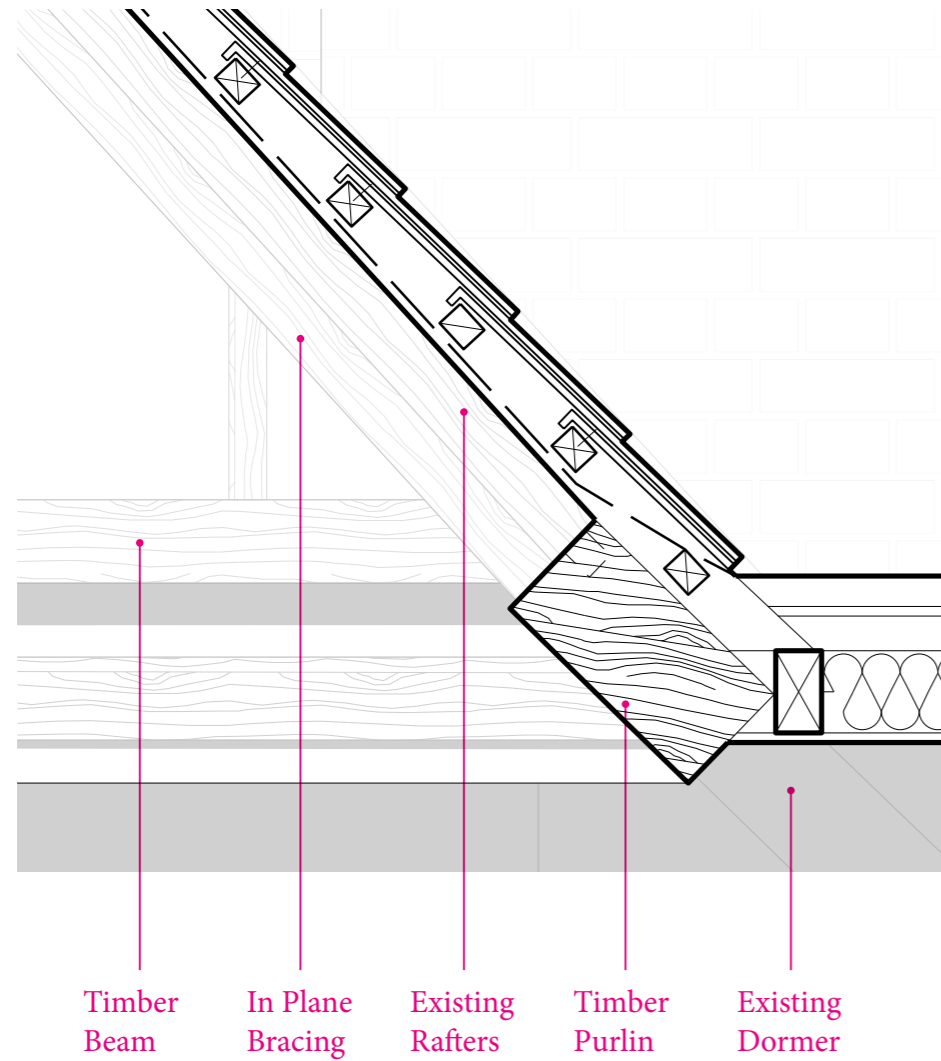
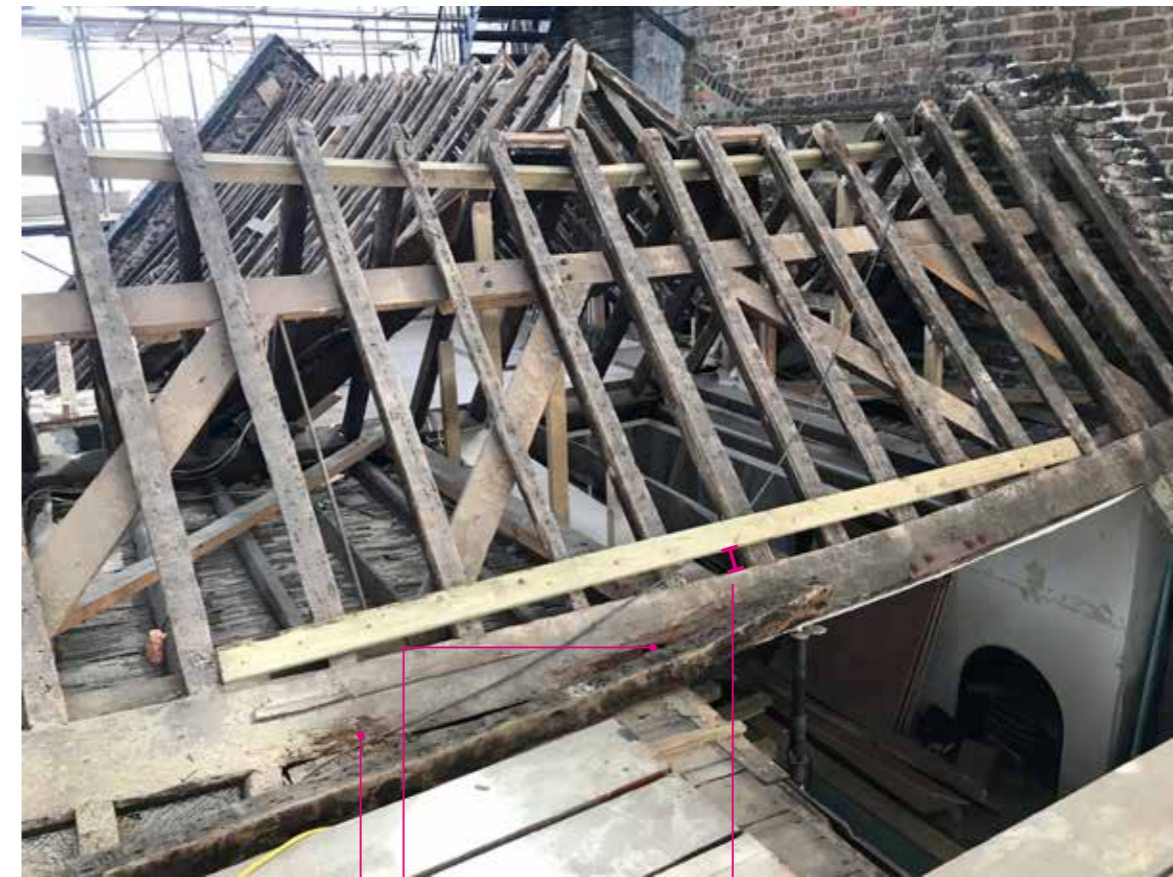
Current Purlin Location

As the image adjacent demonstrates clearly, the front purlin is patently beyond repair and will be replaced with a 'seasoned' timber purlin as a like-for-like swap

As the photo above demonstrates, the severely deflected purlin now falls below the ceiling line. The movement of this member has also affected the rafters adjoining it

The repairs seek to replace the failed purlin with a new member from which the repaired rafters shall spring. In replacing the purlin, its original height and location shall be reinstated

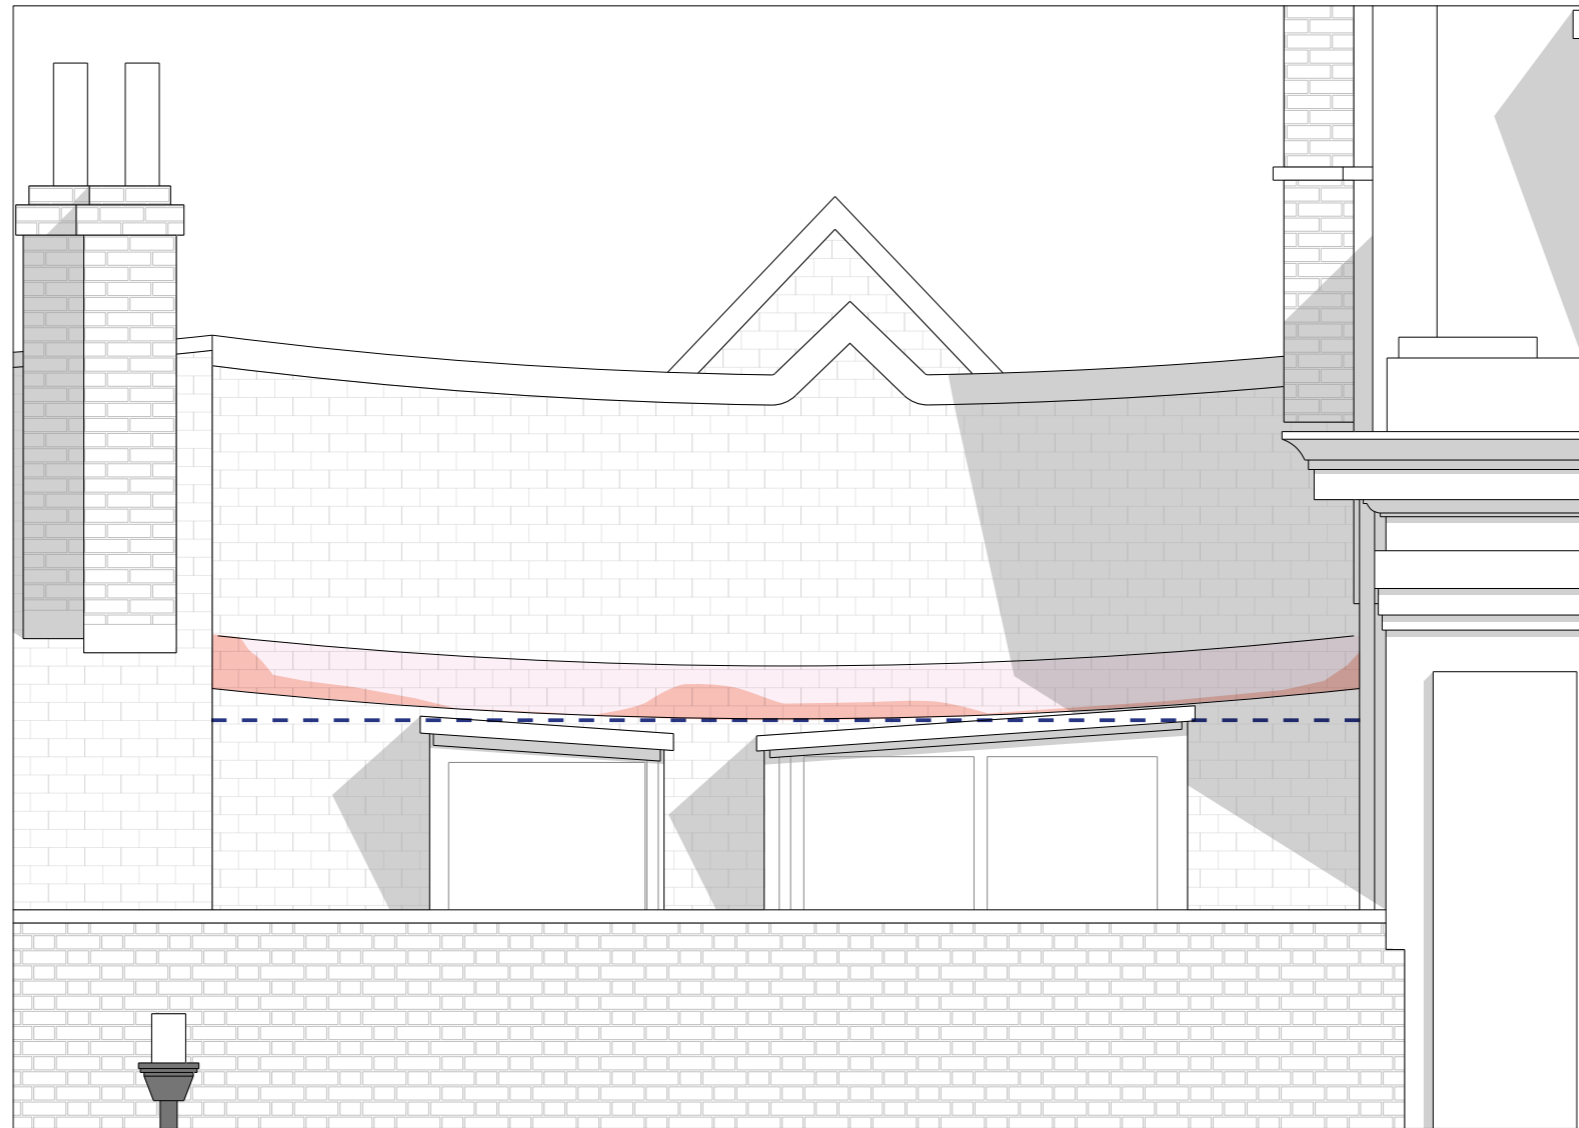
■ Rotted Areas of Purlin
- - Potential Steel Cradle Location

It was agreed that a like-for-like replacement of the purlin was the best solution, ensuring the integrity of the structure into the future and aiding the repairs undertaken to any adjoining elements of the roof structure. The replacement is to be a custom-sized green oak structural beam, sourced from the sustainable supplier, UK Timber.

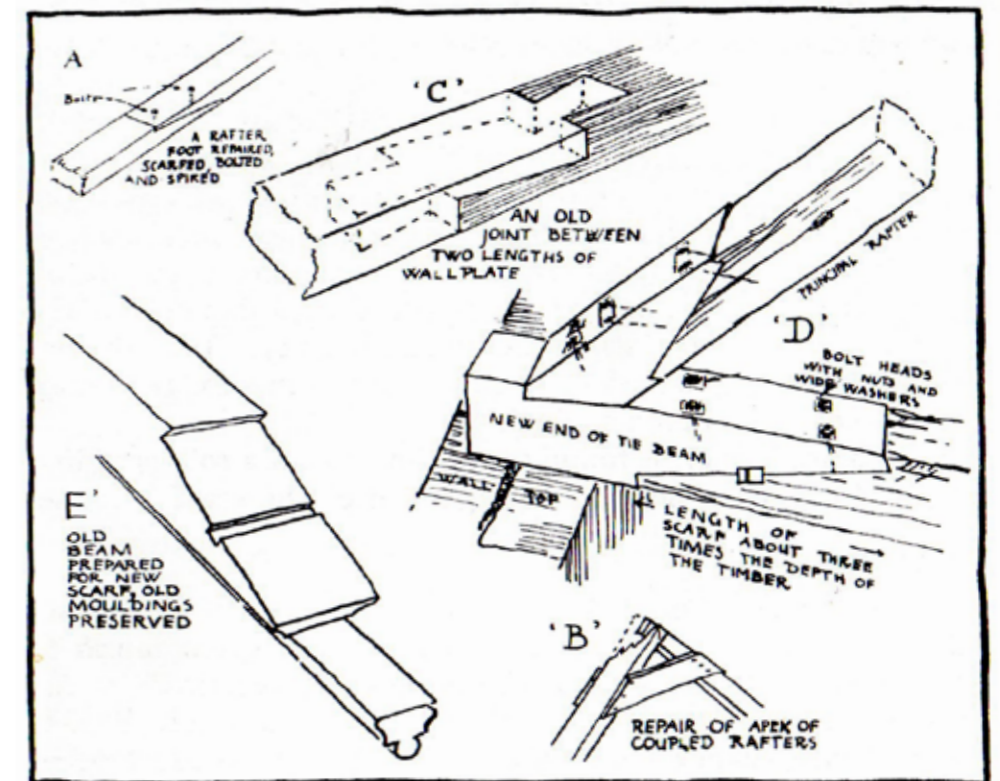
No.6 Denmark Street Rafter Apex
No.6 Denmark Street coupled rafter repair as Diagram B of adjacent S.P.A.B reference. No.7 to receive the same repairs at the apex of coupled rafters

When the apex where two rafters meet is suffering from decay, we shall be follow guidance from S.P.A.B's Repair of Ancient Buildings, as has already been done in no.6 Denmark Street:

"In coupled-rafter roofs where the tops of the rafters are becoming defective it may be convenient in the interests of economy to strengthen the junction of rafter and rafter without adding new tops. This has been done by spiking pieces of one inch thick and nine inch wide planking on each side a little below the ridge."

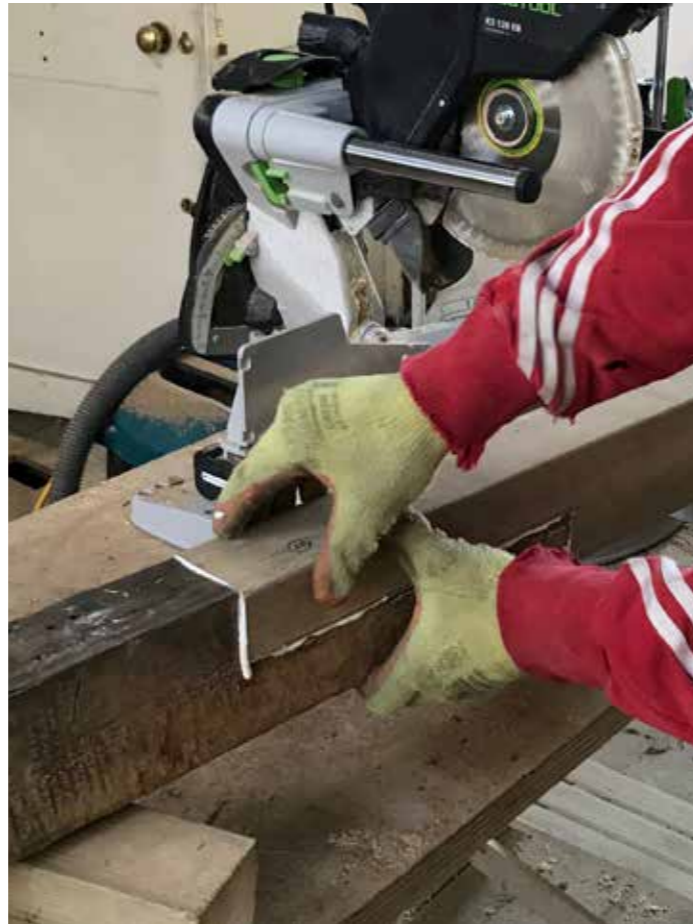
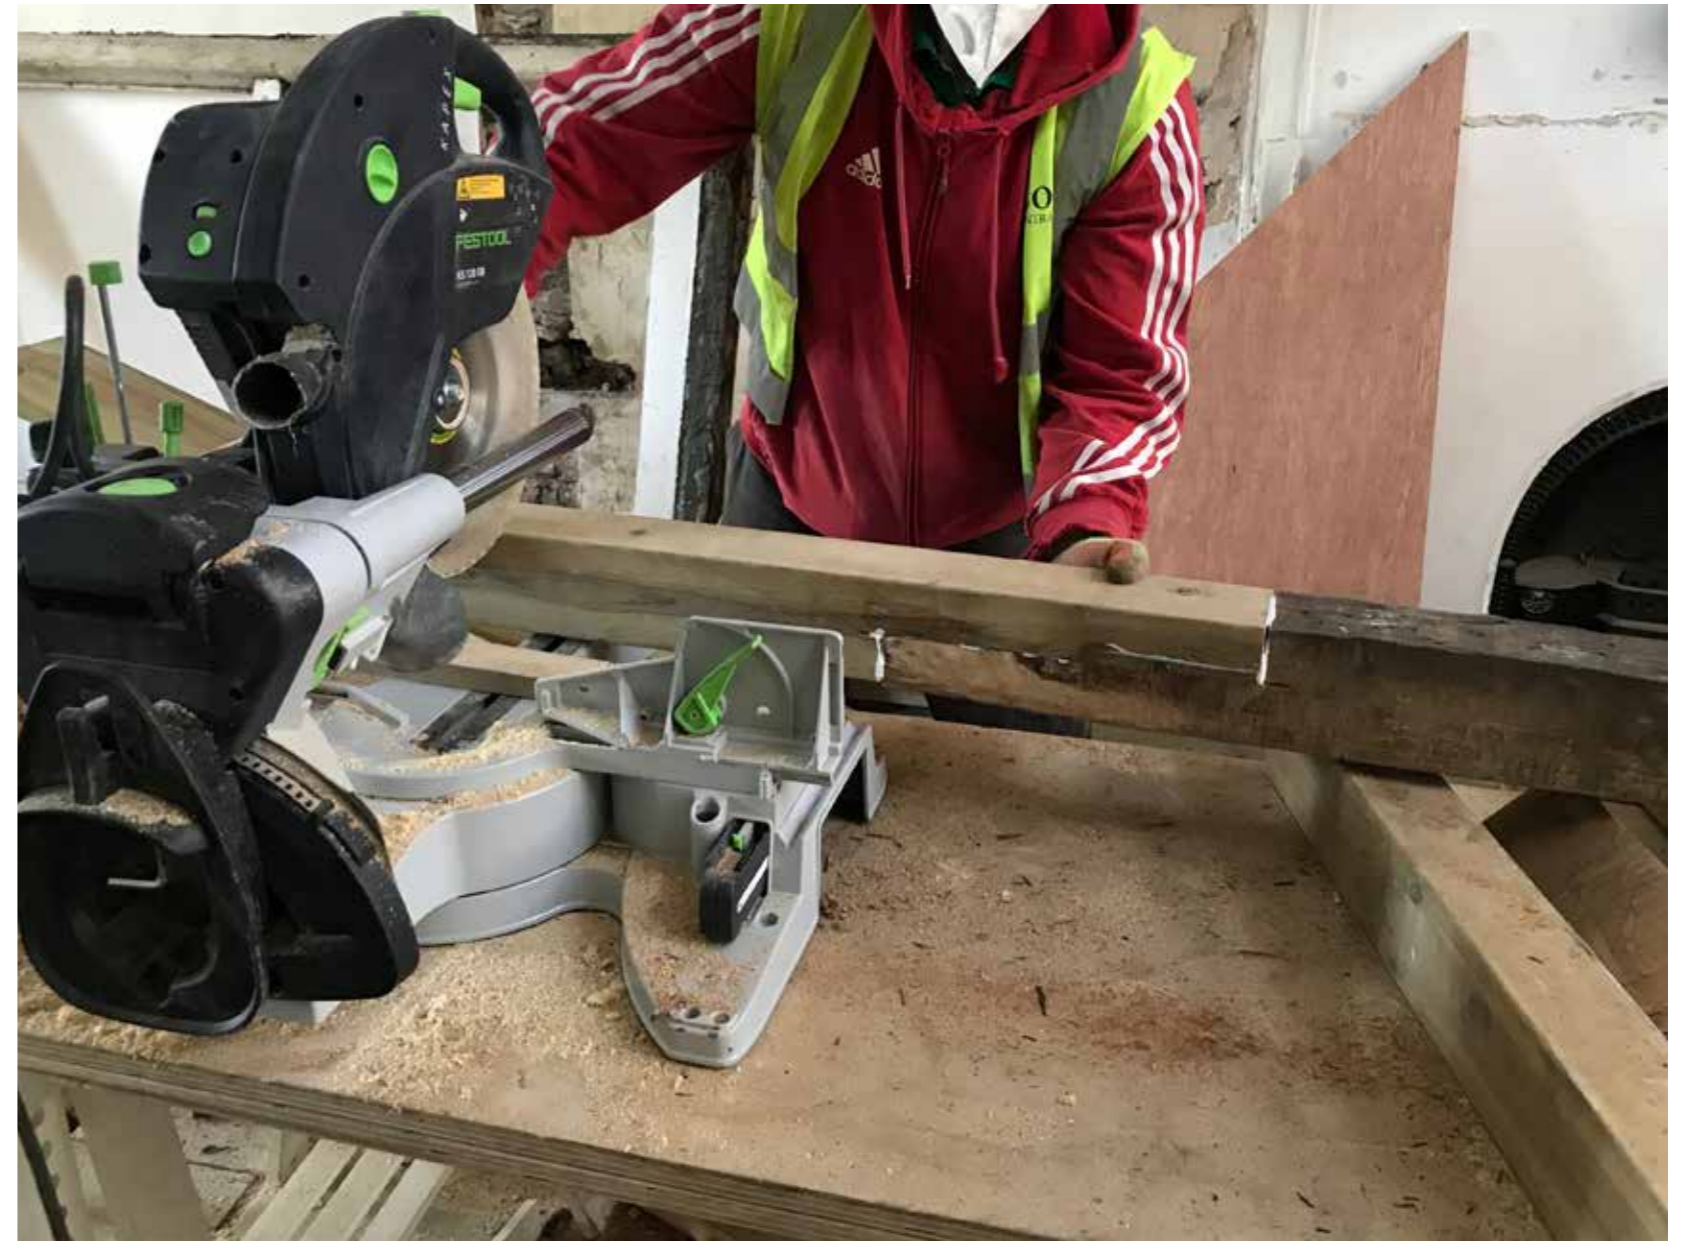
Scarfig of Rafters

Each individual rafter is assessed to ascertain the extent of the damage and how much of the original element can be retained. Following this, rotting and split sections of timber are replaced using a scarf joint.

For no.7 Denmark Street, this method of like-for-like repair shall be used to address the issues of deflection and decay occurring throughout of the roof

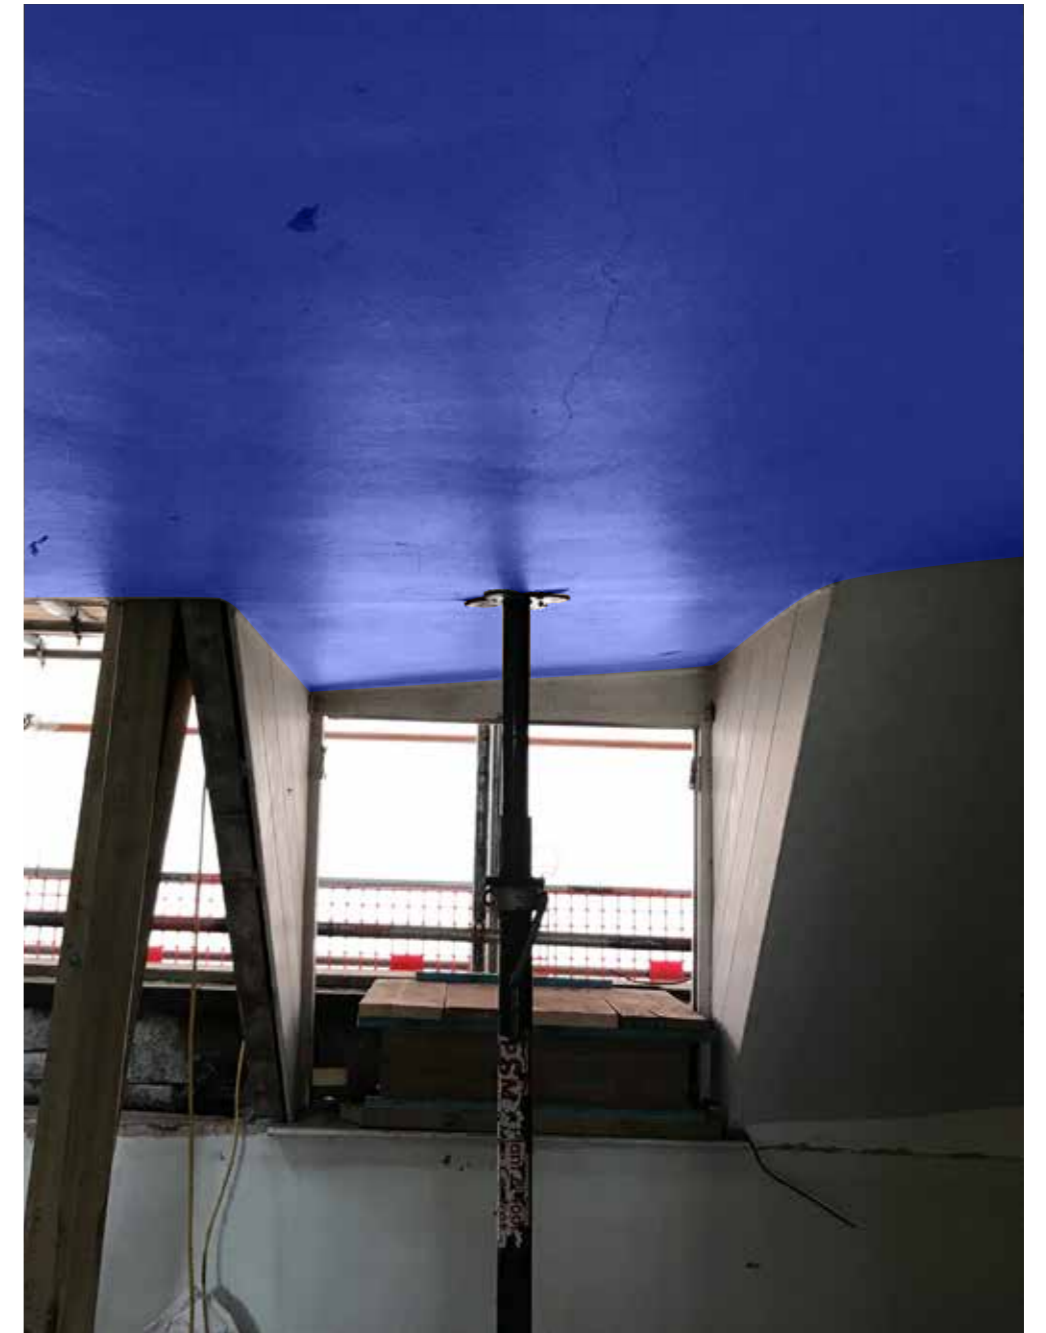
7 Denmark Street: Existing Ceiling
Plasterboard to underside of lath and plaster ceiling

Given the extent of potential repair to the roof, the planned retention of the historic ceilings could be compromised. In addition, when installing a new, straighter purlin, the ceiling would be lower than the structure, making retention more difficult.

This will be reviewed on an ongoing basis as works commence. All stages will be recorded with photographs.
