Project Title: ATHLONE HOUSE			
Drawing Title: BOUNDARY WALL SURVEY			
Scale at A3: NTS	Drawn by: BSP	Date: 30.04.18	Checked: SHL

Drawing Status: FOR INFORMATION			
Project No: 1480	Drawing Type: SK	Drawing No: BW01	Revision: -

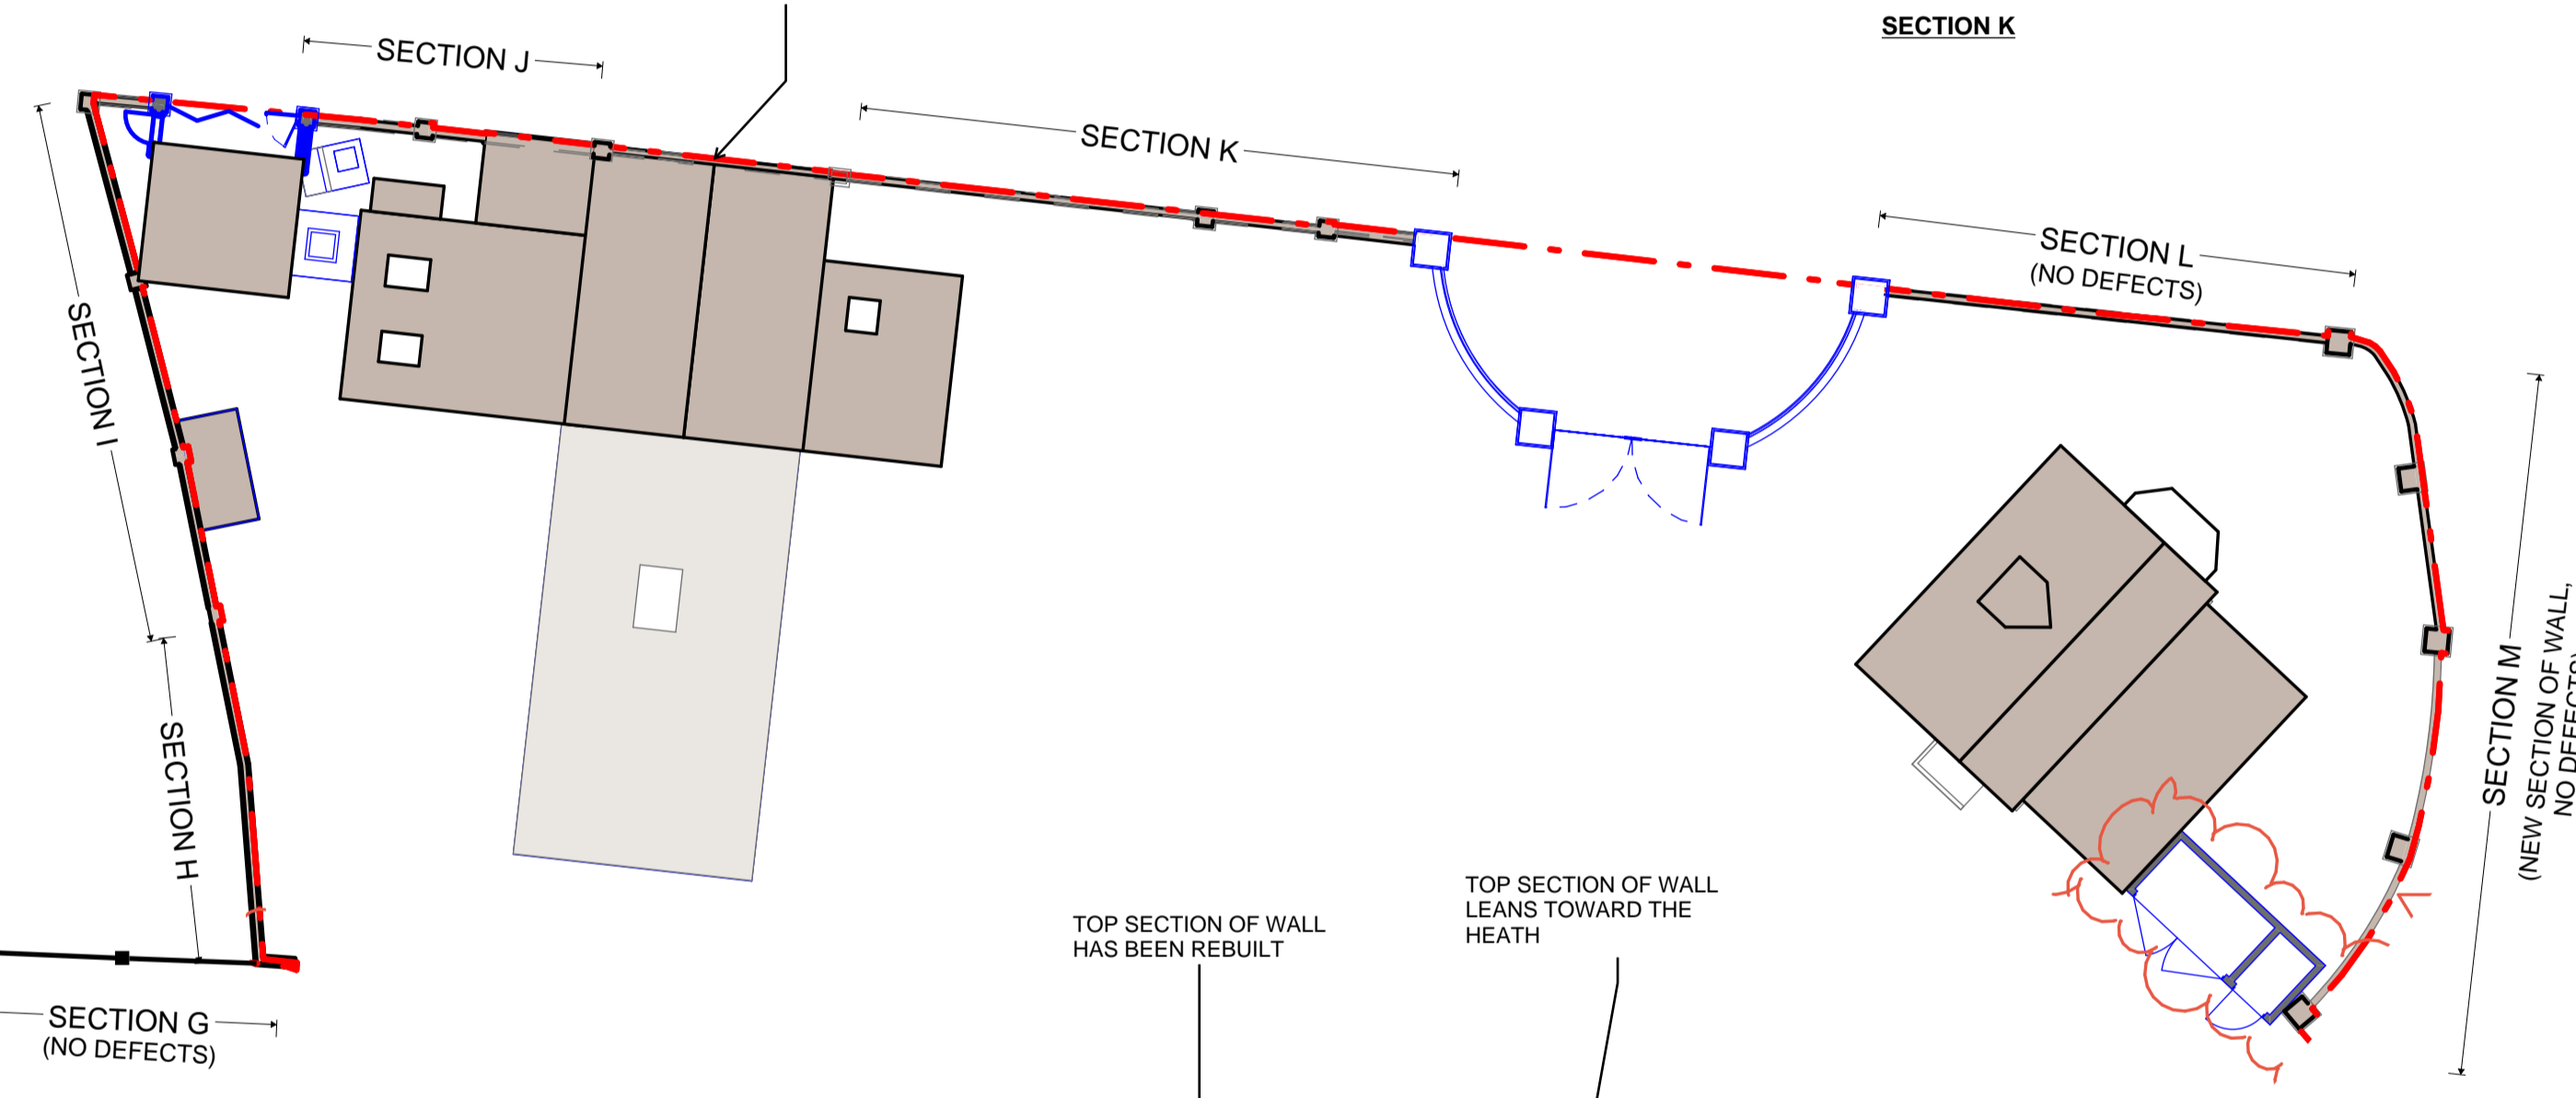
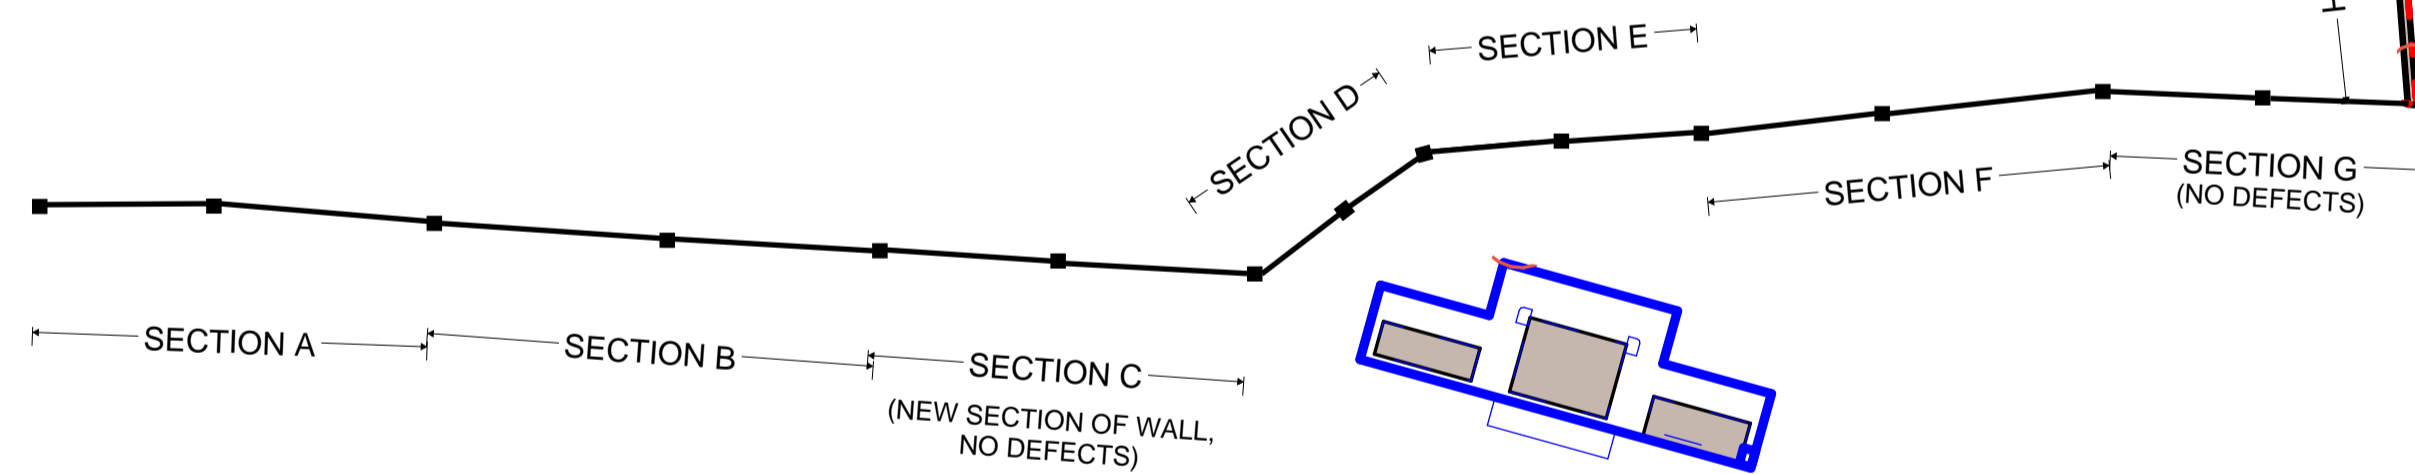
SECTION I

TRIAL PIT INVESTIGATION SHOWED TREE ROOTS HAD PENETRATED THE WALL FOUNDATIONS

RECOMENDED REMEDIAL WORKS
LEANING SECTION OF WALL SHOULD BE CAREFULLY TAKEN DOWN TO GROUND LEVEL AND REBUILT VERTICALLY, FULLY BONDED TO EXISTING WALL AND PIERS. TREE ROOT SHOULD BE EXPOSED AND CAREFULLY CUT AWAY AND BRICKWORK MADE GOOD
