Our Ref: 8334

FLAT 4, 46 CHALCOT CRESCENT, LONDON NW1: DAMP INGRESS & ASSOCIATED WORKS

FLAT 4, 46 CHALCOT CRESCENT, LONDON

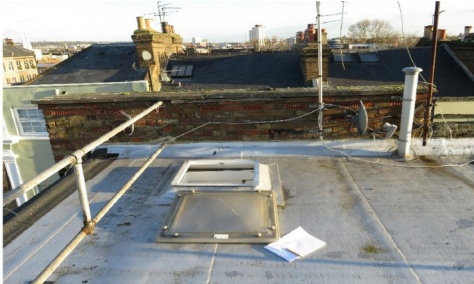
Our major concerns however relate to the condition of the flank wall of 46 Chalcot Crescent where it adjoins the garden of the adjacent property to the north. Any access to carry out the necessary works to the flank wall would necessitate erecting scaffold in the adjoining owner's garden. This would have to be negotiated or dealt with formally under the provisions of the Access to Neighbouring Lands Act. The pointing to this wall is generally poor and there is evidence of some bowing of the wall and stacks.

From the limited views available to us at the time, it appears that there are areas of significant dampness affecting the outside of the chimney flues. There is also some "bowing" of the flank wall and loose and missing pointing to the flank wall.

View of flank wall and adjacent garden from above

The wall would need to be inspected and all loose pointing removed and replaced. We would also recommend that Helifix bars be installed at 900mm centres at second and third floor levels and at roof level, to tie the brickwork back into the main building structure. This will need to be done
