## Arboricultural Consultancy for Co-operative Insurance Society

### 1. Case Details

Insured	Mr David Blagbrough	Address	160 Camden Road, London, NW1 9HJ		
Client	Subsidence Management Services	Contact	Danielle Irving	Claim No.	IFS-CIS-SUB-11-0031154
ES Ref	SA-19426	Consultant	Giles Mercer	Contact No.	0330 380 1036
Report Date	18/06/2018 Revised: 18/06/2018

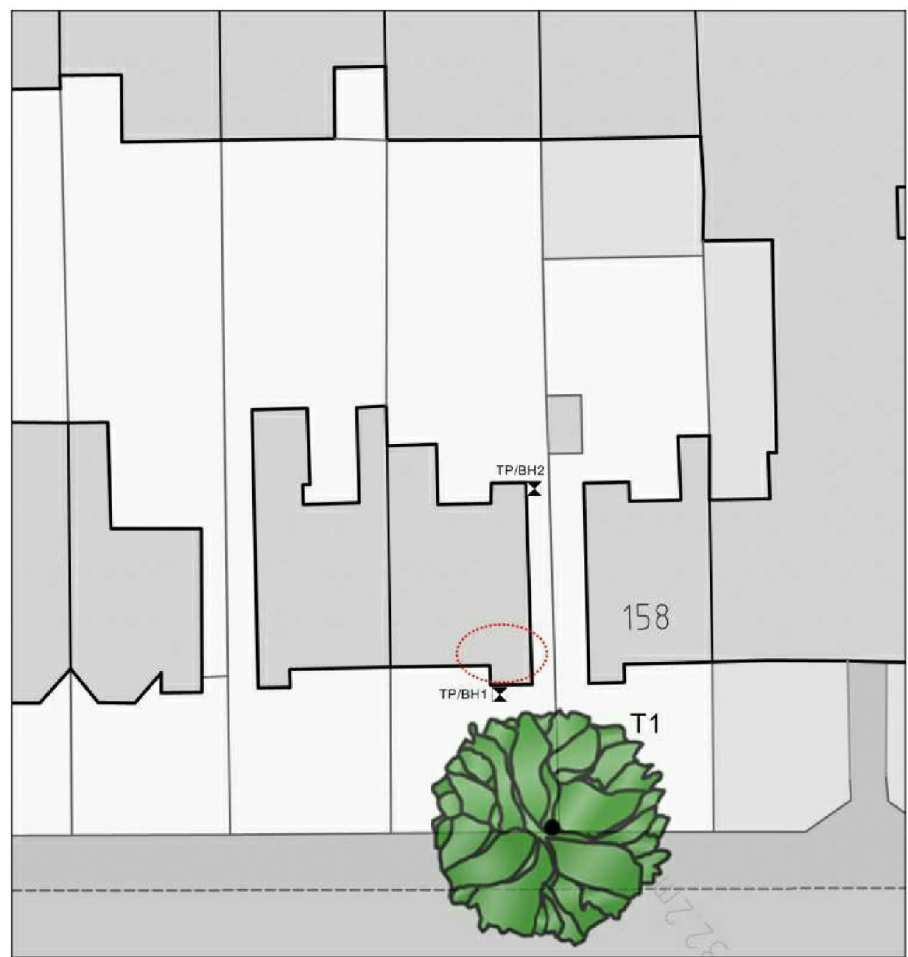
7. Site Plan

Damage relates to the junction between the front porch/bathroom projection and the main front elevation. Please refer to the engineers report for a full description of the claim history and damage.

In order to mitigate the current damage and allow soils beneath the property to recover to a position such that an effective engineering repair solution can be implemented, we recommend T1 be removed.
