Engineer's Report

Our Reference	IFS-CIS-SUB-11-0031154
Claim Reference	[REDACTED]
Prepared for	The Co-operative Insurance

Report Date	30 October 2011
Policyholder	Mr Blagbrough
Address	160 Camden Road, London, NW1 9HJ

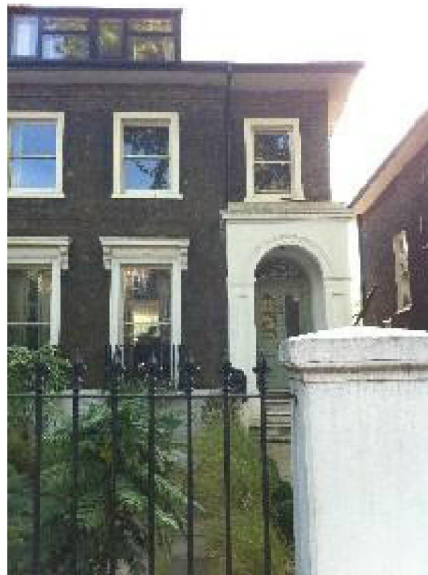
FIGURE 2 Front Elevation

Externally, the main damage to the property is at the junction between the porch and the main house. The maximum separation is between 3-4mm. There is significant cracking on the floor of the porch at the junction of where the porch and threshold of the house meet. There is also some cracking to the front elevation at low level with a maximum crack width of 2mm.
