BS5837 Arboricultural Impact Assessment

1 Rona Road, London, NW3 2HY

Job Reference: 02906Rv2

June 2018

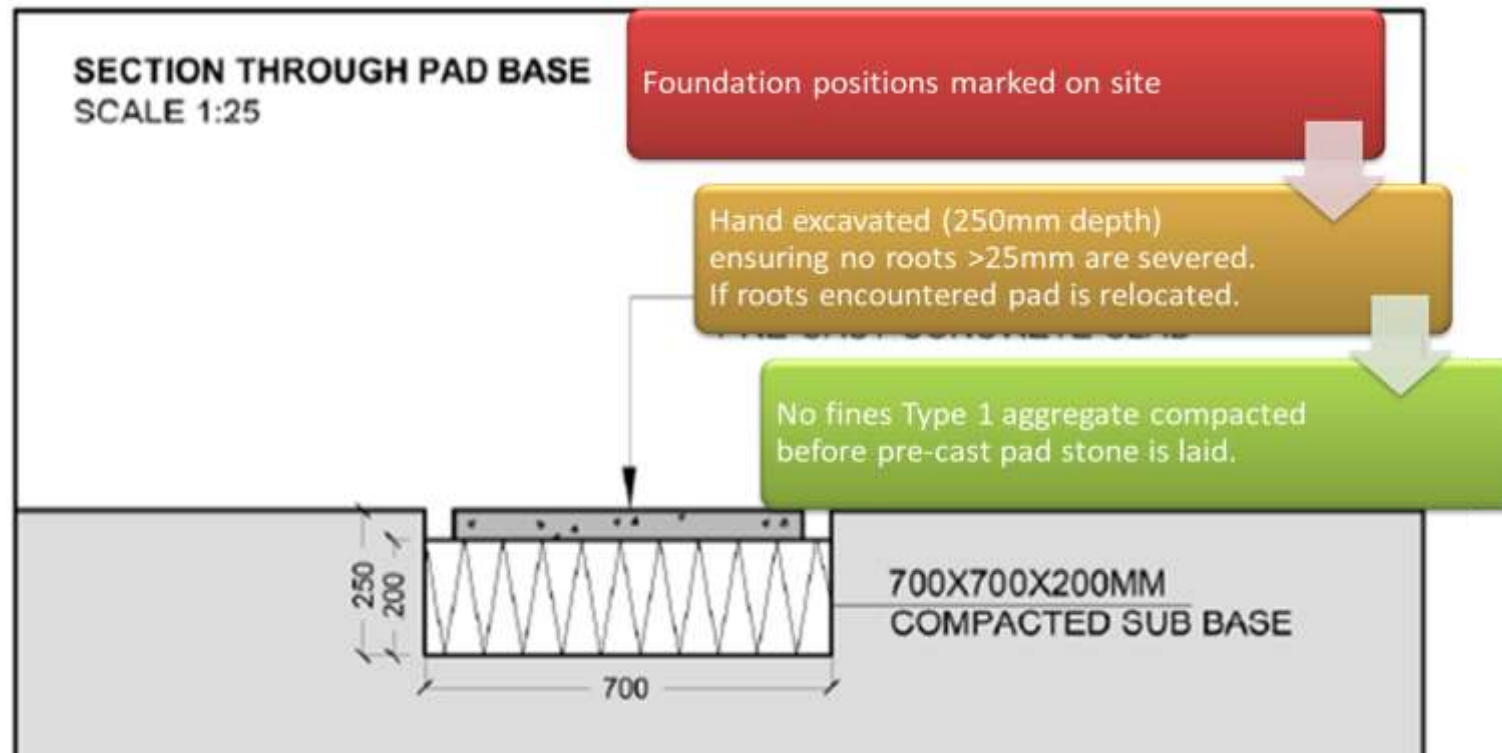
Fig 3 – Typical pad detail with installation (inset). This approach removes the need for a ‘strip’ foundation reducing the impact on underlying roots. Pads are hand dug and localised manipulations to retain roots >25mm diameter are possible as a result. (Note: depth as per image not flow)

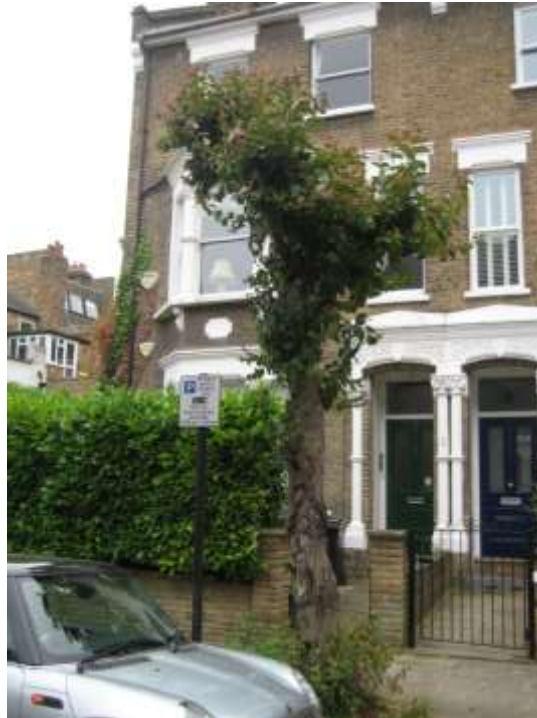
- Access through existing property.
- No special ground protection measures proposed due to existing hard surfacing.
- T6 basally shuttered as an additional precaution.

Fig 5 – The site benefits only from access through the property.

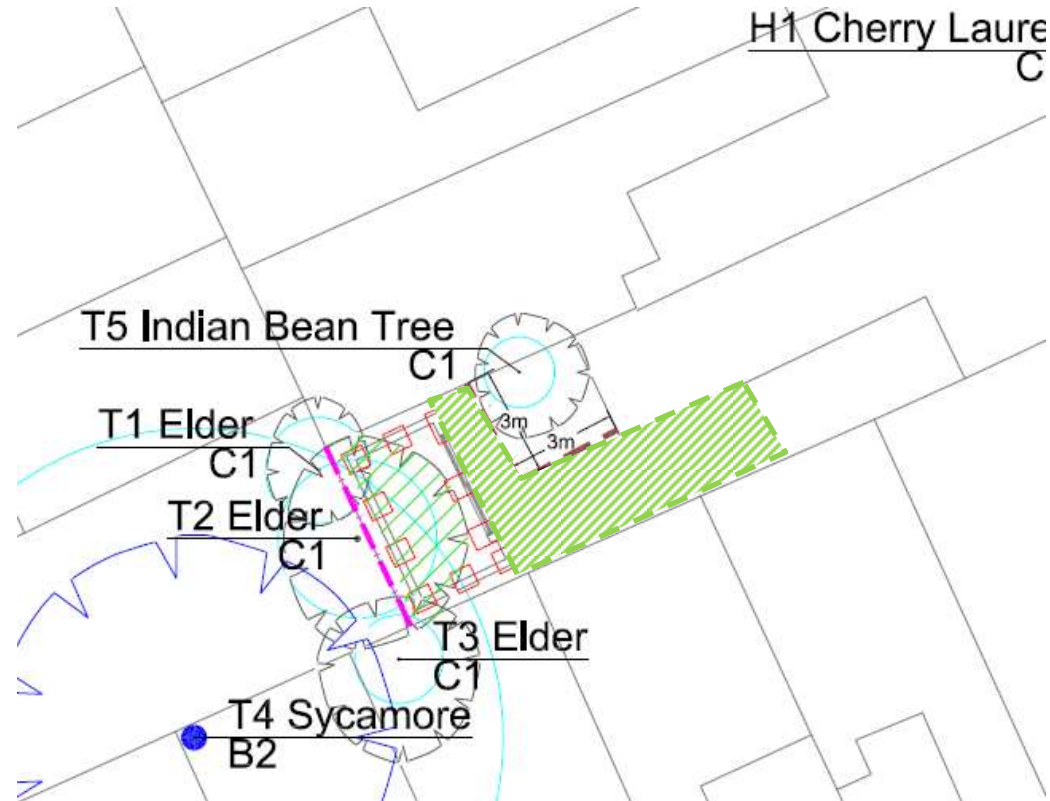
Fig 6 – A large zone (indicated above) is available for service trench installation outside retained tree RPA's

- 5.6.1 The new service trench will be hand dug. It will be positioned to be located outside the RPA of retained trees and will be hand dug as an extra precaution adhering to the principles of hand digging outlined in section 5.4.

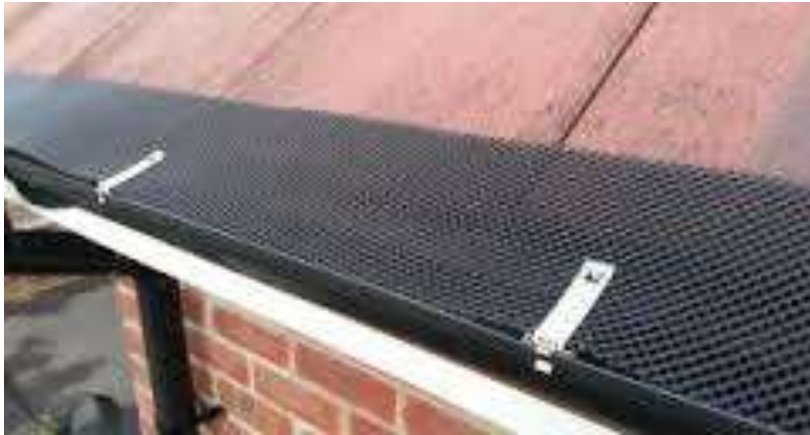
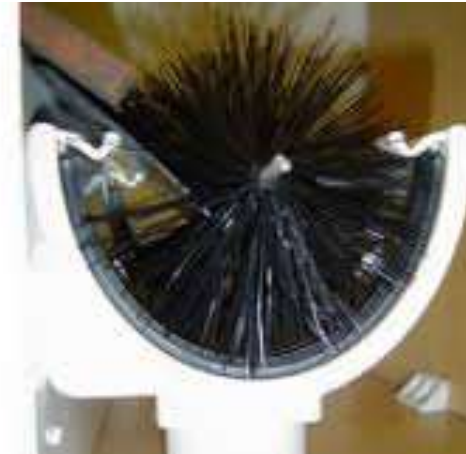
Fig 8 - Suitable gutter guards (2 types shown above) should be fitted to ensure that leaf drop from adjacent trees does not block new guttering leading to potential pressure for tree works.

5.6.3 To limit maintenance impact to the garden room from leaf drop given the proximity/ overhang of trees it is proposed that [gutter guards](#) be installed.

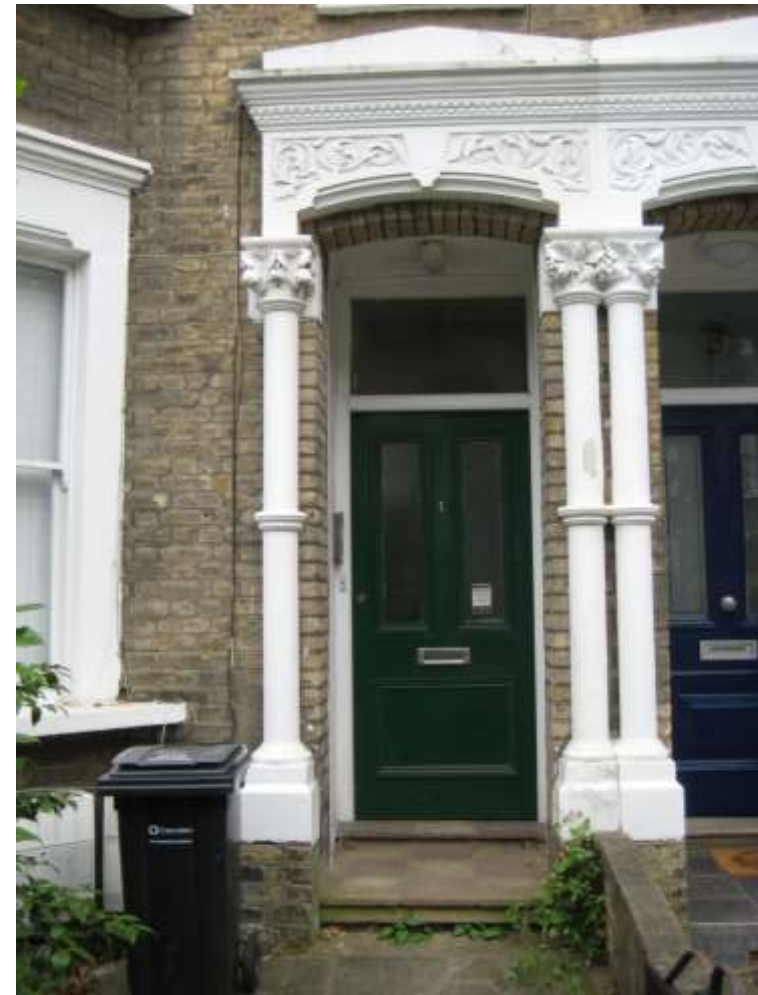
Image 5 –All access is through the house.
