The Hope Project: Investigation of the 'Fly Tower' roof for condition, strength classes and construction

Site note 2 for 8 March 2018, job no. 146.89

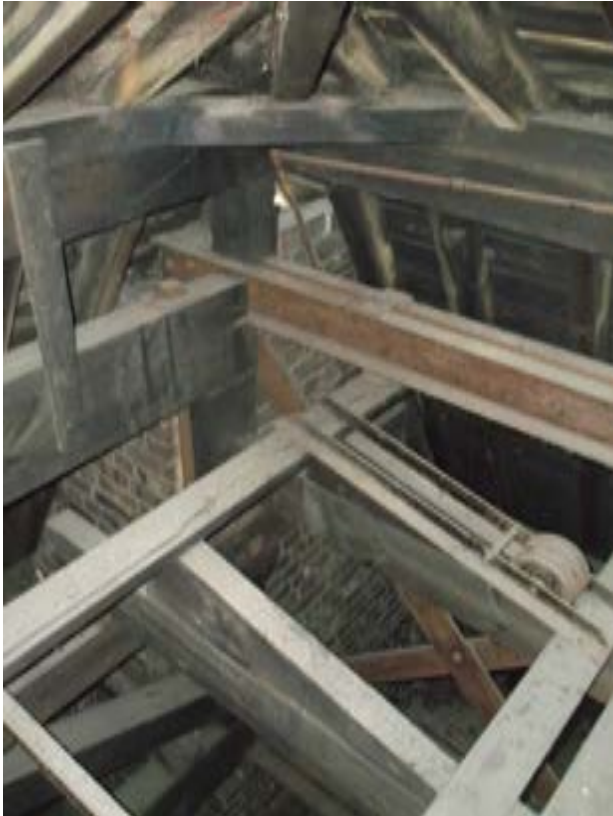
Fig 35:

North-east corner of the roof: showing general view of the first bay , counting from the north, of the steel truss

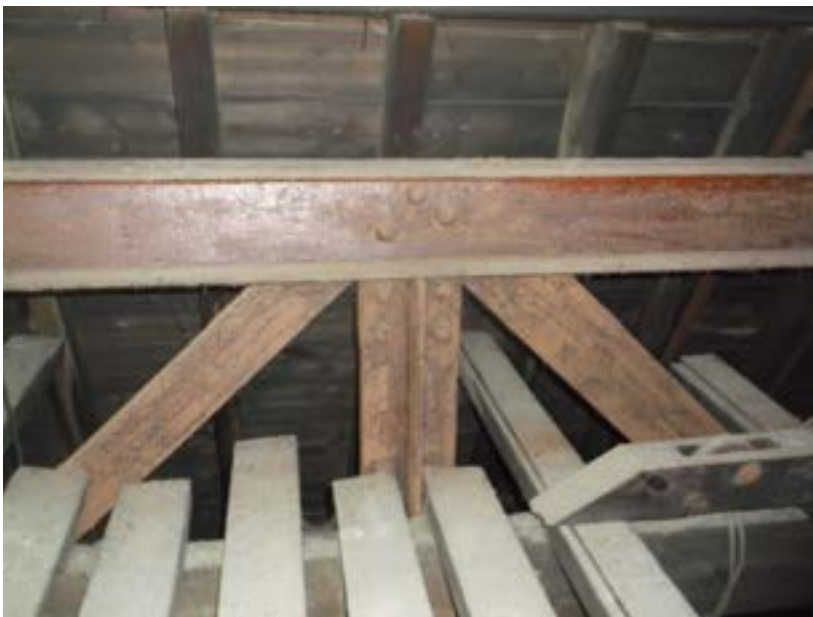
Fig 36:

Steel truss along the east pitch: showing general view of the upper node between the first and second bays of steel truss system

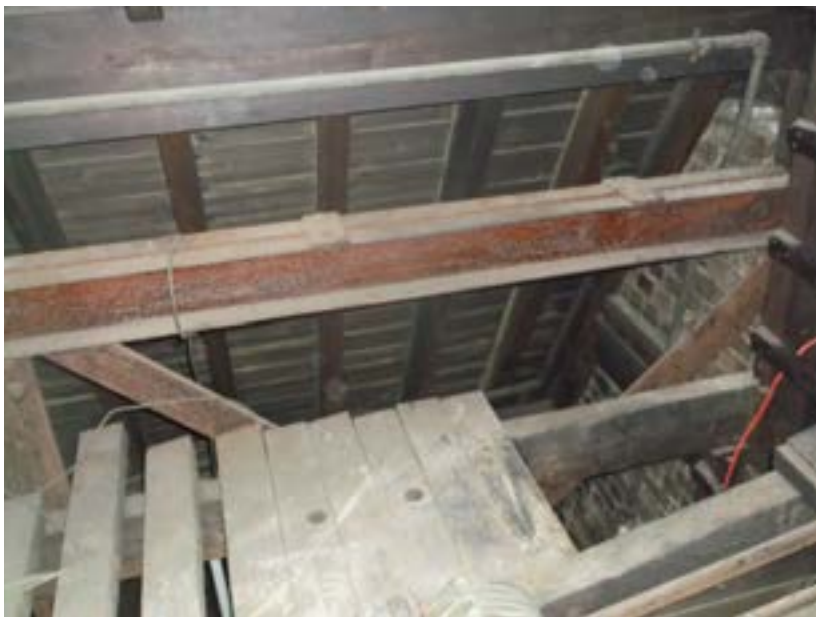
Fig 40:

South-east corner of the roof: showing
general view of the first bay , counting
from the south, of the steel truss

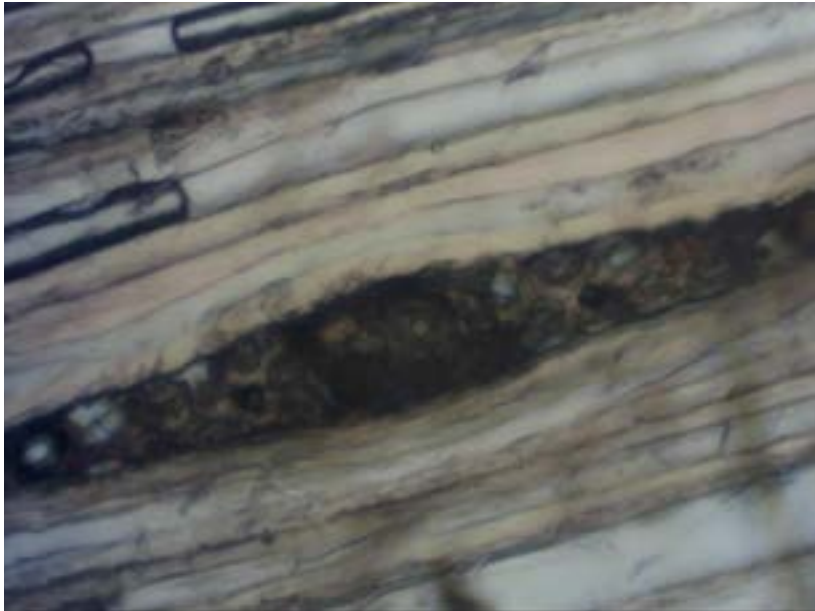
Fig 5:

Showing tangential section of the timber sample on microscopic level. Note resin canal in ray with thin-walled epithelial cells. These are common features of Pitch Pine timbers

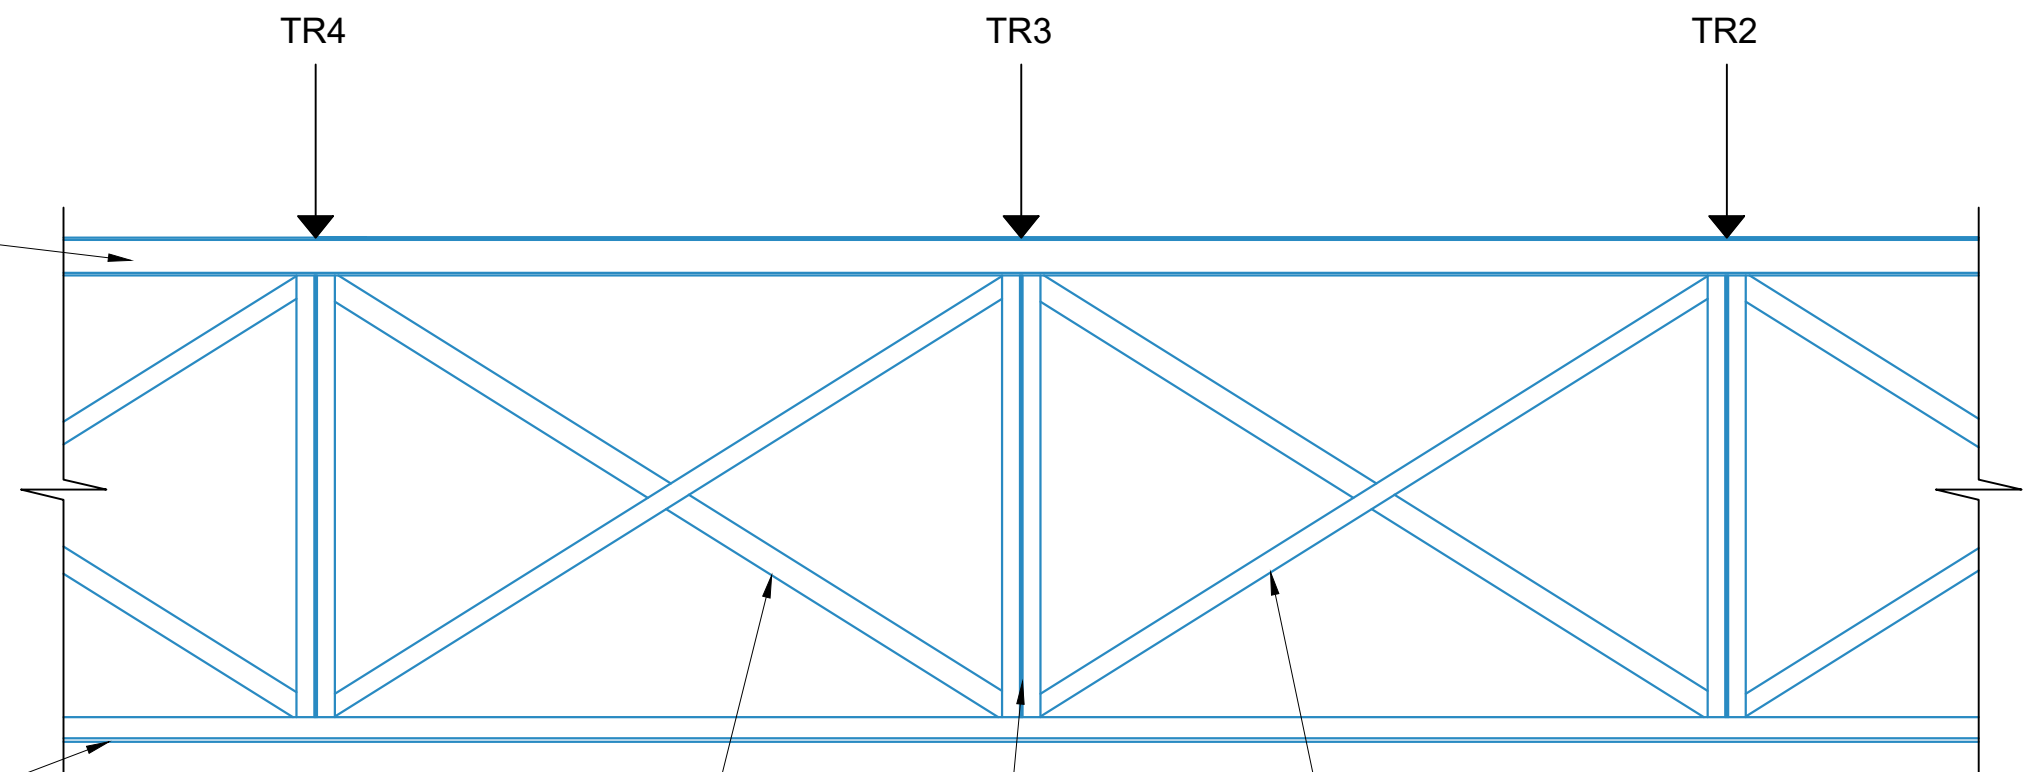
*- The height of the unequal angle section was not measured with high accuracy as the element was difficult to assess due to lack of safe access. Therefore, it can be stipulated that the height of the bottom chord was 96mm, as the rest of the dimensions agree well with the diagonal element (2) dimensions
