BS5837 Arboricultural Impact Assessment

59 Broadhurst Gardens, London, NW6 3QT

Job Reference: 02915R

July 2018

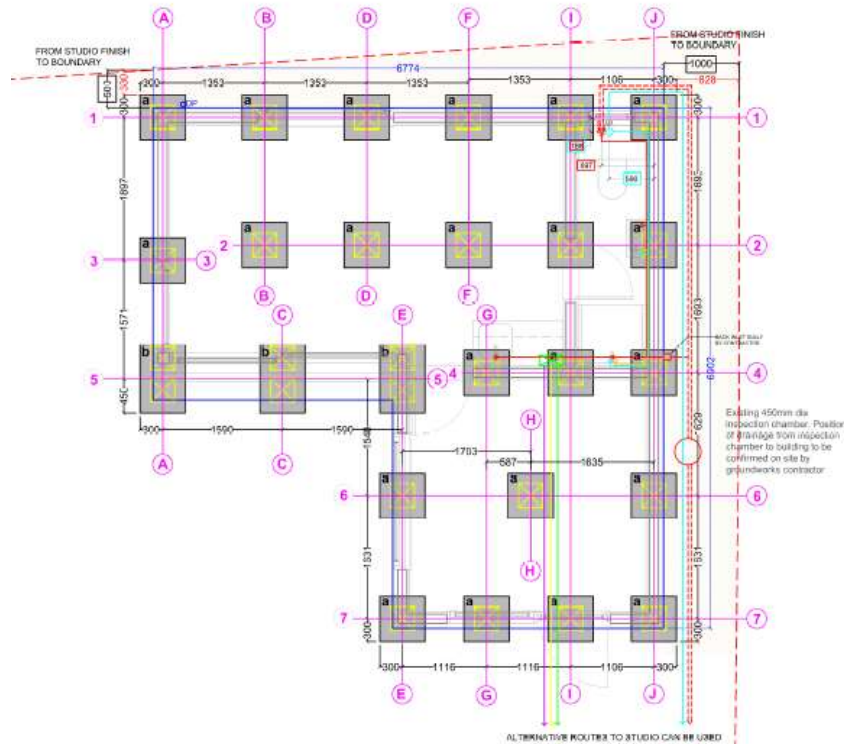
Fig 2 – Foundation pad overview

- Pad footings used to minimise impact.
- Hand dug with localised repositioning to avoid roots >25mm.
- The level of works is such that no special foundation measures are proposed. In summary at this level and in this location we believe there will be no discernible impact on the trees health or stability.
- Service trench hand dug and pipes fed below roots >25mm

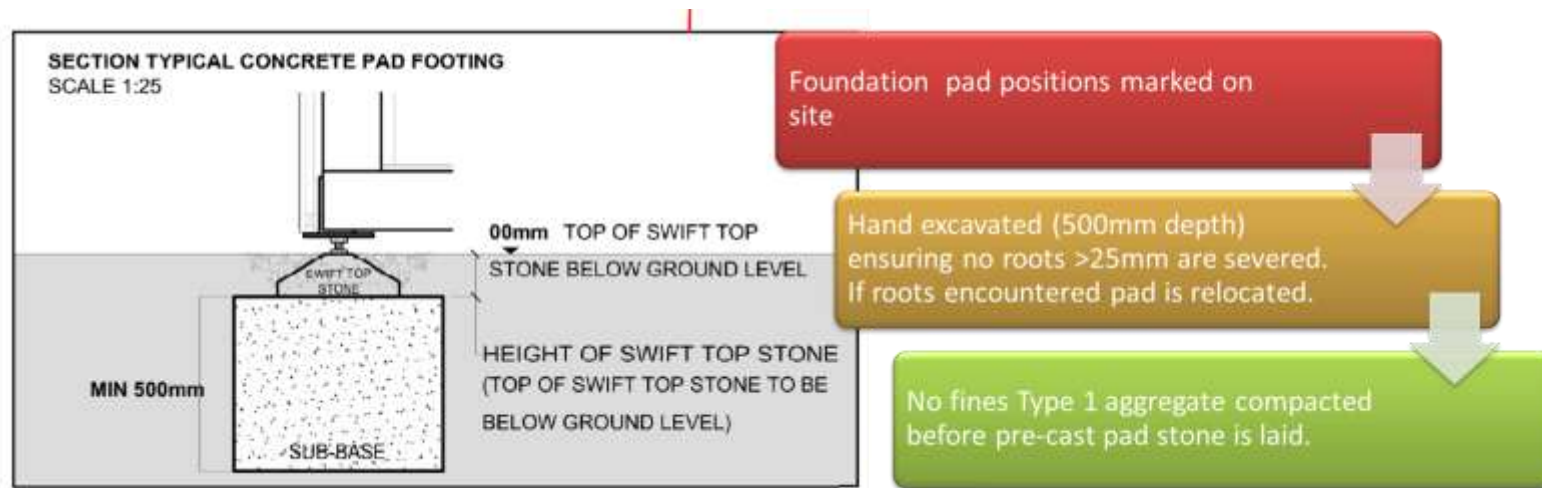
Fig 3 – Pad installation overview. This approach removes the need for a ‘strip’ foundation reducing the impact on underlying roots. Pads are hand dug and localised manipulations to retain roots >25mm diameter are possible as a result.

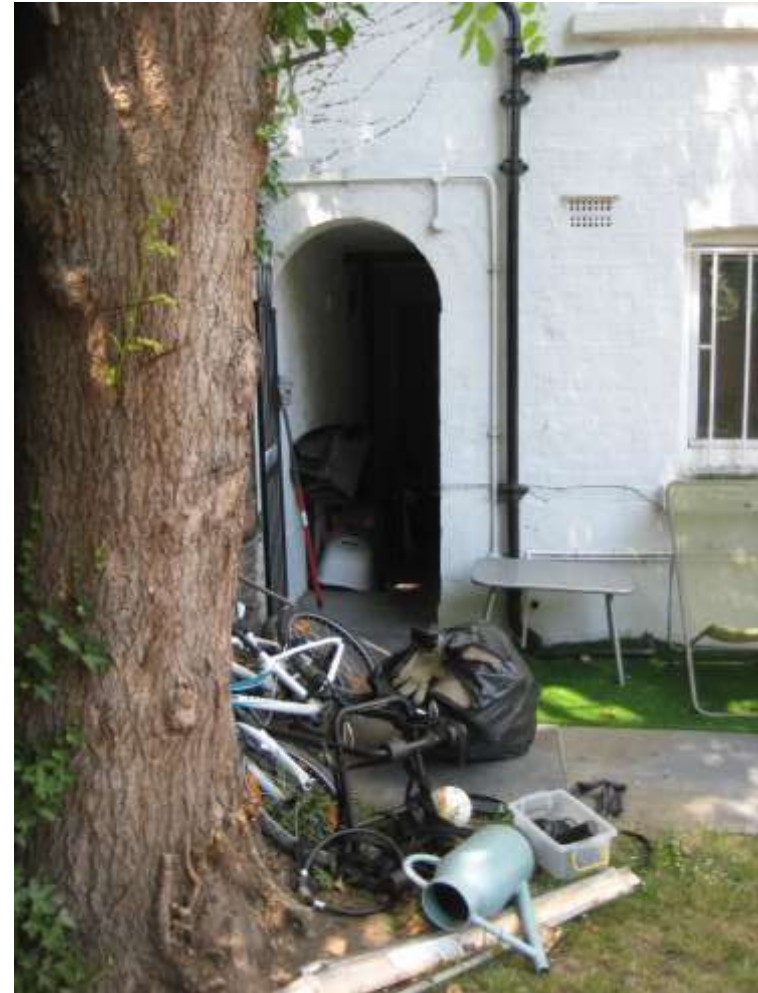
Image 5 –All access is through the side access point
