1&1a Montague Street

Structural Report

Curtins Ref: 063007

Client Name: The British Museum

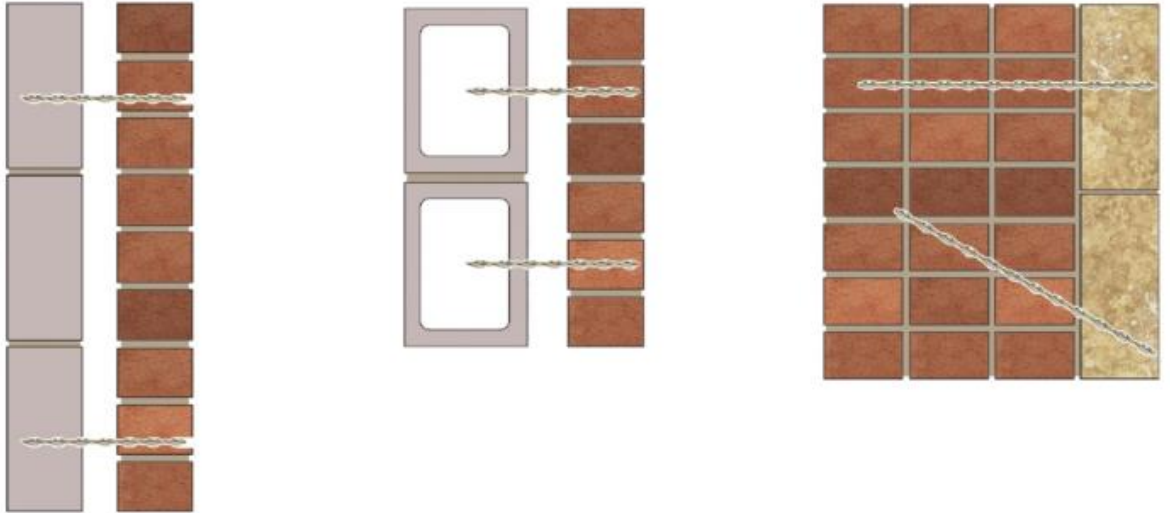
Figure 5 - Examples of how and where DryFix Ties may be utilised

For Montague Street, this form of repair is suggested for the spandrel panel and pier to No.1 at the end of the balcony near the party wall.
