**TECHNICAL REPORT ON A SUBSIDENCE CLAIM**

**Ms Miriam Jane Ramsey  
30B Croftdown Road  
Kentish Town  
London  
NW5 1EN**

**SUBSIDENCE CLAIM**

26 April 2018

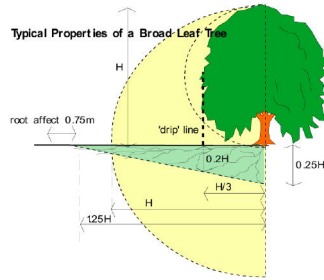
Typical proportions of a broadleaf tree. Note the potential root zone. It must be noted that every tree is different, and the root zone will vary with soil type, health of the tree and climatic conditions.

However heavy pruning of any tree should be avoided if possible, as it stimulates the formation of dense masses of weakly attached new branches which can become dangerous if not re-cut periodically to keep their weight down.

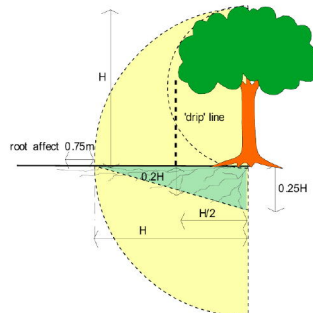
**Cherries, Prunus** species, include Japanese flowering species, which are mainly small growing short lived moderate water demanders and the native wild cherry, *P. avium*, which is generally longer lived and capable of reaching over 20m.

The growth rate is 300mm a year and they have medium root activity. They can be associated with subsidence, although they are not regarded as a particularly aggressive tree.

Typical proportions of a Cherry tree. Note the potential root zone.

The cause of the movement needs to be dealt with first. We have completed a soil risk analysis (VISCAT Assessment) and we are satisfied that your neighbour's T2-T3 trees at 30A can be removed, along with your neighbours T1 at No.28. Our Mitigation Unit will liaise with your neighbours in this respect.
