## Demolition Survey

MANSTON  
AGAR GROVE  
LONDON

APRIL 2018

Report prepared for:	Hill Holdings (Essex) Ltd The Power House Gunpowder Mill Powdermill Lane Waltham Abbey Essex EN9 1BN
Report reference:	J113683
Issue date:	May 2018
Survey completed by: Scott Brookes Senior Surveyor

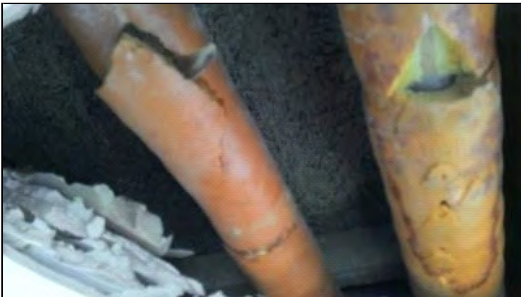
Location:		1 - 16 Marston - Roof Void - Flat 15 ceiling voids - Stramit boards within the ceiling voids in the kitchen, lounge, bathroom, toilet, lobby, hallway, bedroom 1, bedroom 2, bedroom 3 and bedroom 4

Item No:	000002	Laboratory sample no:	CF009140	
Accessibility:		N/A		
Installation:		Boarding		
Approx extent (m² unless stated)		N/A		
Asbestos Type:		NAD		
Condition:	N/A	Surface Treatment:	N/A

Material Risk Assessment	0	Priority Risk Assessment (PA)	N/A	Total Risk	
Recommendation:	None				
Comments:

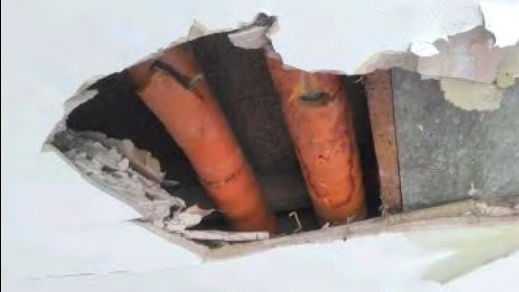
Location:		1 - 16 Marston - Roof Void - Flat 15 ceiling voids - Paper condensate layer to the pipework within the kitchen, lobby and toilet ceiling voids

Item No:	000003	Laboratory sample no:	CF009141	
Accessibility:		N/A		
Installation:		Paper / cardboard		
Approx extent (m² unless stated)		N/A		
Asbestos Type:		NAD		
Condition:	N/A	Surface Treatment:	N/A

Material Risk Assessment	0	Priority Risk Assessment (PA)	N/A	Total Risk	
Recommendation:	None				
Comments:

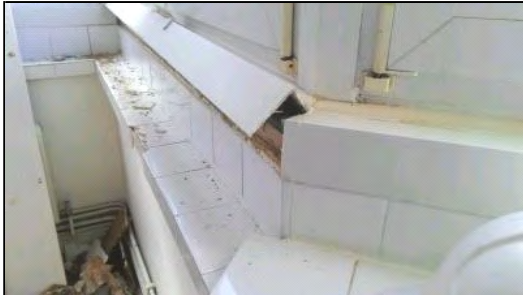
Location:		1 - 16 Marston - Third floor - Flat 15 - Eternite window sills beneath the PVC-u sills within the kitchen, toilet, bedroom 1, bedroom 2, bedroom 3 and bedroom 4

Item No:	000004	Laboratory sample no:	CF009142	
Accessibility:		Easy		
Installation:		Cement (1)		
Approx extent (m² unless stated)		16lm		
Asbestos Type:		Chrysotile (1)		
Condition:	Low damage (1)	Surface Treatment:	Surface sealed (1)

Material Risk Assessment	4	Priority Risk Assessment (PA)	N/A	Total Risk	N/A
Recommendation:	Remove				
Comments:

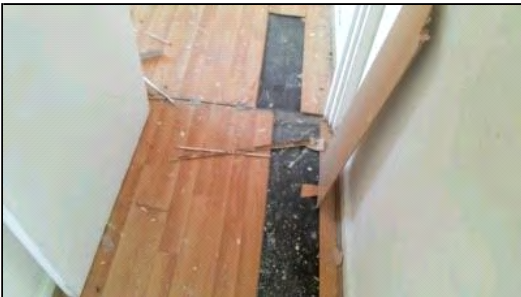
Location:		1 - 16 Marston - Third floor - Flat 15 - Black floor tiles and bitumen to the floor beneath the modern flooring within the lounge, lobby, bathroom, toilet, hallway, bedroom 1, bedroom 2, bedroom 3 and bedroom 4

Item No:	000005	Laboratory sample no:	CF009143	
Accessibility:		Easy		
Installation:		Floor tile(s) & bitumen (1)		
Approx extent (m² unless stated)		50		
Asbestos Type:		Chrysotile (1)		
Condition:	Low damage (1)	Surface Treatment:	Completely sealed (0)

Material Risk Assessment	3	Priority Risk Assessment (PA)	N/A	Total Risk	N/A
Recommendation:	Remove				
Comments:

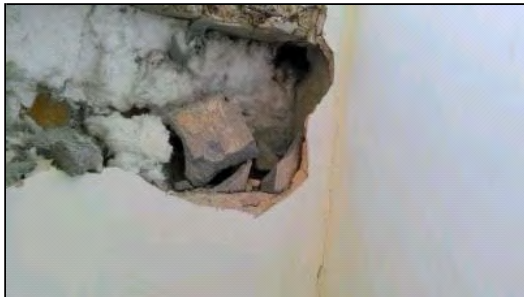
Location:		1 - 16 Marston - Third floor - Flat 15 - Felt damp proof course around the window frames within the kitchen, toilet, bathroom, lounge, bedroom 1, bedroom 2, bedroom 3 and bedroom 4

Item No:	000006	Laboratory sample no:	CF009144	
Accessibility:		N/A		
Installation:		Felt		
Approx extent (m² unless stated)		N/A		
Asbestos Type:		NAD		
Condition:	N/A	Surface Treatment:	N/A

Material Risk Assessment	0	Priority Risk Assessment (PA)	N/A	Total Risk	
Recommendation:	None				
Comments:

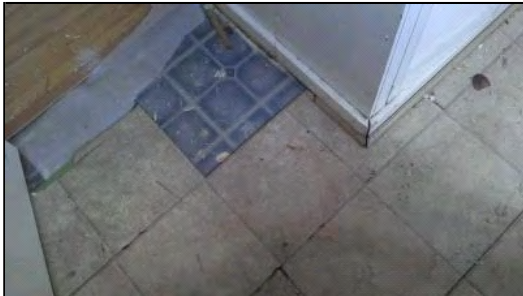
Location:		1 - 16 Marston - Third floor - Flat 15 - Beige tiles and bitumen to the floor beneath the modern flooring within the kitchen

Item No:	000008	Laboratory sample no:	CF009146	
Accessibility:		Easy		
Installation:		Floor tile(s) & bitumen (1)		
Approx extent (m² unless stated)		10		
Asbestos Type:		Chrysotile (1)		
Condition:	Low damage (1)	Surface Treatment:	Completely sealed (0)

Material Risk Assessment	3	Priority Risk Assessment (PA)	N/A	Total Risk	N/A
Recommendation:	Remove				
Comments:

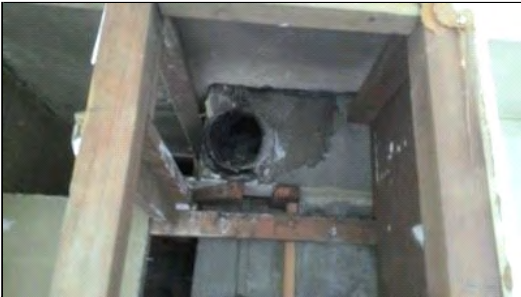
Location:		1 - 16 Marston - Third floor - Flat 15 - Boarding used as shuttering beneath and behind the mortar at high level in the former heater cupboard, in the kitchen

Item No:	000009	Laboratory sample no:	CF009147	
Accessibility:		Moderate		
Installation:		Boarding (2)		
Approx extent (m² unless stated)		<1		
Asbestos Type:		Amosite (2)		
Condition:	Low damage (1)	Surface Treatment:	Unsealed AIB/encapsulated lagging (2)

Material Risk Assessment	7	Priority Risk Assessment (PA)	N/A	Total Risk	N/A
Recommendation:	Remove				
Comments:

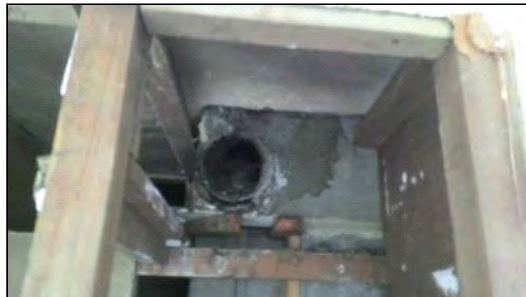
Location:		1 - 16 Marston - Third floor - Flat 15 - Cement flue at high level in the former heater cupboard, in the kitchen

Item No:	000010	Laboratory sample no:	CF009148	
Accessibility:		Moderate		
Installation:		Cement (1)		
Approx extent (m² unless stated)		11m		
Asbestos Type:		Chrysotile (1)		
Condition:	Low damage (1)	Surface Treatment:	Surface sealed (1)

Material Risk Assessment	4	Priority Risk Assessment (PA)	N/A	Total Risk	N/A
Recommendation:	Remove				
Comments:

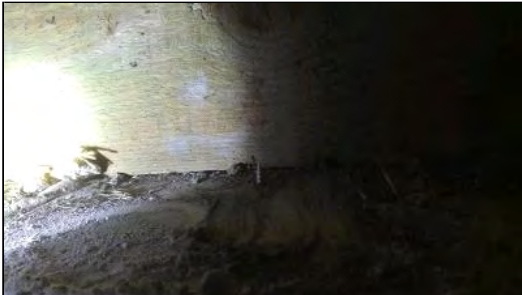
Location:		1 - 16 Marston - Roof Void - Flat 16 ceiling voids - Roofing felt debris within the ceiling voids in the kitchen, lounge, bathroom, toilet, lobby, hallway, bedroom 1, bedroom 2 and bedroom 3

Item No:	000012	Laboratory sample no:	SP CF009139	
Accessibility:		N/A		
Installation:		Roofing felt		
Approx extent (m² unless stated)		N/A		
Asbestos Type:		NAD		
Condition:	N/A	Surface Treatment:	N/A

Material Risk Assessment	0	Priority Risk Assessment (PA)	N/A	Total Risk	
Recommendation:	None				
Comments:	please note the debris is scattered in every ceiling void

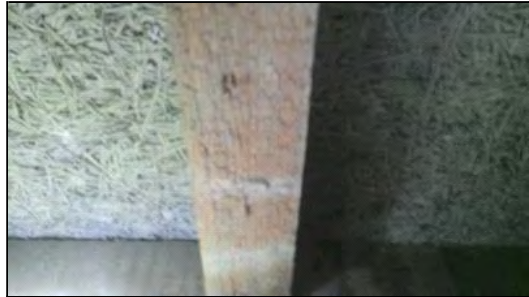
Location:		1 - 16 Marston - Roof Void - Flat 16 ceiling voids - Stramit boards within the ceiling voids in the kitchen, lounge, bathroom, toilet, lobby, hallway, bedroom 1, bedroom 2 and bedroom 3

Item No:	000013	Laboratory sample no:	SP CF009140	
Accessibility:		N/A		
Installation:		Boarding		
Approx extent (m <sup>2</sup> unless stated)		N/A		
Asbestos Type:		NAD		
Condition:	N/A	Surface Treatment:	N/A

Material Risk Assessment	0	Priority Risk Assessment (PA)	N/A	Total Risk	
Recommendation:		None			
Comments:

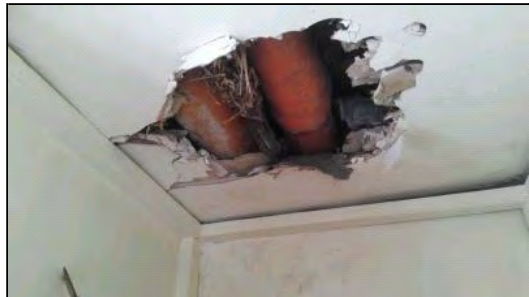
Location:		1 - 16 Marston - Roof Void - Flat 16 ceiling voids - Paper condensate layer to the pipework within the kitchen, lobby and toilet ceiling voids

Item No:	000014	Laboratory sample no:	SP CF009141	
Accessibility:		N/A		
Installation:		Paper / cardboard		
Approx extent (m <sup>2</sup> unless stated)		N/A		
Asbestos Type:		NAD		
Condition:	N/A	Surface Treatment:	N/A

Material Risk Assessment	0	Priority Risk Assessment (PA)	N/A	Total Risk	
Recommendation:		None			
Comments:

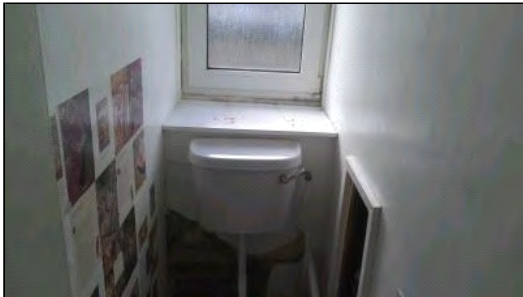
Location:		1 - 16 Marston - Third floor - Flat 16 - Eternite window sills beneath the PVC-u sills within the kitchen, toilet, bedroom 1, bedroom 2 and bedroom 3

Item No:	000015	Laboratory sample no:	SP CF009142	
Accessibility:		Easy		
Installation:		Cement (1)		
Approx extent (m² unless stated)		121m		
Asbestos Type:		Chrysotile (1)		
Condition:	Low damage (1)	Surface Treatment:	Surface sealed (1)

Material Risk Assessment	4	Priority Risk Assessment (PA)	N/A	Total Risk	N/A
Recommendation:	Remove				
Comments:

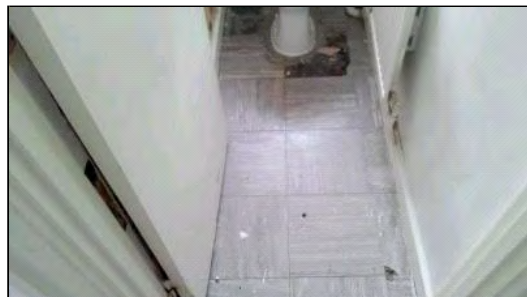
Location:		1 - 16 Marston - Third floor - Flat 16 - Grey floor tiles and bitumen to the floor beneath the modern flooring within the lounge, lobby, bathroom, toilet, hallway, kitchen, bedroom 1, bedroom 2 and bedroom 3

Item No:	000016	Laboratory sample no:	CF009150	
Accessibility:		Easy		
Installation:		Floor tile(s) & bitumen (1)		
Approx extent (m² unless stated)		60		
Asbestos Type:		Chrysotile (1)		
Condition:	Low damage (1)	Surface Treatment:	Completely sealed (0)

Material Risk Assessment	3	Priority Risk Assessment (PA)	N/A	Total Risk	N/A
Recommendation:	Remove				
Comments:

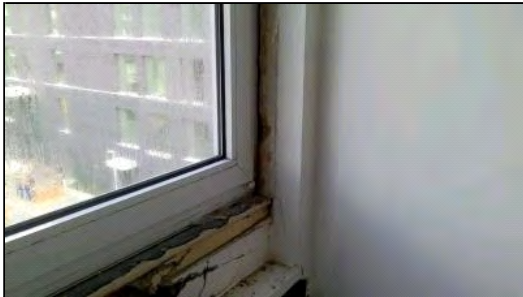
Location:		1 - 16 Marston - Third floor - Flat 16 - Felt damp proof course around the window frames within the kitchen, toilet, bathroom, lounge, bedroom 1, bedroom 2 and bedroom 3

Item No:	000017	Laboratory sample no:	SP CF009144	
Accessibility:		N/A		
Installation:		Felt		
Approx extent (m² unless stated)		N/A		
Asbestos Type:		NAD		
Condition:	N/A	Surface Treatment:	N/A

Material Risk Assessment	0	Priority Risk Assessment (PA)	N/A	Total Risk	
Recommendation:	None				
Comments:

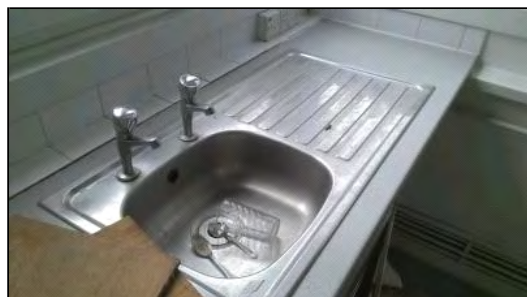
Location:		1 - 16 Marston - Third floor - Flat 16 - Bitumen pads to the underside of the sink unit in the kitchen

Item No:	000018	Laboratory sample no:	CF009151	
Accessibility:	N/A			
Installation:	Sink pad			
Approx extent (m² unless stated)	N/A			
Asbestos Type:	NAD			
Condition:	N/A	Surface Treatment:	N/A

Material Risk Assessment	0	Priority Risk Assessment (PA)	N/A	Total Risk	
Recommendation:	None				
Comments:

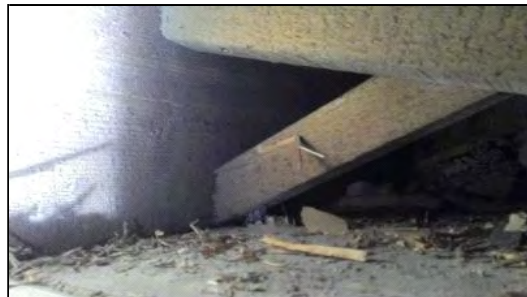
Location:		1 - 16 Marston - Roof Void - Flat 13 ceiling voids - Roofing felt debris within the ceiling voids in the kitchen, lounge, bathroom, toilet, lobby, hallway, bedroom 1, bedroom 2 and bedroom 3

Item No:	000022	Laboratory sample no:	CF009155	
Accessibility:		Difficult		
Installation:		Roofing felt (1)		
Approx extent (m² unless stated)		<5		
Asbestos Type:		Chrysotile (1)		
Condition:	Medium damage (2)	Surface Treatment:	Completely sealed (0)

Material Risk Assessment	4	Priority Risk Assessment (PA)	N/A	Total Risk	N/A
Recommendation:	Remove				
Comments:	please note the debris is scattered in every ceiling void

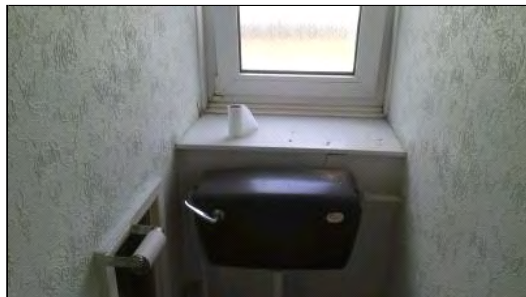
Location:		1 - 16 Marston - Third floor - Flat 13 - Eternite window sills beneath the PVC-u sills within the kitchen, toilet, bedroom 1, bedroom 2 and bedroom 3

Item No:	000025	Laboratory sample no:	CF009158	
Accessibility:		Easy		
Installation:		Cement (1)		
Approx extent (m² unless stated)		10lm		
Asbestos Type:		Chrysotile (1)		
Condition:	Low damage (1)	Surface Treatment:	Surface sealed (1)

Material Risk Assessment	4	Priority Risk Assessment (PA)	N/A	Total Risk	N/A
Recommendation:	Remove				
Comments:

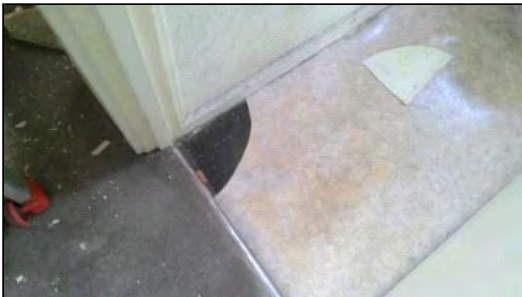
Location:		1 - 16 Marston - Third floor - Flat 13 - Black floor tiles and bitumen to the floor beneath the modern flooring and carpet within the lounge, lobby, bathroom, toilet, hallway, bedroom 1, bedroom 2 and bedroom 3

Item No:	000026	Laboratory sample no:	CF009159	
Accessibility:		Easy		
Installation:		Floor tile(s) & bitumen (1)		
Approx extent (m² unless stated)		40		
Asbestos Type:		Chrysotile (1)		
Condition:	Low damage (1)	Surface Treatment:	Completely sealed (0)

Material Risk Assessment	3	Priority Risk Assessment (PA)	N/A	Total Risk	N/A
Recommendation:	Remove				
Comments:

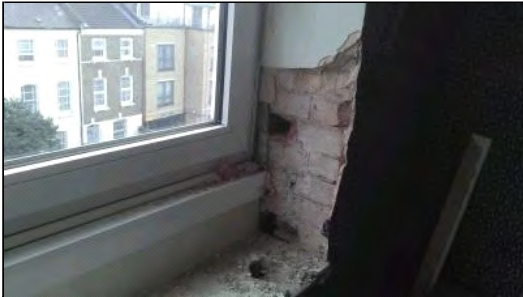
Location:		1 - 16 Marston - Third floor - Flat 13 - Felt damp proof course around the window frames within the kitchen, toilet, bathroom, lounge, bedroom 1, bedroom 2 and bedroom 3

Item No:	000027	Laboratory sample no:	CF009160	
Accessibility:		N/A		
Installation:		Felt		
Approx extent (m² unless stated)		N/A		
Asbestos Type:		NAD		
Condition:	N/A	Surface Treatment:	N/A

Material Risk Assessment	0	Priority Risk Assessment (PA)	N/A	Total Risk	
Recommendation:	None				
Comments:

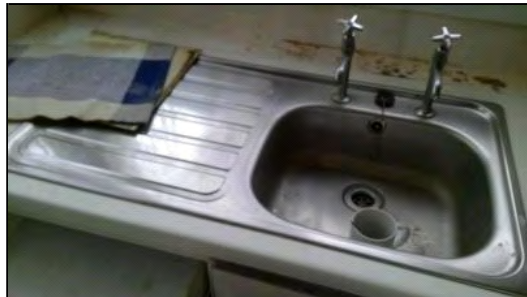
Location:		1 - 16 Marston - Third floor - Flat 13 - Bitumen pads to the underside of the sink unit in the kitchen

Item No:	000028	Laboratory sample no:	CF009161	
Accessibility:		N/A		
Installation:		Sink pad		
Approx extent (m² unless stated)		N/A		
Asbestos Type:		NAD		
Condition:	N/A	Surface Treatment:	N/A

Material Risk Assessment	0	Priority Risk Assessment (PA)	N/A	Total Risk	
Recommendation:	None				
Comments:

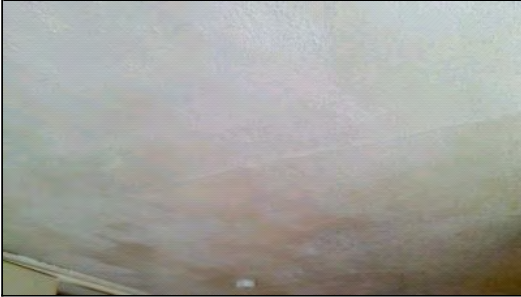
Location:		1 - 16 Marston - Third floor - Flat 13 - Textured coating to the ceilings within the kitchen, lounge, toilet, bedroom 1, bedroom 2 and bedroom 2

Item No:	000029	Laboratory sample no:	CF009162	
Accessibility:		N/A		
Installation:		Textured coating		
Approx extent (m² unless stated)		N/A		
Asbestos Type:		NAD		
Condition:	N/A	Surface Treatment:	N/A

Material Risk Assessment	0	Priority Risk Assessment (PA)	N/A	Total Risk	
Recommendation:	None				
Comments:

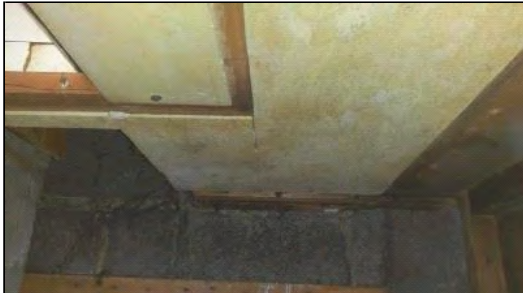
Location:		1 - 16 Marston - Third floor - Flat 13 - Boarding to the underside of the bottom timber shelf in the former heater cupboard, in the kitchen

Item No:	000030	Laboratory sample no:	CF009163	
Accessibility:		Easy		
Installation:		Boarding (2)		
Approx extent (m² unless stated)		<1		
Asbestos Type:		Amosite (2)		
Condition:	Low damage (1)	Surface Treatment:	Unsealed AIB/encapsulated lagging (2)

Material Risk Assessment	7	Priority Risk Assessment (PA)	N/A	Total Risk	N/A
Recommendation:	Remove				
Comments:

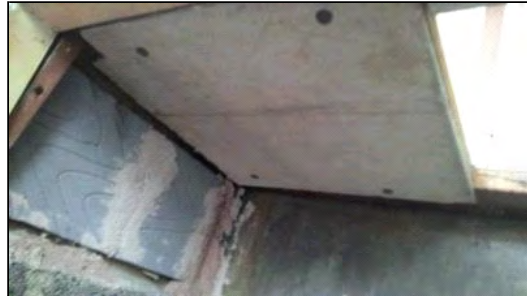
Location:		1 - 16 Marston - Third floor - Flat 13 - Boarding to the underside of the bottom timber shelf in the former heater cupboard, in the kitchen

Item No:	000031	Laboratory sample no:	CF009164	
Accessibility:		Easy		
Installation:		Boarding (2)		
Approx extent (m² unless stated)		<1		
Asbestos Type:		Amosite (2)		
Condition:	Low damage (1)	Surface Treatment:	Unsealed AIB/encapsulated lagging (2)

Material Risk Assessment	7	Priority Risk Assessment (PA)	N/A	Total Risk	N/A
Recommendation:	Remove				
Comments:

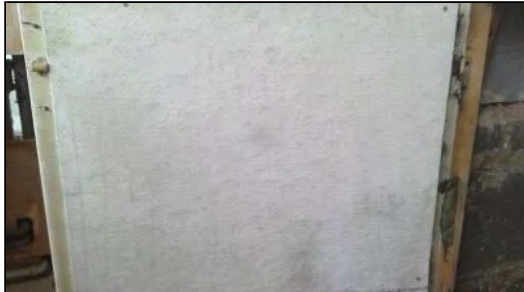
Location:		1 - 16 Marston - Third floor - Flat 13 - Boarding to the rear of the lower doors of the former heater cupboard, in the kitchen

Item No:	000032	Laboratory sample no:	CF009165	
Accessibility:	Easy			
Installation:	Boarding (2)			
Approx extent (m² unless stated)	1			
Asbestos Type:	Amosite (2)			
Condition:	Low damage (1)	Surface Treatment:	Unsealed AIB/encapsulated lagging (2)

Material Risk Assessment	7	Priority Risk Assessment (PA)	N/A	Total Risk	N/A
Recommendation:	Remove				
Comments:

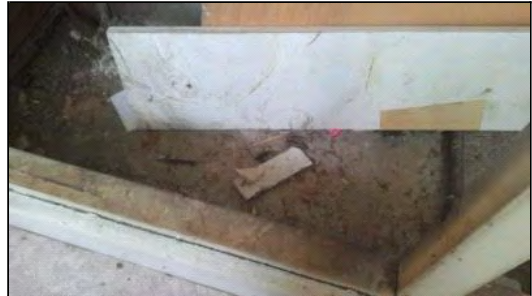
Location:		1 - 16 Marston - Third floor - Flat 13 - Supalux boarding debris in the base of the former heater cupboard

Item No:	000033	Laboratory sample no:	CF009166	
Accessibility:		N/A		
Installation:		Boarding		
Approx extent (m² unless stated)		N/A		
Asbestos Type:		NAD		
Condition:	N/A	Surface Treatment:	N/A

Material Risk Assessment	0	Priority Risk Assessment (PA)	N/A	Total Risk	
Recommendation:	None				
Comments:

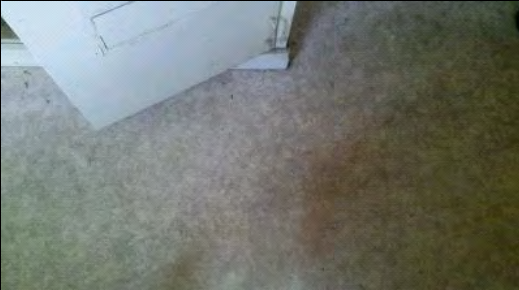
Location:		1 - 16 Marston - Third floor - Flat 13 - Beige tiles and bitumen to the floor beneath the modern flooring within the kitchen

Item No:	000034	Laboratory sample no:	CF009167	
Accessibility:		Easy		
Installation:		Floor tile(s) & bitumen (1)		
Approx extent (m² unless stated)		10		
Asbestos Type:		Chrysotile (1)		
Condition:	Low damage (1)		Surface Treatment:

Material Risk Assessment	3	Priority Risk Assessment (PA)	N/A	Total Risk	N/A
Recommendation:	Remove				
Comments:

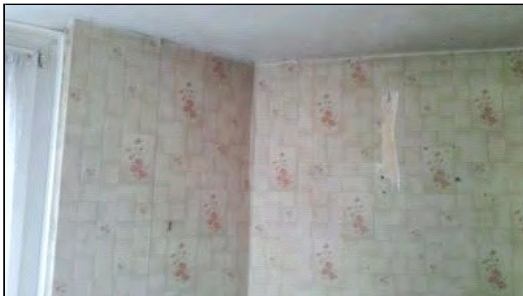
Location:		1 - 16 Marston - Third floor - Flat 13 - Panel at high level behind the wall paper in the kitchen

Item No:	000035	Laboratory sample no:	CF009168	
Accessibility:		Moderate		
Installation:		Boarding (2)		
Approx extent (m² unless stated)		<1		
Asbestos Type:		Amosite (2)		
Condition:	Low damage (1)	Surface Treatment:	Surface sealed (1)

Material Risk Assessment	6	Priority Risk Assessment (PA)	N/A	Total Risk	N/A
Recommendation:	Remove				
Comments:

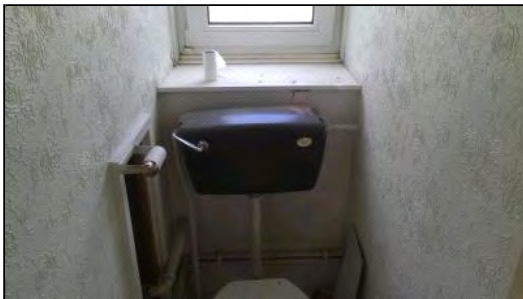
Location:		1 - 16 Marston - Third floor - Flat 13 - Toilet cistern within the toilet

Item No:	000036	Laboratory sample no:	CF009169	
Accessibility:		Easy		
Installation:		Toilet cistern(s) (1)		
Approx extent (m² unless stated)		1no.		
Asbestos Type:		Amosite (2)		
Condition:		Low damage (1)	Surface Treatment:

Material Risk Assessment	4	Priority Risk Assessment (PA)	N/A	Total Risk	N/A
Recommendation:	Remove				
Comments:

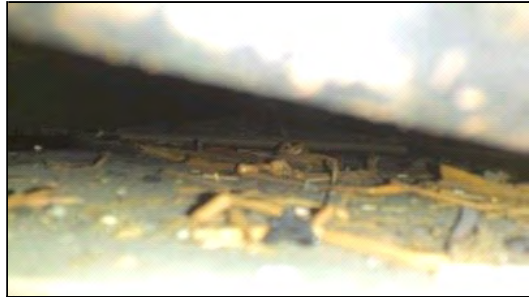
Location:		1 - 16 Marston - Roof Void - Flat 14 ceiling voids - Roofing felt debris within the ceiling voids in the kitchen, lounge, bathroom, toilet, lobby, hallway, bedroom 1, bedroom 2 and bedroom 3

Item No:	000037	Laboratory sample no:	SP CF009155	
Accessibility:		Difficult		
Installation:		Roofing felt (1)		
Approx extent (m <sup>2</sup> unless stated)		<5		
Asbestos Type:		Chrysotile (1)		
Condition:		Medium damage (2)	Surface Treatment: Completely sealed (0)

Material Risk Assessment	4	Priority Risk Assessment (PA)	N/A	Total Risk	N/A
Recommendation:		Remove			
Comments: please note the debris is scattered in every ceiling void

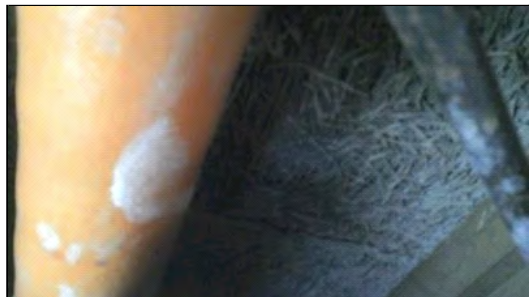
Location:		1 - 16 Marston - Roof Void - Flat 14 ceiling voids - Stramit boards within the ceiling voids in the kitchen, lounge, bathroom, toilet, lobby, hallway, bedroom 1, bedroom 2 and bedroom 3

Item No:	000038	Laboratory sample no:	SP CF009156	
Accessibility:		N/A		
Installation:		Boarding		
Approx extent (m <sup>2</sup> unless stated)		N/A		
Asbestos Type:		NAD		
Condition:		N/A	Surface Treatment: N/A

Material Risk Assessment	0	Priority Risk Assessment (PA)	N/A	Total Risk	
Recommendation:		None			
Comments:

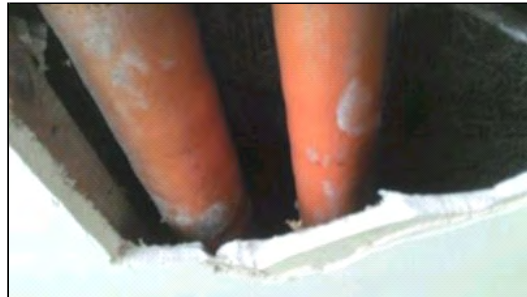
Location:		1 - 16 Marston - Roof Void - Flat 14 ceiling voids - Paper condensate layer to the pipework within the kitchen, lobby and toilet ceiling voids

Item No:	000039	Laboratory sample no:	SP CF009157	
Accessibility:		N/A		
Installation:		Paper / cardboard		
Approx extent (m² unless stated)		N/A		
Asbestos Type:		NAD		
Condition:	N/A	Surface Treatment:	N/A

Material Risk Assessment	0	Priority Risk Assessment (PA)	N/A	Total Risk	
Recommendation:	None				
Comments:

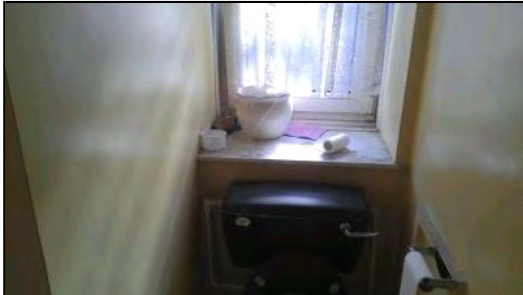
Location:		1 - 16 Marston - Third floor - Flat 14 - Eternite window sills beneath the PVC-u sills within the kitchen, toilet, bedroom 1, bedroom 2 and bedroom 3

Item No:	000040	Laboratory sample no:	SP CF009158	
Accessibility:		Easy		
Installation:		Cement (1)		
Approx extent (m² unless stated)		12lm		
Asbestos Type:		Chrysotile (1)		
Condition:	Low damage (1)		Surface Treatment:	Surface sealed (1)

Material Risk Assessment	4	Priority Risk Assessment (PA)	N/A	Total Risk	N/A
Recommendation:	Remove				
Comments:

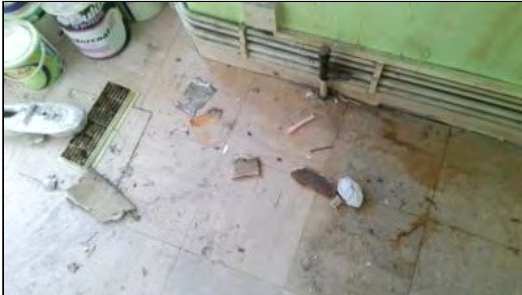
Location:		1 - 16 Marston - Third floor - Flat 14 - Beige tiles and bitumen to the floor beneath the modern flooring within the kitchen

Item No:	000047	Laboratory sample no:	SP CF009167	
Accessibility:		Easy		
Installation:		Floor tile(s) & bitumen (1)		
Approx extent (m² unless stated)		10		
Asbestos Type:		Chrysotile (1)		
Condition:	Low damage (1)	Surface Treatment:	Completely sealed (0)

Material Risk Assessment	3	Priority Risk Assessment (PA)	N/A	Total Risk	N/A
Recommendation:	Remove				
Comments:

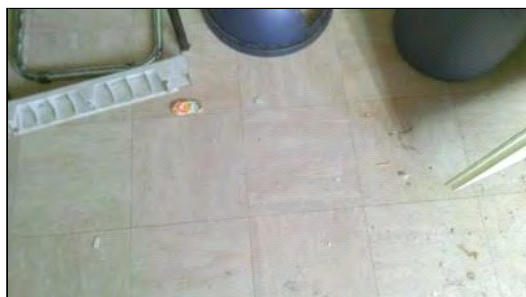
Location:		1 - 16 Marston - Third floor - Flat 14 - Pink tiles to the floor within the kitchen

Item No:	000048	Laboratory sample no:	CF009174	
Accessibility:	N/A			
Installation:	Floor tile(s)			
Approx extent (m² unless stated)		N/A		
Asbestos Type:	NAD			
Condition:	N/A	Surface Treatment:	N/A

Material Risk Assessment	0	Priority Risk Assessment (PA)	N/A	Total Risk	
Recommendation:	None				
Comments:

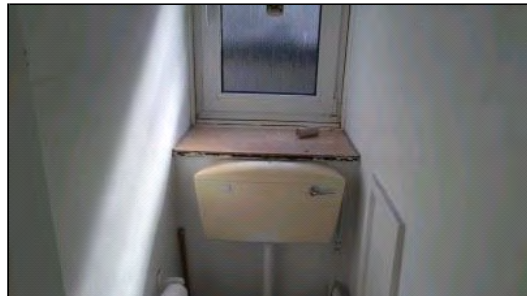
Location:		1 - 16 Marston - Second floor - Flat 10 - Eternite window sills beneath the PVC-u sills within the kitchen, toilet, bedroom 1, bedroom 2 and bedroom 3

Item No:	000052	Laboratory sample no:	CF009177	
Accessibility:		Easy		
Installation:		Cement (1)		
Approx extent (m² unless stated)		12lm		
Asbestos Type:		Chrysotile (1)		
Condition:	Low damage (1)	Surface Treatment:	Surface sealed (1)

Material Risk Assessment	4	Priority Risk Assessment (PA)	N/A	Total Risk	N/A
Recommendation:	Remove				
Comments:

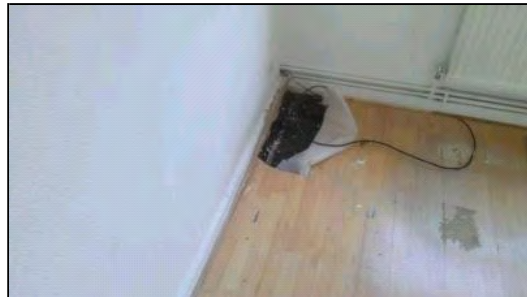
Location:		1 - 16 Marston - Second floor - Flat 10 - Black floor tiles and bitumen to the floor beneath the modern flooring within the lounge, lobby, bathroom, toilet, hallway, bedroom 1, bedroom 2 and bedroom 3

Item No:	000053	Laboratory sample no:	CF009178	
Accessibility:		Easy		
Installation:		Floor tile(s) & bitumen (1)		
Approx extent (m² unless stated)		40		
Asbestos Type:		Chrysotile (1)		
Condition:	Low damage (1)	Surface Treatment:	Completely sealed (0)

Material Risk Assessment	3	Priority Risk Assessment (PA)	N/A	Total Risk	N/A
Recommendation:	Remove				
Comments:

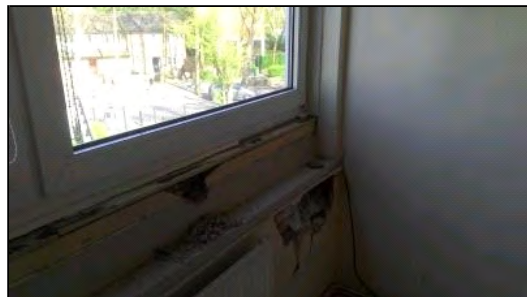
Location:		1 - 16 Marston - Second floor - Flat 10 - Felt damp proof course around the window frames within the kitchen, toilet, bathroom, lounge, bedroom 1, bedroom 2 and bedroom 3

Item No:	000054	Laboratory sample no:	CF009179	
Accessibility:		N/A		
Installation:		Felt		
Approx extent (m² unless stated)		N/A		
Asbestos Type:		NAD		
Condition:	N/A	Surface Treatment:	N/A

Material Risk Assessment	0	Priority Risk Assessment (PA)	N/A	Total Risk	
Recommendation:	None				
Comments:

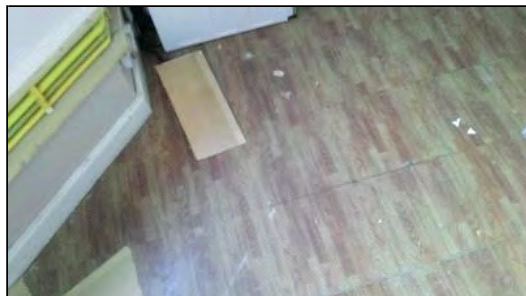
Location:		1 - 16 Marston - Second floor - Flat 10 - Beige tiles and bitumen to the floor beneath the modern flooring within the kitchen

Item No:	000057	Laboratory sample no:	CF009182	
Accessibility:		Easy		
Installation:		Floor tile(s) & bitumen (1)		
Approx extent (m² unless stated)		10		
Asbestos Type:		Chrysotile (1)		
Condition:	Low damage (1)	Surface Treatment:	Completely sealed (0)

Material Risk Assessment	3	Priority Risk Assessment (PA)	N/A	Total Risk	N/A
Recommendation:	Remove				
Comments:

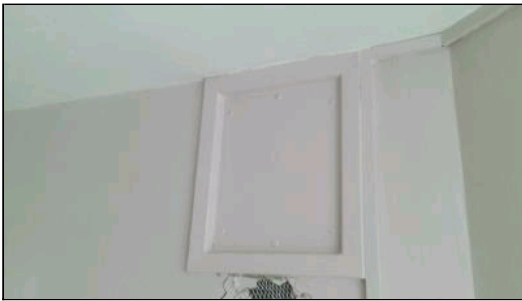
Location:		1 - 16 Marston - Second floor - Flat 10 - Panel at high level in the kitchen

Item No:	000058	Laboratory sample no:	CF009183	
Accessibility:		Moderate		
Installation:		Boarding (2)		
Approx extent (m² unless stated)		<1		
Asbestos Type:		Chrysotile + Amosite (2)		
Condition:	Low damage (1)	Surface Treatment:	Surface sealed (1)

Material Risk Assessment	6	Priority Risk Assessment (PA)	N/A	Total Risk	N/A
Recommendation:	Remove				
Comments:

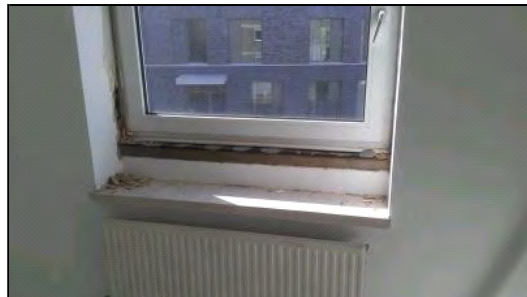
Location:		1 - 16 Marston - Second floor - Flat 9 - Eternite window sills beneath the PVC-u sills within the kitchen, bedroom 1, bedroom 2 and bedroom 3

Item No:	000060	Laboratory sample no:	SP CF009177	
Accessibility:		Easy		
Installation:		Cement (1)		
Approx extent (m² unless stated)		11lm		
Asbestos Type:		Chrysotile (1)		
Condition:	Low damage (1)		Surface Treatment:

Material Risk Assessment	4	Priority Risk Assessment (PA)	N/A	Total Risk	N/A
Recommendation:	Remove				
Comments:

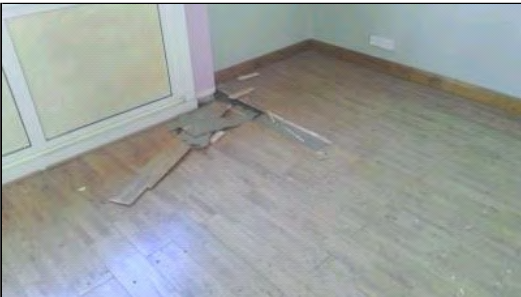
Location:		1 - 16 Marston - Second floor - Flat 9 - Black floor tiles and bitumen to the floor beneath the modern flooring within the lounge, lobby, bathroom, toilet, hallway, bedroom 1, bedroom 2 and bedroom 3

Item No:	000061	Laboratory sample no:	SP CF009178	
Accessibility:		Easy		
Installation:		Floor tile(s) & bitumen (1)		
Approx extent (m² unless stated)		40		
Asbestos Type:		Chrysotile (1)		
Condition:	Low damage (1)		Surface Treatment:	Completely sealed (0)

Material Risk Assessment	3	Priority Risk Assessment (PA)	N/A	Total Risk	N/A
Recommendation:	Remove				
Comments:

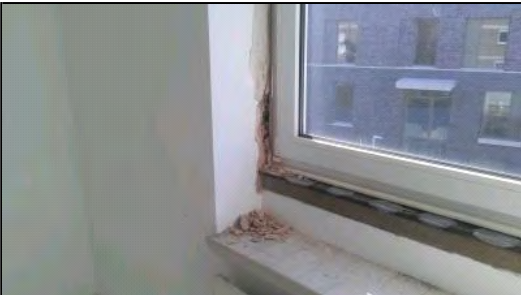
Location:		1 - 16 Marston - Second floor - Flat 9 - Felt damp proof course around the window frames within the kitchen, toilet, bathroom, lounge, bedroom 1, bedroom 2 and bedroom 3

Item No:	000062	Laboratory sample no:	SP CF009179	
Accessibility:		N/A		
Installation:		Felt		
Approx extent (m² unless stated)		N/A		
Asbestos Type:		NAD		
Condition:	N/A	Surface Treatment:	N/A

Material Risk Assessment	0	Priority Risk Assessment (PA)	N/A	Total Risk	
Recommendation:	None				
Comments:

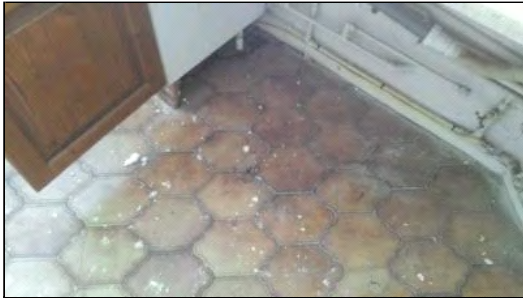
Location:		1 - 16 Marston - Second floor - Flat 9 - Beige tiles and bitumen to the floor beneath the modern flooring within the kitchen

Item No:	000064	Laboratory sample no:	SP CF009182	
Accessibility:		Easy		
Installation:		Floor tile(s) & bitumen (1)		
Approx extent (m² unless stated)		10		
Asbestos Type:		Chrysotile (1)		
Condition:	Low damage (1)	Surface Treatment:	Completely sealed (0)

Material Risk Assessment	3	Priority Risk Assessment (PA)	N/A	Total Risk	N/A
Recommendation:	Remove				
Comments:

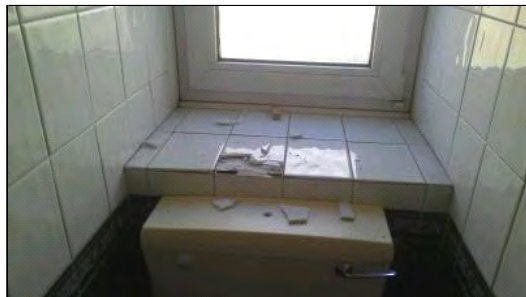
Location:		1 - 16 Marston - Second floor - Flat 12 - Eternite window sills beneath the PVC-u sills within the kitchen, toilet, bedroom 1, bedroom 2 and bedroom 3

Item No:	000065	Laboratory sample no:	CF009186	
Accessibility:		Easy		
Installation:		Cement (1)		
Approx extent (m² unless stated)		12lm		
Asbestos Type:		Chrysotile (1)		
Condition:	Low damage (1)	Surface Treatment:	Surface sealed (1)

Material Risk Assessment	4	Priority Risk Assessment (PA)	N/A	Total Risk	N/A
Recommendation:	Remove				
Comments:

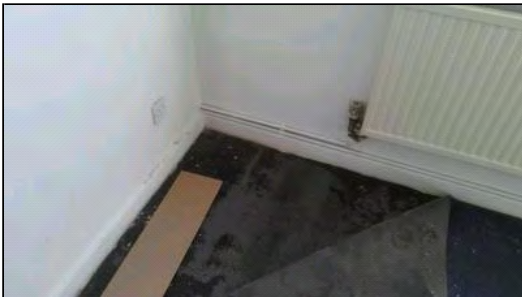
Location:		1 - 16 Marston - Second floor - Flat 12 - Black floor tiles and bitumen to the floor beneath the modern flooring within the lounge, lobby, bathroom, toilet, hallway, bedroom 1, bedroom 2 and bedroom 3

Item No:	000066	Laboratory sample no:	CF009187	
Accessibility:		Easy		
Installation:		Floor tile(s) & bitumen (1)		
Approx extent (m² unless stated)		40		
Asbestos Type:		Chrysotile (1)		
Condition:	Low damage (1)	Surface Treatment:	Completely sealed (0)

Material Risk Assessment	3	Priority Risk Assessment (PA)	N/A	Total Risk	N/A
Recommendation:	Remove				
Comments:

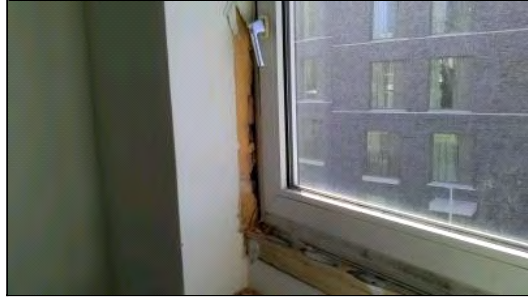
Location:	1 - 16 Marston - Second floor - Flat 12 - Felt damp proof course around the window frames within the kitchen, toilet, bathroom, lounge, bedroom 1, bedroom 2 and bedroom 3

Item No:	000067	Laboratory sample no:	CF009188	
Accessibility:	N/A			
Installation:	Felt			
Approx extent (m <sup>2</sup> unless stated)	N/A			
Asbestos Type:	NAD			
Condition:	N/A	Surface Treatment:	N/A

Material Risk Assessment	0	Priority Risk Assessment (PA)	N/A	Total Risk	
Recommendation:	None				
Comments:

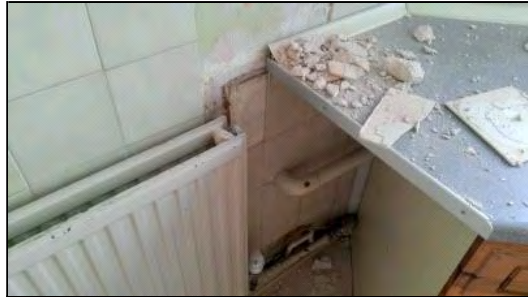
Location:	1 - 16 Marston - Second floor - Flat 12 - Panel to the wall adjacent the sink unit

Item No:	000068	Laboratory sample no:	CF009189	
Accessibility:	Easy			
Installation:	Boarding (2)			
Approx extent (m <sup>2</sup> unless stated)	<1			
Asbestos Type:	Amosite (2)			
Condition:	Low damage (1)	Surface Treatment:	Surface sealed (1)

Material Risk Assessment	6	Priority Risk Assessment (PA)	N/A	Total Risk	N/A
Recommendation:	Remove				
Comments:

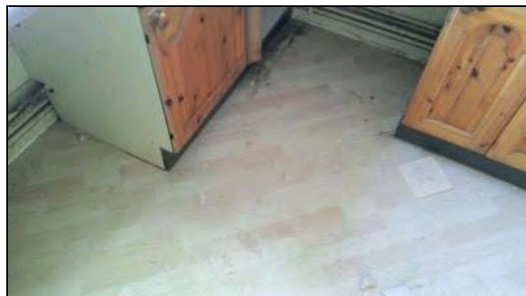
Location:		1 - 16 Marston - Second floor - Flat 12 - Beige tiles and bitumen to the floor beneath the modern flooring within the kitchen

Item No:	000069	Laboratory sample no:	CF009190	
Accessibility:		Easy		
Installation:		Floor tile(s) & bitumen (1)		
Approx extent (m² unless stated)		10		
Asbestos Type:		Chrysotile (1)		
Condition:	Low damage (1)	Surface Treatment:	Completely sealed (0)

Material Risk Assessment	3	Priority Risk Assessment (PA)	N/A	Total Risk	N/A
Recommendation:	Remove				
Comments:

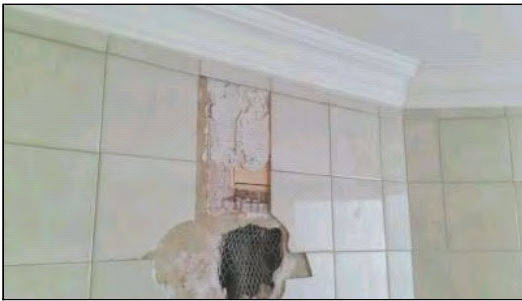
Location:		1 - 16 Marston - Second floor - Flat 12 - Panel at high level in the kitchen

Item No:	000070	Laboratory sample no:	CF009191	
Accessibility:		Easy		
Installation:		Boarding (2)		
Approx extent (m² unless stated)		<1		
Asbestos Type:		Chrysotile + Amosite (2)		
Condition:		Low damage (1)	Surface Treatment:

Material Risk Assessment	6	Priority Risk Assessment (PA)	N/A	Total Risk	N/A
Recommendation:	Remove				
Comments:

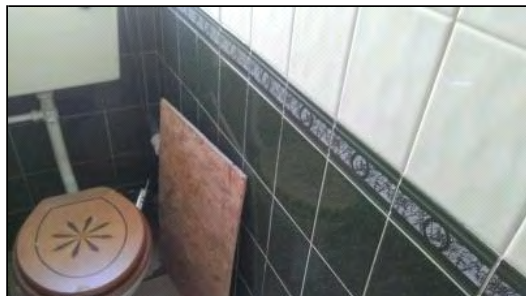
Location:		1 - 16 Marston - Second floor - Flat 12 - Panel at low level beneath the ceramic tiles in the toilet

Item No:	000071	Laboratory sample no:	SP CF009184	
Accessibility:		Easy		
Installation:		Boarding (2)		
Approx extent (m² unless stated)		<1		
Asbestos Type:		Chrysotile + Amosite (2)		
Condition:		Low damage (1)	Surface Treatment:

Material Risk Assessment	6	Priority Risk Assessment (PA)	N/A	Total Risk	N/A
Recommendation:	Remove				
Comments:

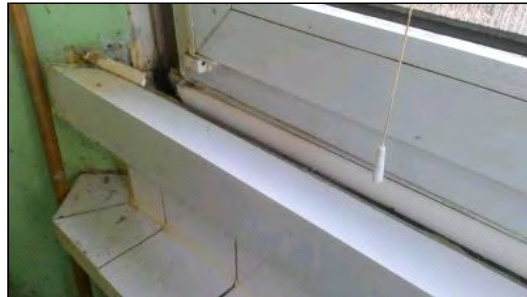
Location:		1 - 16 Marston - Second floor - Flat 11 - Eternite window sills beneath the PVC-u sills within the kitchen, toilet, bedroom 1, bedroom 2, bedroom 3 and bedroom 4

Item No:	000073	Laboratory sample no:	SP CF009186	
Accessibility:		Easy		
Installation:		Cement (1)		
Approx extent (m² unless stated)		14lm		
Asbestos Type:		Chrysotile (1)		
Condition:	Low damage (1)		Surface Treatment:

Material Risk Assessment	4	Priority Risk Assessment (PA)	N/A	Total Risk	N/A
Recommendation:	Remove				
Comments:

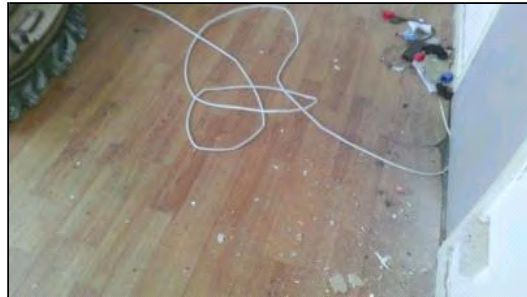
Location:		1 - 16 Marston - Second floor - Flat 11 - Black tiles and bitumen to the floor beneath the modern flooring within the lounge, lobby, bathroom, toilet, hallway, bedroom 1, bedroom 2, bedroom 3 and bedroom 4

Item No:	000074	Laboratory sample no:	SP CF009187	
Accessibility:		Easy		
Installation:		Floor tile(s) & bitumen (1)		
Approx extent (m² unless stated)		50		
Asbestos Type:		Chrysotile (1)		
Condition:	Low damage (1)	Surface Treatment:	Completely sealed (0)

Material Risk Assessment	3	Priority Risk Assessment (PA)	N/A	Total Risk	N/A
Recommendation:	Remove				
Comments:

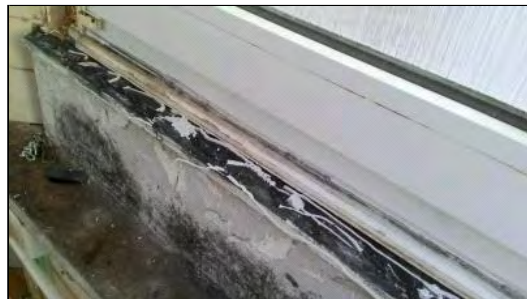
Location:		1 - 16 Marston - First floor - Flat 5 - Eternite window sills beneath the PVC-u sills within the kitchen, toilet, bedroom 1, bedroom 2 and bedroom 3

Item No:	000081	Laboratory sample no:	CF009198	
Accessibility:		Easy		
Installation:		Cement (1)		
Approx extent (m² unless stated)		12lm		
Asbestos Type:		Chrysotile (1)		
Condition:	Low damage (1)	Surface Treatment:	Surface sealed (1)

Material Risk Assessment	4	Priority Risk Assessment (PA)	N/A	Total Risk	N/A
Recommendation:	Remove				
Comments:

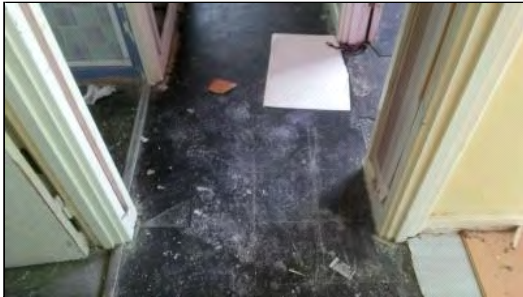
Location:		1 - 16 Marston - First floor - Flat 5 - Black floor tiles and bitumen to the floor beneath the modern flooring within the lounge, lobby, hallway, bedroom 1, bedroom 2 and bedroom 3

Item No:	000082	Laboratory sample no:	CF009199	
Accessibility:		Easy		
Installation:		Floor tile(s) & bitumen (1)		
Approx extent (m² unless stated)		35		
Asbestos Type:		Chrysotile (1)		
Condition:	Low damage (1)	Surface Treatment:	Completely sealed (0)

Material Risk Assessment	3	Priority Risk Assessment (PA)	N/A	Total Risk	N/A
Recommendation:	Remove				
Comments:

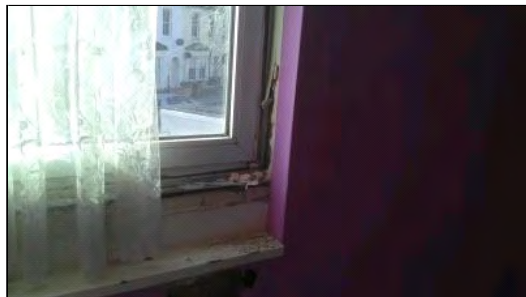
Location:		1 - 16 Marston - First floor - Flat 5 - Felt damp proof course around the window frames within the kitchen, toilet, bathroom, lounge, bedroom 1, bedroom 2 and bedroom 3

Item No:	000083	Laboratory sample no:	CF009200	
Accessibility:		N/A		
Installation:		Felt		
Approx extent (m² unless stated)		N/A		
Asbestos Type:		NAD		
Condition:	N/A	Surface Treatment:	N/A

Material Risk Assessment	0	Priority Risk Assessment (PA)	N/A	Total Risk	
Recommendation:	None				
Comments:

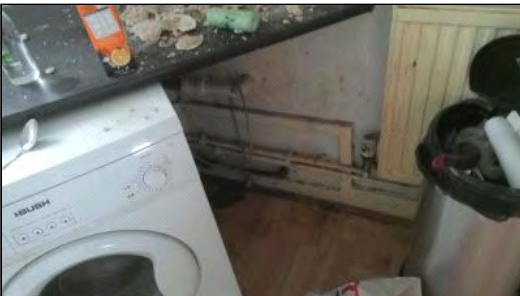
Location:		1 - 16 Marston - First floor - Flat 5 - Panel to the wall adjacent the sink unit in the kitchen

Item No:	000085	Laboratory sample no:	CF009202	
Accessibility:		Easy		
Installation:		Boarding (2)		
Approx extent (m² unless stated)		<1		
Asbestos Type:		Amosite (2)		
Condition:	Low damage (1)	Surface Treatment:	Surface sealed (1)

Material Risk Assessment	6	Priority Risk Assessment (PA)	N/A	Total Risk	N/A
Recommendation:	Remove				
Comments:

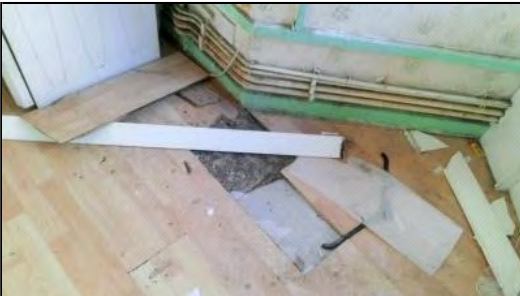
Location:		1 - 16 Marston - First floor - Flat 5 - Bitumen to the floor beneath the modern flooring within the kitchen, toilet and bathroom

Item No:	000086	Laboratory sample no:	CF009203	
Accessibility:		Easy		
Installation:		Bitumen (1)		
Approx extent (m² unless stated)		15		
Asbestos Type:		Chrysotile (1)		
Condition:	Low damage (1)	Surface Treatment:	Completely sealed (0)

Material Risk Assessment	3	Priority Risk Assessment (PA)	N/A	Total Risk	N/A
Recommendation:	Remove				
Comments:

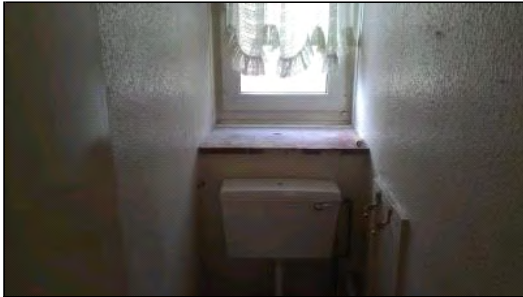
Location:		1 - 16 Marston - First floor - Flat 8 - Eternite window sills beneath the PVC-u sills within the kitchen, toilet, bedroom 1, bedroom 2 and bedroom 3

Item No:	000090	Laboratory sample no:	SP CF009198	
Accessibility:		Easy		
Installation:		Cement (1)		
Approx extent (m² unless stated)		12lm		
Asbestos Type:		Chrysotile (1)		
Condition:		Low damage (1)	Surface Treatment:

Material Risk Assessment	4	Priority Risk Assessment (PA)	N/A	Total Risk	N/A
Recommendation:	Remove				
Comments:

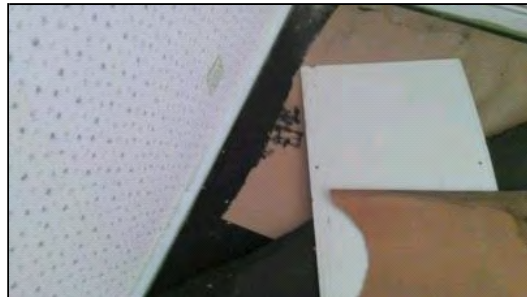
Location:		1 - 16 Marston - First floor - Flat 8 - Black floor tiles and bitumen to the floor beneath the carpet within the lounge, lobby, hallway, bedroom 1, bedroom 2 and bedroom 3

Item No:	000091	Laboratory sample no:	SP CF009199	
Accessibility:		Easy		
Installation:		Floor tile(s) & bitumen (1)		
Approx extent (m² unless stated)		35		
Asbestos Type:		Chrysotile (1)		
Condition:	Low damage (1)	Surface Treatment:	Completely sealed (0)

Material Risk Assessment	3	Priority Risk Assessment (PA)	N/A	Total Risk	N/A
Recommendation:	Remove				
Comments:

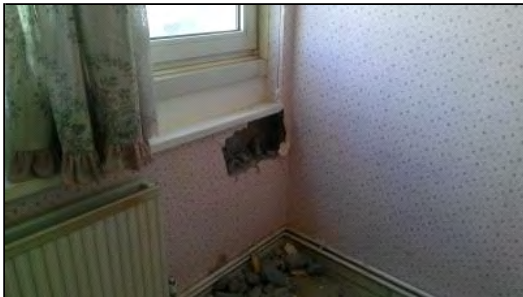
Location:		1 - 16 Marston - First floor - Flat 8 - Felt damp proof course around the window frames within the kitchen, toilet, bathroom, lounge, bedroom 1, bedroom 2 and bedroom 3

Item No:	000092	Laboratory sample no:	SP CF009200	
Accessibility:		N/A		
Installation:		Felt		
Approx extent (m² unless stated)		N/A		
Asbestos Type:		NAD		
Condition:	N/A	Surface Treatment:	N/A

Material Risk Assessment	0	Priority Risk Assessment (PA)	N/A	Total Risk	
Recommendation:	None				
Comments:

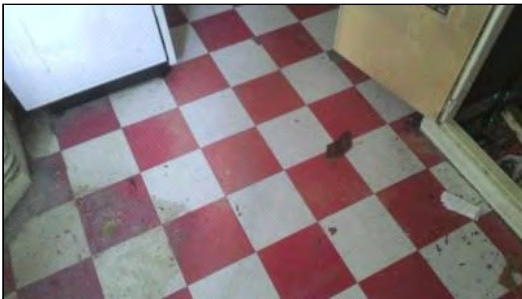
Location:		1 - 16 Marston - First floor - Flat 8 - Red tiles and bitumen to the floor within the kitchen

Item No:	000095	Laboratory sample no:	CF009208	
Accessibility:		Easy		
Installation:		Floor tile(s) & bitumen (1)		
Approx extent (m² unless stated)		5		
Asbestos Type:		Chrysotile (1)		
Condition:	Low damage (1)	Surface Treatment:	Completely sealed (0)

Material Risk Assessment	3	Priority Risk Assessment (PA)	N/A	Total Risk	N/A
Recommendation:	Remove				
Comments:

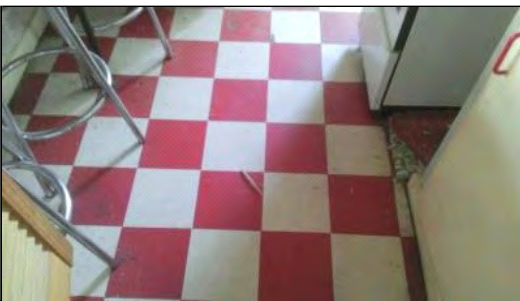
Location:		1 - 16 Marston - First floor - Flat 8 - White tiles and bitumen to the floor within the kitchen

Item No:	000097	Laboratory sample no:	CF009211	
Accessibility:		N/A		
Installation:		Floor tile(s) & bitumen		
Approx extent (m² unless stated)		N/A		
Asbestos Type:		NAD		
Condition:	N/A	Surface Treatment:	N/A

Material Risk Assessment	0	Priority Risk Assessment (PA)	N/A	Total Risk	
Recommendation:	None				
Comments:

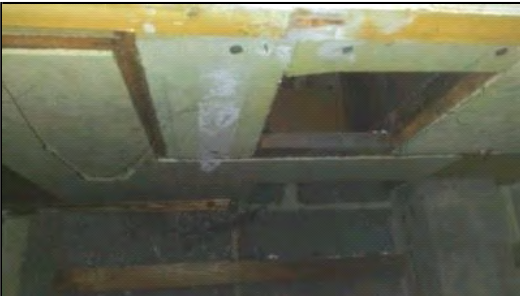
Location:		1 - 16 Marston - First floor - Flat 8 - Boarding to the underside of the bottom timber shelf in the former heater cupboard, in the kitchen

Item No:	000098	Laboratory sample no:	CF009212	
Accessibility:		Easy		
Installation:		Boarding (2)		
Approx extent (m² unless stated)		<1		
Asbestos Type:		Chrysotile + Amosite (2)		
Condition:	Low damage (1)	Surface Treatment:	Unsealed AIB/encapsulated lagging (2)

Material Risk Assessment	7	Priority Risk Assessment (PA)	N/A	Total Risk	N/A
Recommendation:	Remove				
Comments:

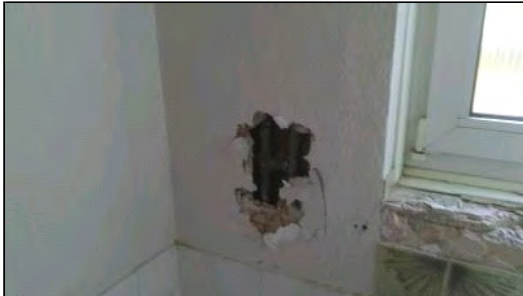
Location:		1 - 16 Marston - First floor - Flat 8 - Preformed cement panel in the wall cavity above the bath in the bathroom

Item No:	000100	Laboratory sample no:	SP CF009205	
Accessibility:		Moderate		
Installation:		Cement (1)		
Approx extent (m² unless stated)		1no.		
Asbestos Type:		Chrysotile + Crocidolite (3)		
Condition:	Low damage (1)		Surface Treatment:	
				Surface sealed (1)

Material Risk Assessment	6	Priority Risk Assessment (PA)	N/A	Total Risk	N/A
Recommendation:	Remove				
Comments:

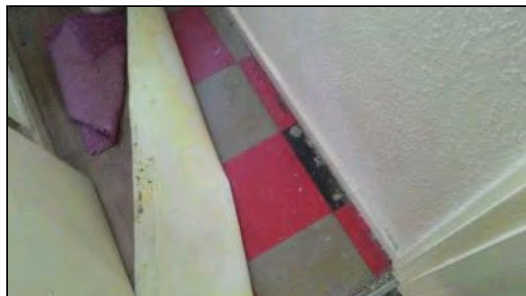
Location:		1 - 16 Marston - First floor - Flat 8 - Red tiles and bitumen to the floor beneath the carpet within the toilet

Item No:	000101	Laboratory sample no:	CF009213	
Accessibility:		Easy		
Installation:		Floor tile(s) & bitumen (1)		
Approx extent (m² unless stated)		<2		
Asbestos Type:		Chrysotile (1)		
Condition:	Low damage (1)	Surface Treatment:	Completely sealed (0)

Material Risk Assessment	3	Priority Risk Assessment (PA)	N/A	Total Risk	N/A
Recommendation:	Remove				
Comments:

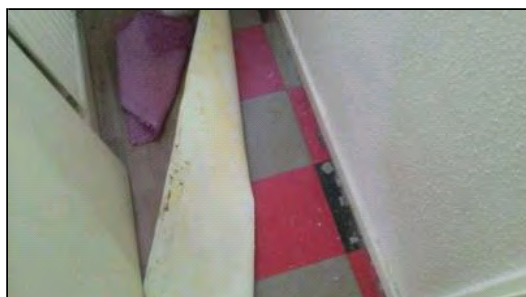
Location:		1 - 16 Marston - First floor - Flat 8 - Grey tiles and bitumen to the floor beneath the carpet within the toilet

Item No:	000102	Laboratory sample no:	CF009214	
Accessibility:		Easy		
Installation:		Floor tile(s) & bitumen (1)		
Approx extent (m² unless stated)		<2		
Asbestos Type:		Chrysotile (1)		
Condition:	Low damage (1)	Surface Treatment:	Completely sealed (0)

Material Risk Assessment	3	Priority Risk Assessment (PA)	N/A	Total Risk	N/A
Recommendation:	Remove				
Comments:

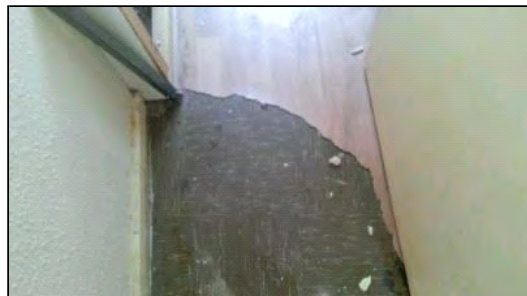
Location:		1 - 16 Marston - First floor - Flat 8 - Brown tiles and bitumen to the floor beneath the modern flooring within the bathroom

Item No:	000103	Laboratory sample no:	CF009215	
Accessibility:		Easy		
Installation:		Floor tile(s) & bitumen (1)		
Approx extent (m² unless stated)		<3		
Asbestos Type:		Chrysotile (1)		
Condition:	Low damage (1)	Surface Treatment:	Completely sealed (0)

Material Risk Assessment	3	Priority Risk Assessment (PA)	N/A	Total Risk	N/A
Recommendation:	Remove				
Comments:

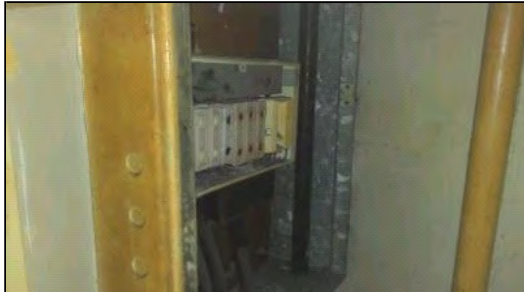
Location:		1 - 16 Marston - First floor - Flat 8 - Textile flash pads within fuse box in the cupboard, in the lobby

Item No:	000104	Laboratory sample no:	SP CF009175	
Accessibility:		Easy		
Installation:		Textile (2)		
Approx extent (m² unless stated)		6no.		
Asbestos Type:		Chrysotile (1)		
Condition:	Low damage (1)	Surface Treatment:	Surface sealed (1)

Material Risk Assessment	5	Priority Risk Assessment (PA)	N/A	Total Risk	N/A
Recommendation:	Remove				
Comments:

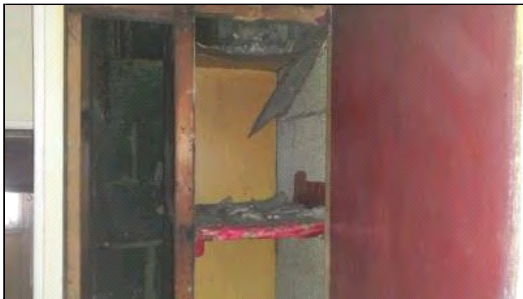
Location:		1 - 16 Marston - First floor - Flat 8 - Cement debris within the former heater cupboard in the kitchen

Item No:	000105	Laboratory sample no:	CF009217	
Accessibility:		Easy		
Installation:		Cement (1)		
Approx extent (m² unless stated)		<1		
Asbestos Type:		Chrysotile + Amosite (2)		
Condition:	Medium damage (2)	Surface Treatment:	Surface sealed (1)

Material Risk Assessment	6	Priority Risk Assessment (PA)	N/A	Total Risk	N/A
Recommendation:	Remove				
Comments:

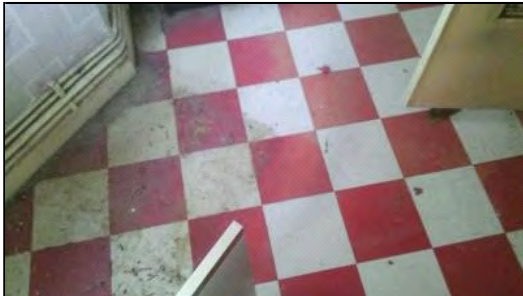
Location:		1 - 16 Marston - First floor - Flat 8 - Beige tiles and bitumen to the floor beneath the red and white tiles within the kitchen

Item No:	000106	Laboratory sample no:	CF009218	
Accessibility:		Easy		
Installation:		Floor tile(s) & bitumen (1)		
Approx extent (m² unless stated)		10		
Asbestos Type:		Chrysotile (1)		
Condition:	Low damage (1)	Surface Treatment:	Completely sealed (0)

Material Risk Assessment	3	Priority Risk Assessment (PA)	N/A	Total Risk	N/A
Recommendation:	Remove				
Comments:

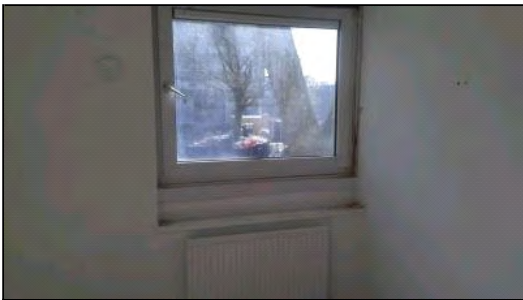
Location:		1 - 16 Marston - First floor - Flat 7 - Eternite window sills beneath the PVC-u sills within the kitchen, toilet, bedroom 1, bedroom 2, bedroom 3 and bedroom 4

Item No:	000108	Laboratory sample no:	SP CF009198	
Accessibility:		Easy		
Installation:		Cement (1)		
Approx extent (m² unless stated)		14lm		
Asbestos Type:		Chrysotile (1)		
Condition:	Low damage (1)	Surface Treatment:	Surface sealed (1)

Material Risk Assessment	4	Priority Risk Assessment (PA)	N/A	Total Risk	N/A
Recommendation:	Remove				
Comments:

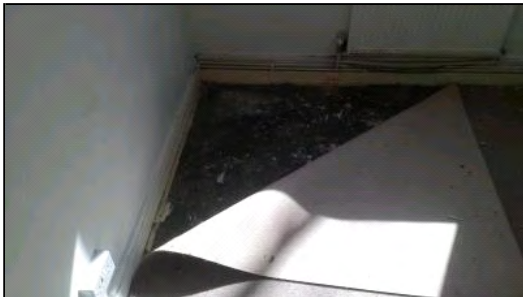
Location:		1 - 16 Marston - First floor - Flat 7 - Black floor tiles and bitumen to the floor beneath the modern flooring within the lounge, lobby, hallway, bedroom 1, bedroom 2, bedroom 3 and bedroom 4

Item No:	000109	Laboratory sample no:	SP CF009199	
Accessibility:		Easy		
Installation:		Floor tile(s) & bitumen (1)		
Approx extent (m² unless stated)		45		
Asbestos Type:		Chrysotile (1)		
Condition:	Low damage (1)	Surface Treatment:	Completely sealed (0)

Material Risk Assessment	3	Priority Risk Assessment (PA)	N/A	Total Risk	N/A
Recommendation:	Remove				
Comments:

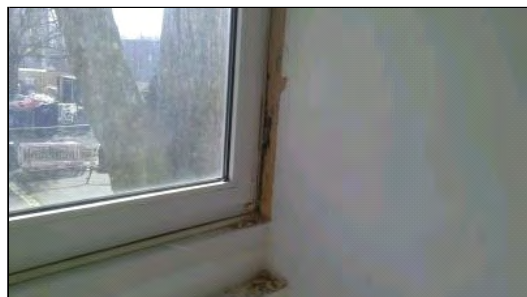
Location:		1 - 16 Marston - First floor - Flat 7 - Felt damp proof course around the window frames within the kitchen, toilet, bathroom, lounge, bedroom 1, bedroom 2, bedroom 3 and bedroom 4

Item No:	000110	Laboratory sample no:	SP CF009200	
Accessibility:		N/A		
Installation:		Felt		
Approx extent (m² unless stated)		N/A		
Asbestos Type:		NAD		
Condition:	N/A	Surface Treatment:	N/A

Material Risk Assessment	0	Priority Risk Assessment (PA)	N/A	Total Risk	
Recommendation:	None				
Comments:

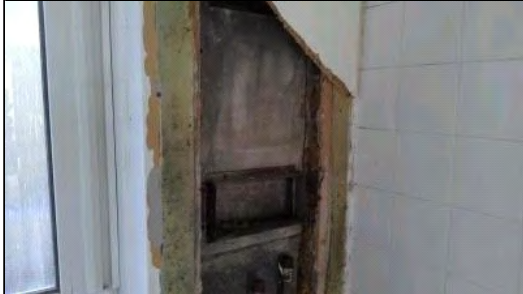
Location:		1 - 16 Marston - First floor - Flat 7 - Preformed cement panel in the wall cavity above the bath in the bathroom

Item No:	000114	Laboratory sample no:	CF009223	
Accessibility:		Moderate		
Installation:		Cement (1)		
Approx extent (m² unless stated)		1no.		
Asbestos Type:		Chrysotile (1)		
Condition:	Low damage (1)	Surface Treatment:	Surface sealed (1)

Material Risk Assessment	4	Priority Risk Assessment (PA)	N/A	Total Risk	N/A
Recommendation:	Remove				
Comments:
