## Demolition Survey

MANSTON  
AGAR GROVE  
LONDON

APRIL 2018

Report prepared for:	Hill Holdings (Essex) Ltd The Power House Gunpowder Mill Powdermill Lane Waltham Abbey Essex EN9 1BN
Report reference:	J113683
Issue date:	May 2018
Survey completed by: Scott Brookes Senior Surveyor

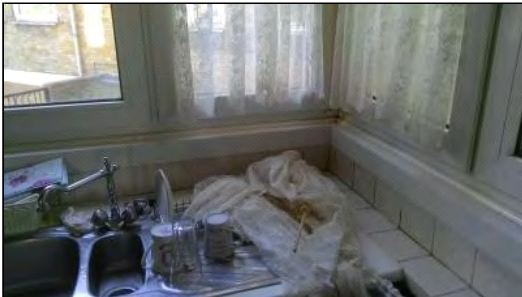
Location:		1 - 16 Marston - First floor - Flat 6 - Eternite window sills beneath the PVC-u sills within the kitchen, toilet, bedroom 1, bedroom 2 and bedroom 3

Item No:	000117	Laboratory sample no:	SP CF009198	
Accessibility:		Easy		
Installation:		Cement (1)		
Approx extent (m² unless stated)		12lm		
Asbestos Type:		Chrysotile (1)		
Condition:	Low damage (1)	Surface Treatment:	Surface sealed (1)

Material Risk Assessment	4	Priority Risk Assessment (PA)	N/A	Total Risk	N/A
Recommendation:	Remove				
Comments:

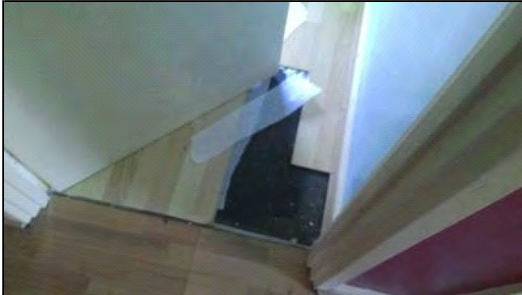
Location:		1 - 16 Marston - First floor - Flat 6 - Black floor tiles and bitumen to the floor beneath the modern flooring within the lounge, lobby, hallway, toilet, shower room, bedroom 1, bedroom 2 and bedroom 3

Item No:	000118	Laboratory sample no:	SP CF009199	
Accessibility:		Easy		
Installation:		Floor tile(s) & bitumen (1)		
Approx extent (m² unless stated)		40		
Asbestos Type:		Chrysotile (1)		
Condition:	Low damage (1)	Surface Treatment:	Completely sealed (0)

Material Risk Assessment	3	Priority Risk Assessment (PA)	N/A	Total Risk	N/A
Recommendation:	Remove				
Comments:

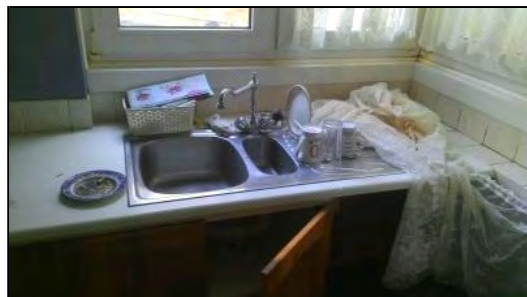
Location:		1 - 16 Marston - First floor - Flat 6 - Bitumen pads to the underside of the sink unit in the kitchen

Item No:	000120	Laboratory sample no:	CF009226	
Accessibility:		N/A		
Installation:		Sink pad		
Approx extent (m² unless stated)		N/A		
Asbestos Type:		NAD		
Condition:	N/A		Surface Treatment:	N/A

Material Risk Assessment	0	Priority Risk Assessment (PA)	N/A	Total Risk	
Recommendation:	None				
Comments:

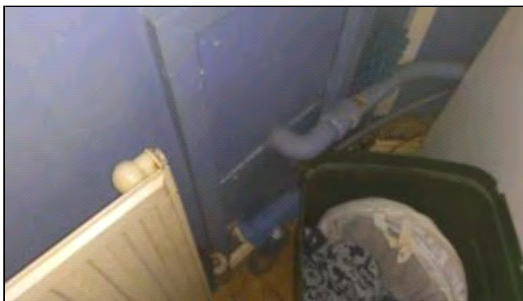
Location:		1 - 16 Marston - First floor - Flat 6 - Panel at low level adjacent the sink in the kitchen

Item No:	000121	Laboratory sample no:	CF009227	
Accessibility:		Easy		
Installation:		Boarding (2)		
Approx extent (m² unless stated)		<1		
Asbestos Type:		Chrysotile + Amosite (2)		
Condition:	Low damage (1)	Surface Treatment:	Surface sealed (1)

Material Risk Assessment	6	Priority Risk Assessment (PA)	N/A	Total Risk	N/A
Recommendation:	Remove				
Comments:

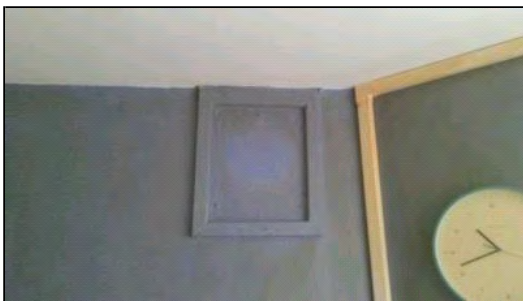
Location:		1 - 16 Marston - First floor - Flat 6 - Panel at high level in the kitchen

Item No:	000122	Laboratory sample no:	CF009228	
Accessibility:		Moderate		
Installation:		Boarding (2)		
Approx extent (m² unless stated)		<1		
Asbestos Type:		Chrysotile + Amosite (2)		
Condition:		Low damage (1)	Surface Treatment:

Material Risk Assessment	6	Priority Risk Assessment (PA)	N/A	Total Risk	N/A
Recommendation:	Remove				
Comments:

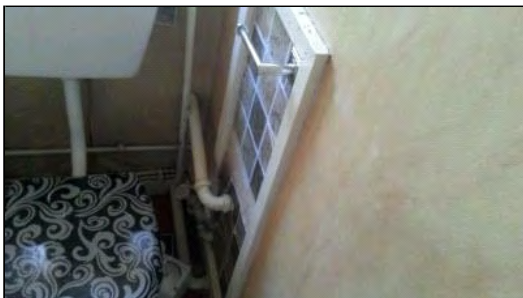
Location:		1 - 16 Marston - First floor - Flat 6 - Panel at low level in the toilet

Item No:	000123	Laboratory sample no:	CF009229	
Accessibility:		Easy		
Installation:		Boarding (2)		
Approx extent (m² unless stated)		<1		
Asbestos Type:		Chrysotile + Amosite (2)		
Condition:	Low damage (1)	Surface Treatment:	Surface sealed (1)

Material Risk Assessment	6	Priority Risk Assessment (PA)	N/A	Total Risk	N/A
Recommendation:	Remove				
Comments:

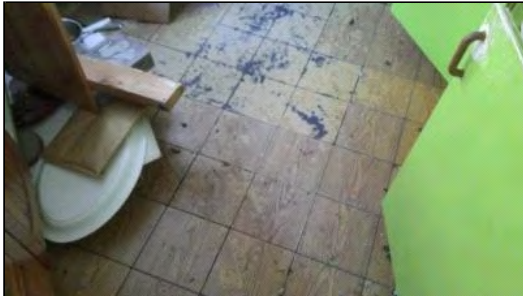
Location:		1 - 16 Marston - First floor - Flat 6 - Beige tiles and bitumen to the floor beneath the modern flooring within the kitchen

Item No:	000124	Laboratory sample no:	SP CF009225	
Accessibility:		Easy		
Installation:		Floor tile(s) & bitumen (1)		
Approx extent (m² unless stated)		10		
Asbestos Type:		Chrysotile (1)		
Condition:	Low damage (1)		Surface Treatment:	
				Completely sealed (0)

Material Risk Assessment	3	Priority Risk Assessment (PA)	N/A	Total Risk	N/A
Recommendation:	Remove				
Comments:

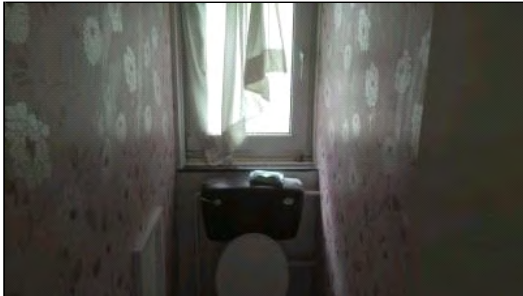
Location:		1 - 16 Marston - Ground floor - Flat 1 1 - Eternite window sills beneath the PVC-u sills within the kitchen, toilet, bedroom 1, bedroom 2 and bedroom 3

Item No:	000126	Laboratory sample no:	CF009231	
Accessibility:		Easy		
Installation:		Cement (1)		
Approx extent (m² unless stated)		12lm		
Asbestos Type:		Chrysotile (1)		
Condition:	Low damage (1)	Surface Treatment:	Surface sealed (1)

Material Risk Assessment	4	Priority Risk Assessment (PA)	N/A	Total Risk	N/A
Recommendation:	Remove				
Comments:

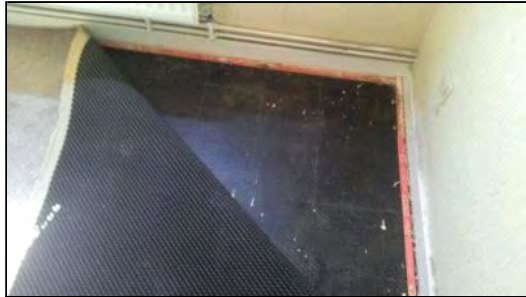
Location:	1 - 16 Marston - Ground floor - Flat 1 1 - Black floor tiles and bitumen to the floor beneath the modern flooring and carpet within the lounge, lobby, hallway, toilet, bathroom, bedroom 1, bedroom 2 and bedroom 3

Item No:	000127	Laboratory sample no:	CF009232	
Accessibility:	Easy			
Installation:	Floor tile(s) & bitumen (1)			
Approx extent (m <sup>2</sup> unless stated)	40			
Asbestos Type:	Chrysotile (1)			
Condition:	Low damage (1)	Surface Treatment:	Completely sealed (0)

Material Risk Assessment	3	Priority Risk Assessment (PA)	N/A	Total Risk	N/A
Recommendation:	Remove				
Comments:

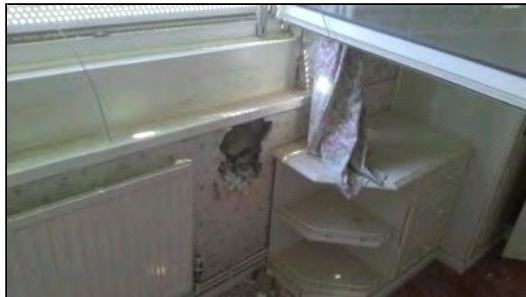
Location:	1 - 16 Marston - Ground floor - Flat 1 1 - Felt damp proof course around the window frames within the kitchen, toilet, bathroom, lounge, bedroom 1, bedroom 2 and bedroom 3

Item No:	000128	Laboratory sample no:	CF009233	
Accessibility:	N/A			
Installation:	Felt			
Approx extent (m <sup>2</sup> unless stated)	N/A			
Asbestos Type:	NAD			
Condition:	N/A	Surface Treatment:	N/A

Material Risk Assessment	0	Priority Risk Assessment (PA)	N/A	Total Risk	
Recommendation:	None				
Comments:

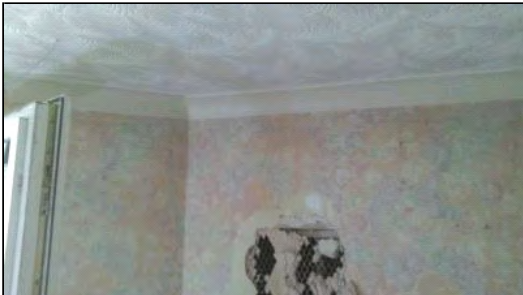
Location:		1 - 16 Marston - Ground floor - Flat 1 1 - Panel at high level beneath the wallpaper in the kitchen

Item No:	000130	Laboratory sample no:	CF009235	
Accessibility:		Moderate		
Installation:		Boarding (2)		
Approx extent (m² unless stated)		<1		
Asbestos Type:		Chrysotile + Amosite (2)		
Condition:		Low damage (1)	Surface Treatment:

Material Risk Assessment	6	Priority Risk Assessment (PA)	N/A	Total Risk	N/A
Recommendation:	Remove				
Comments:

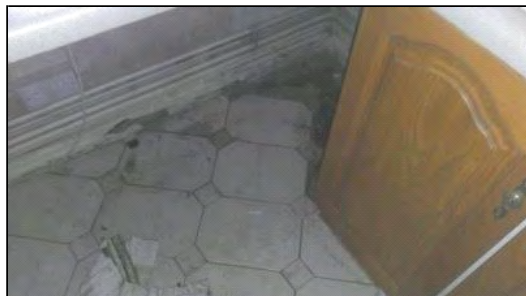
Location:		1 - 16 Marston - Ground floor - Flat 1 - Beige tiles and bitumen to the floor beneath the modern flooring within the kitchen

Item No:	000131	Laboratory sample no:	CF009236	
Accessibility:		Easy		
Installation:		Floor tile(s) & bitumen (1)		
Approx extent (m² unless stated)		10		
Asbestos Type:		Chrysotile (1)		
Condition:	Low damage (1)		Surface Treatment:	Completely sealed (0)

Material Risk Assessment	3	Priority Risk Assessment (PA)	N/A	Total Risk	N/A
Recommendation:	Remove				
Comments:

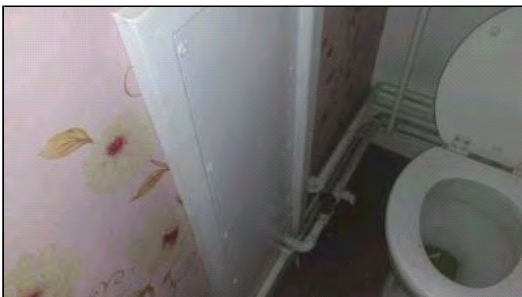
Location:		1 - 16 Marston - Ground floor - Flat 1 1 - Panel at low level in the toilet

Item No:	000132	Laboratory sample no:	CF009237	
Accessibility:		Easy		
Installation:		Boarding (2)		
Approx extent (m² unless stated)		1		
Asbestos Type:		Chrysotile + Amosite (2)		
Condition:	Low damage (1)		Surface Treatment:	Surface sealed (1)

Material Risk Assessment	6	Priority Risk Assessment (PA)	N/A	Total Risk	N/A
Recommendation:	Remove				
Comments:

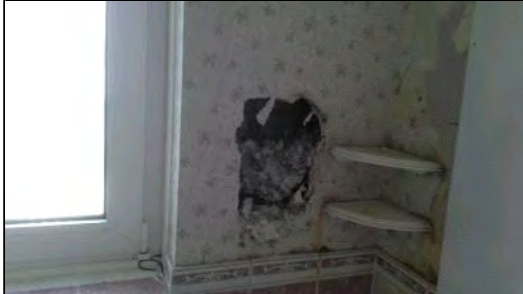
Location:		1 - 16 Marston - Ground floor - Flat 1 1 - Bitumen felt damp proof course in the outer wall cavity, above the bath in the bathroom

Item No:	000134	Laboratory sample no:	CF009239	
Accessibility:		N/A		
Installation:		Felt		
Approx extent (m² unless stated)		N/A		
Asbestos Type:		NAD		
Condition:	N/A	Surface Treatment:	N/A

Material Risk Assessment	0	Priority Risk Assessment (PA)	N/A	Total Risk	
Recommendation:	None				
Comments:

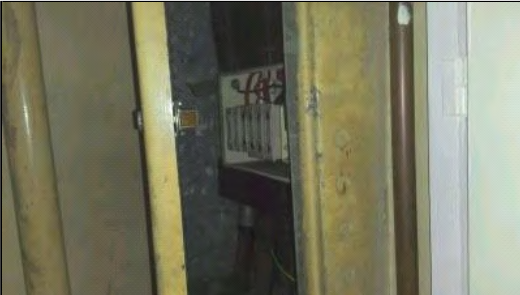
Location:		1 - 16 Marston - Ground floor - Flat 1 1 - Textile flash pads within the cupboard adjacent the front door in the lobby

Item No:	000135	Laboratory sample no:	SP CF009175	
Accessibility:		Easy		
Installation:		Textile (2)		
Approx extent (m² unless stated)		6no.		
Asbestos Type:		Chrysotile (1)		
Condition:	Low damage (1)		Surface Treatment:

Material Risk Assessment	5	Priority Risk Assessment (PA)	N/A	Total Risk	N/A
Recommendation:	Remove				
Comments:

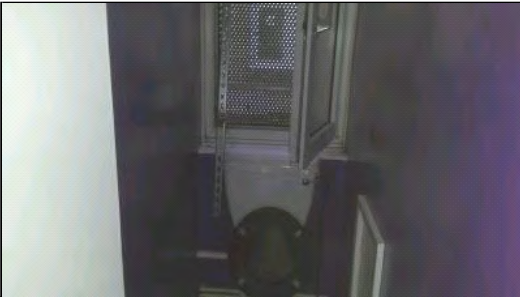
Location:		1 - 16 Marston - Ground floor - Flat 2 - Eternite window sills beneath the PVC-u sills within the kitchen, toilet, bedroom 1, bedroom 2 and bedroom 3

Item No:	000136	Laboratory sample no:	SP CF009231	
Accessibility:		Easy		
Installation:		Cement (1)		
Approx extent (m² unless stated)		12lm		
Asbestos Type:		Chrysotile (1)		
Condition:	Low damage (1)		Surface Treatment:	Surface sealed (1)

Material Risk Assessment	4	Priority Risk Assessment (PA)	N/A	Total Risk	N/A
Recommendation:	Remove				
Comments:

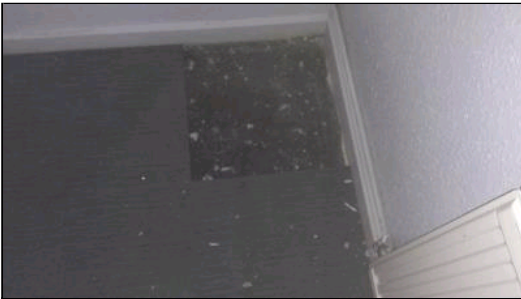
Location:		1 - 16 Marston - Ground floor - Flat 2 - Black floor tiles and bitumen to the floor beneath the modern flooring and carpet within the lounge, lobby, hallway, toilet, bathroom, bedroom 1, bedroom 2 and bedroom 3

Item No:	000137	Laboratory sample no:	SP CF009232	
Accessibility:		Easy		
Installation:		Floor tile(s) & bitumen (1)		
Approx extent (m² unless stated)		40		
Asbestos Type:		Chrysotile (1)		
Condition:	Low damage (1)		Surface Treatment:	Completely sealed (0)

Material Risk Assessment	3	Priority Risk Assessment (PA)	N/A	Total Risk	N/A
Recommendation:	Remove				
Comments:

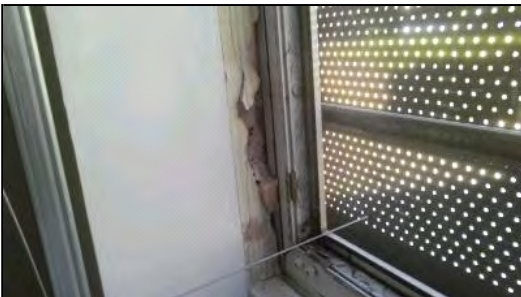
Location:		1 - 16 Marston - Ground floor - Flat 2 - Felt damp proof course around the window frames within the kitchen, toilet, bathroom, lounge, bedroom 1, bedroom 2 and bedroom 3

Item No:	000138	Laboratory sample no:	SP CF009233	
Accessibility:		N/A		
Installation:		Felt		
Approx extent (m² unless stated)		N/A		
Asbestos Type:		NAD		
Condition:	N/A	Surface Treatment:	N/A

Material Risk Assessment	0	Priority Risk Assessment (PA)	N/A	Total Risk	
Recommendation:	None				
Comments:

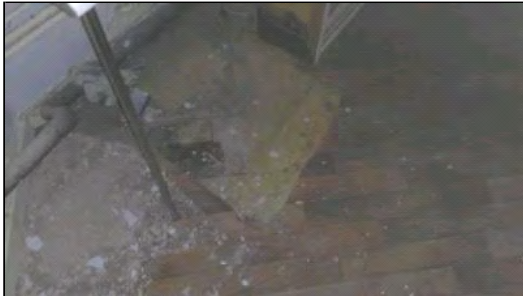
Location:		1 - 16 Marston - Ground floor - Flat 2 - Beige tiles and bitumen to the floor beneath the modern flooring within the kitchen

Item No:	000142	Laboratory sample no:	SP CF009236	
Accessibility:		Easy		
Installation:		Floor tile(s) & bitumen (1)		
Approx extent (m² unless stated)		10		
Asbestos Type:		Chrysotile (1)		
Condition:	Low damage (1)	Surface Treatment:	Completely sealed (0)

Material Risk Assessment	3	Priority Risk Assessment (PA)	N/A	Total Risk	N/A
Recommendation:	Remove				
Comments:

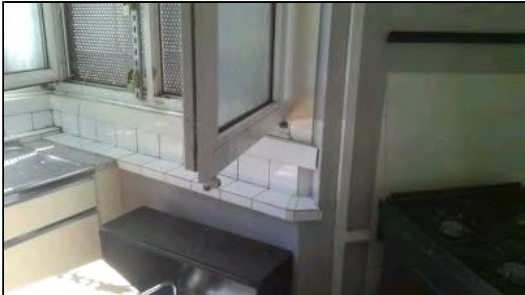
Location:		1 - 16 Marston - Ground floor - Flat 4 4 - Eternite window sills beneath the PVC-u sills within the kitchen, toilet, bedroom 1, bedroom 2 and bedroom 3

Item No:	000144	Laboratory sample no:	CF009243	
Accessibility:		Easy		
Installation:		Cement (1)		
Approx extent (m² unless stated)		12lm		
Asbestos Type:		Chrysotile (1)		
Condition:	Low damage (1)		Surface Treatment:	Surface sealed (1)

Material Risk Assessment	4	Priority Risk Assessment (PA)	N/A	Total Risk	N/A
Recommendation:	Remove				
Comments:

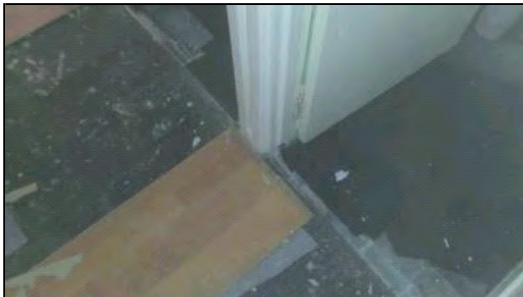
Location:		1 - 16 Marston - Ground floor - Flat 4 - Black floor tiles and bitumen to the floor beneath the modern flooring and carpet within the lounge, lobby, hallway, toilet, bathroom, bedroom 1, bedroom 2 and bedroom 3

Item No:	000145	Laboratory sample no:	CF009244	
Accessibility:		Easy		
Installation:		Floor tile(s) & bitumen (1)		
Approx extent (m² unless stated)		40		
Asbestos Type:		Chrysotile (1)		
Condition:	Low damage (1)	Surface Treatment:	Completely sealed (0)

Material Risk Assessment	3	Priority Risk Assessment (PA)	N/A	Total Risk	N/A
Recommendation:	Remove				
Comments:

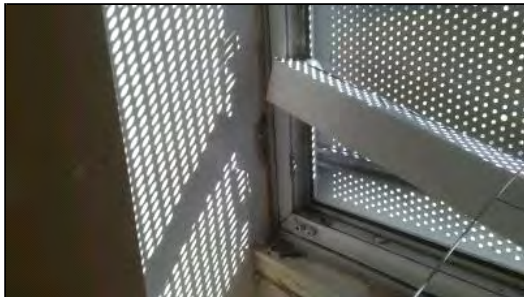
Location:		1 - 16 Marston - Ground floor - Flat 4 - Felt damp proof course around the window frames within the kitchen, toilet, bathroom, lounge, bedroom 1, bedroom 2 and bedroom 3

Item No:	000146	Laboratory sample no:	CF009245	
Accessibility:		N/A		
Installation:		Felt		
Approx extent (m² unless stated)		N/A		
Asbestos Type:		NAD		
Condition:	N/A	Surface Treatment:	N/A

Material Risk Assessment	0	Priority Risk Assessment (PA)	N/A	Total Risk	
Recommendation:	None				
Comments:

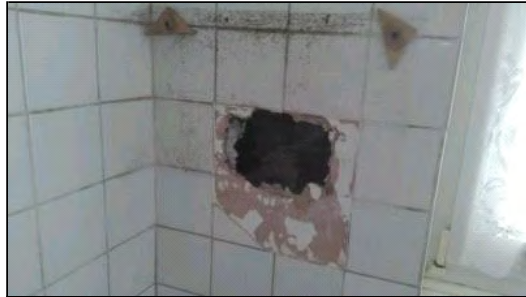
Location:		1 - 16 Marston - Ground floor - Flat 4 - Bitumen felt damp proof course in the outer wall cavity, above the bath in the bathroom

Item No:	000151	Laboratory sample no:	CF009250	
Accessibility:		N/A		
Installation:		Felt		
Approx extent (m² unless stated)		N/A		
Asbestos Type:		NAD		
Condition:	N/A	Surface Treatment:	N/A

Material Risk Assessment	0	Priority Risk Assessment (PA)	N/A	Total Risk	
Recommendation:	None				
Comments:

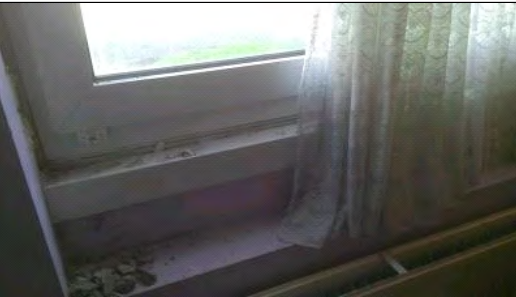
Location:		1 - 16 Marston - Ground floor - Flat 3 - Eternite window sills beneath the PVC-u sills within the kitchen and bedroom 1

Item No:	000152	Laboratory sample no:	SP CF009243	
Accessibility:		Easy		
Installation:		Cement (1)		
Approx extent (m² unless stated)		4lm		
Asbestos Type:		Chrysotile (1)		
Condition:	Low damage (1)		Surface Treatment:

Material Risk Assessment	4	Priority Risk Assessment (PA)	N/A	Total Risk	N/A
Recommendation:	Remove				
Comments:

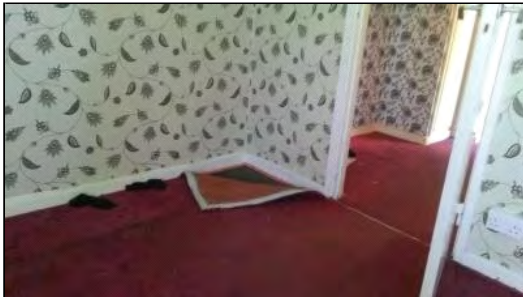
Location:		1 - 16 Marston - Ground floor - Flat 3 - Black floor tiles and bitumen to the floor beneath the carpet within the lounge, lobby, hallway and bedroom 1

Item No:	000153	Laboratory sample no:	SP CF009244	
Accessibility:		Easy		
Installation:		Floor tile(s) & bitumen (1)		
Approx extent (m² unless stated)		30		
Asbestos Type:		Chrysotile (1)		
Condition:	Low damage (1)		Surface Treatment:

Material Risk Assessment	3	Priority Risk Assessment (PA)	N/A	Total Risk	N/A
Recommendation:	Remove				
Comments:

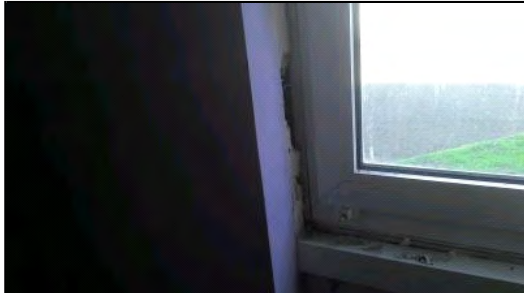
Location:		1 - 16 Marston - Ground floor - Flat 3 - Felt damp proof course around the window frames within the kitchen, bathroom, lounge and bedroom 1

Item No:	000154	Laboratory sample no:	SP CF009245	
Accessibility:		N/A		
Installation:		Felt		
Approx extent (m² unless stated)		N/A		
Asbestos Type:		NAD		
Condition:	N/A	Surface Treatment:	N/A

Material Risk Assessment	0	Priority Risk Assessment (PA)	N/A	Total Risk	
Recommendation:	None				
Comments:

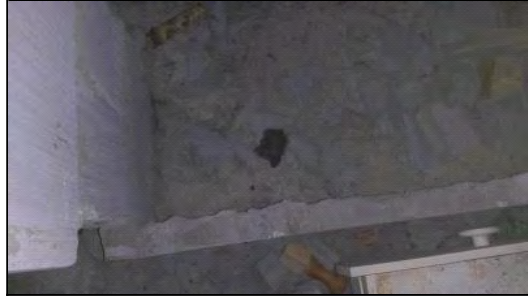
Location:	1 - 16 Marston - External - Tenants store 11 - Bitumen debris to the floor behind the block wall within the store

Item No:	000155	Laboratory sample no:	CF009269	
Accessibility:	N/A			
Installation:	Bitumen			
Approx extent (m² unless stated)	N/A			
Asbestos Type:	NAD			
Condition:	N/A	Surface Treatment:	N/A

Material Risk Assessment	0	Priority Risk Assessment (PA)	N/A	Total Risk	
Recommendation:	None				
Comments:

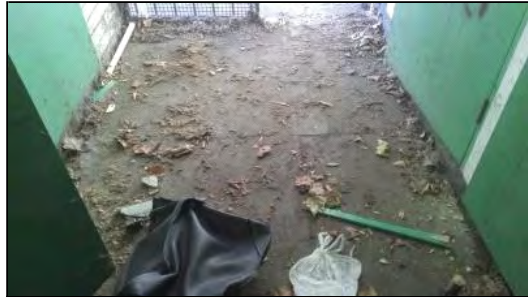
Location:	1 - 16 Marston - External - Tenant store corridor - No suspect materials

Item No:	000156	Laboratory sample no:	Not sampled	
Accessibility:	N/A			
Installation:	Unknown			
Approx extent (m² unless stated)	N/A			
Asbestos Type:	NAD			
Condition:	N/A	Surface Treatment:	N/A

Material Risk Assessment	0	Priority Risk Assessment (PA)	N/A	Total Risk	
Recommendation:	None				
Comments:

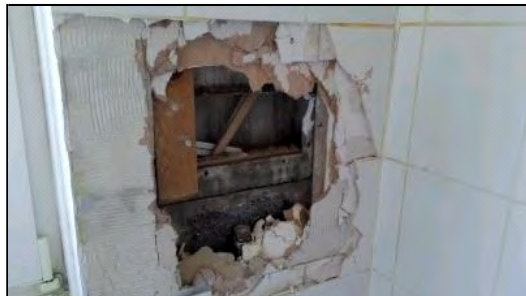
Location:		1 - 16 Marston - Third floor - Flat 15 - Preformed cement panel in the wall cavity above the bath in the bathroom

Item No:	000160	Laboratory sample no:	CF009254	
Accessibility:		Moderate		
Installation:		Cement (1)		
Approx extent (m² unless stated)		1no.		
Asbestos Type:		Chrysotile (1)		
Condition:	Low damage (1)	Surface Treatment:	Surface sealed (1)

Material Risk Assessment	4	Priority Risk Assessment (PA)	N/A	Total Risk	N/A
Recommendation:	Remove				
Comments:

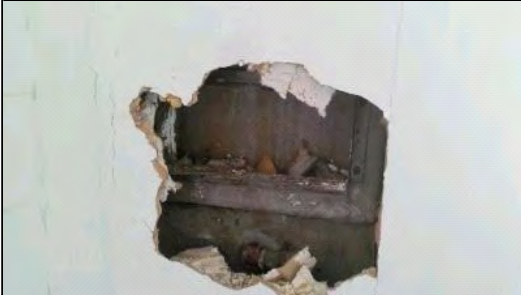
Location:		1 - 16 Marston - Third floor - Flat 16 - Preformed cement panel in the wall cavity above the bath in the bathroom

Item No:	000161	Laboratory sample no:	SP CF009254	
Accessibility:		Moderate		
Installation:		Cement (1)		
Approx extent (m² unless stated)		1no.		
Asbestos Type:		Chrysotile (1)		
Condition:	Low damage (1)	Surface Treatment:	Surface sealed (1)

Material Risk Assessment	4	Priority Risk Assessment (PA)	N/A	Total Risk	N/A
Recommendation:	Remove				
Comments:

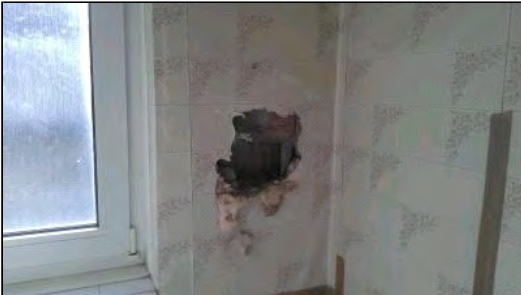
Location:		1 - 16 Marston - Third floor - Flat 13 - Preformed cement panel in the wall cavity above the bath in the bathroom

Item No:	000162	Laboratory sample no:	CF009255	
Accessibility:		Moderate		
Installation:		Cement (1)		
Approx extent (m² unless stated)		1no.		
Asbestos Type:		Chrysotile + Crocidolite (3)		
Condition:	Low damage (1)	Surface Treatment:	Surface sealed (1)

Material Risk Assessment	6	Priority Risk Assessment (PA)	N/A	Total Risk	N/A
Recommendation:	Remove				
Comments:

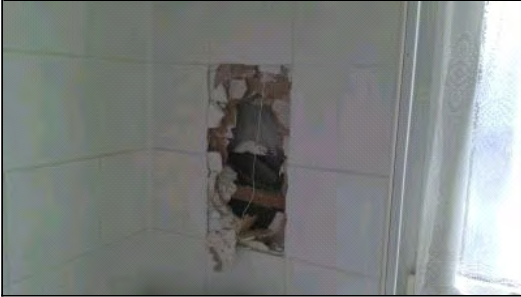
Location:		1 - 16 Marston - Third floor - Flat 14 - Preformed cement panel in the wall cavity above the bath in the bathroom

Item No:	000163	Laboratory sample no:	SP CF009255	
Accessibility:		Moderate		
Installation:		Cement (1)		
Approx extent (m² unless stated)		1no.		
Asbestos Type:		Chrysotile + Crocidolite (3)		
Condition:	Low damage (1)	Surface Treatment:	Surface sealed (1)

Material Risk Assessment	6	Priority Risk Assessment (PA)	N/A	Total Risk	N/A
Recommendation:	Remove				
Comments:

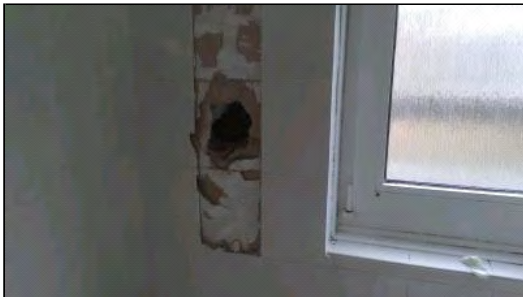
Location:		1 - 16 Marston - Second floor - Flat 10 - Bitumen felt damp proof course in the outer wall cavity, above the bath in the bathroom

Item No:	000164	Laboratory sample no:	CF009256	
Accessibility:		N/A		
Installation:		Felt		
Approx extent (m² unless stated)		N/A		
Asbestos Type:		NAD		
Condition:	N/A	Surface Treatment:	N/A

Material Risk Assessment	0	Priority Risk Assessment (PA)	N/A	Total Risk	
Recommendation:	None				
Comments:

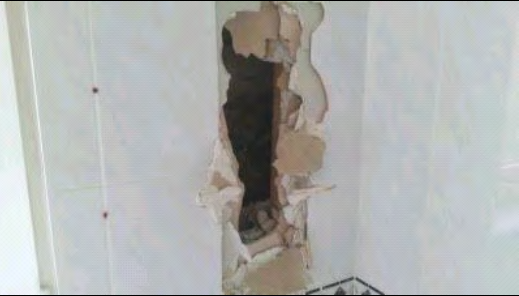
Location:		1 - 16 Marston - Second floor - Flat 9 - Bitumen felt damp proof course in the outer wall cavity, above the bath in the bathroom

Item No:	000165	Laboratory sample no:	SP CF009256	
Accessibility:		N/A		
Installation:		Felt		
Approx extent (m² unless stated)		N/A		
Asbestos Type:		NAD		
Condition:	N/A		Surface Treatment:

Material Risk Assessment	0	Priority Risk Assessment (PA)	N/A	Total Risk	
Recommendation:	None				
Comments:

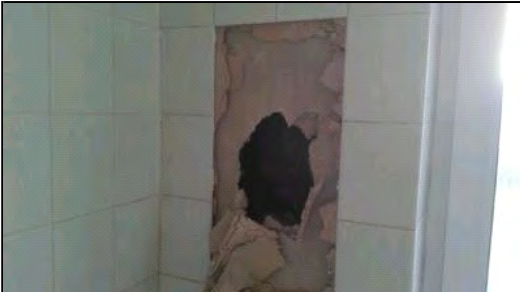
Location:		1 - 16 Marston - Second floor - Flat 12 - Bitumen felt damp proof course in the outer wall cavity, above the bath in the bathroom

Item No:	000166	Laboratory sample no:	SP CF009256	
Accessibility:		N/A		
Installation:		Felt		
Approx extent (m² unless stated)		N/A		
Asbestos Type:		NAD		
Condition:	N/A	Surface Treatment:	N/A

Material Risk Assessment	0	Priority Risk Assessment (PA)	N/A	Total Risk	
Recommendation:	None				
Comments:

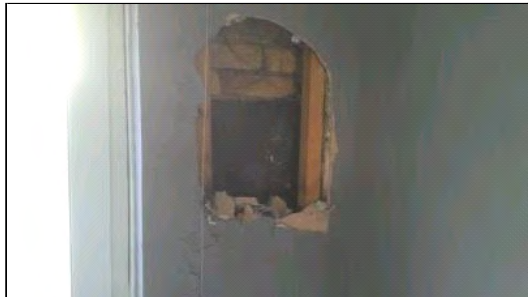
Location:	1 - 16 Marston - Second floor - Flat 11 - Bitumen felt damp proof course in the outer wall cavity, above the bath in the bathroom

Item No:	000167	Laboratory sample no:	SP CF009256	
Accessibility:	N/A			
Installation:	Felt			
Approx extent (m² unless stated)	N/A			
Asbestos Type:	NAD			
Condition:	N/A	Surface Treatment:	N/A

Material Risk Assessment	0	Priority Risk Assessment (PA)	N/A	Total Risk	
Recommendation:	None				
Comments:

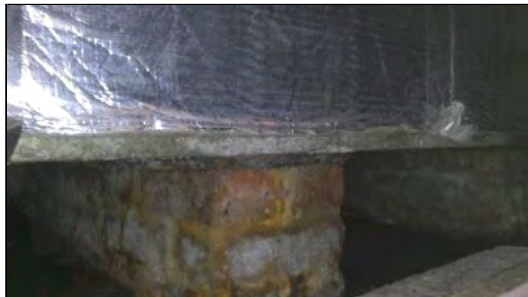
Location:	1 - 16 Marston - Roof Void - Tank room - Panels beneath water tank 1

Item No:	000168	Laboratory sample no:	CF009257	
Accessibility:	N/A			
Installation:	Boarding			
Approx extent (m² unless stated)	N/A			
Asbestos Type:	NAD			
Condition:	N/A	Surface Treatment:	N/A

Material Risk Assessment	0	Priority Risk Assessment (PA)	N/A	Total Risk	
Recommendation:	None				
Comments:

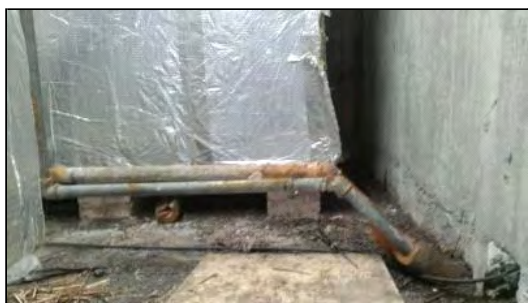
Location:	1 - 16 Marston - Roof Void - Tank room - Paper condensate layer to the pipework

Item No:	000170	Laboratory sample no:	CF009259	
Accessibility:	N/A			
Installation:	Paper / cardboard			
Approx extent (m <sup>2</sup> unless stated)	N/A			
Asbestos Type:	NAD			
Condition:	N/A	Surface Treatment:	N/A

Material Risk Assessment	0	Priority Risk Assessment (PA)	N/A	Total Risk	
Recommendation:	None				
Comments:

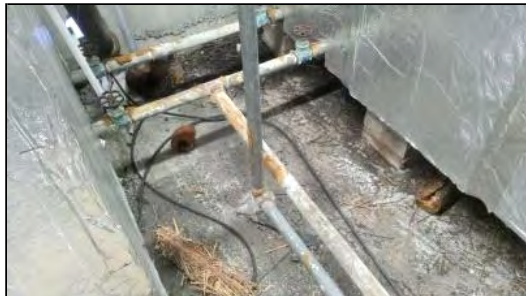
Location:		1 - 16 Marston - Roof Void - Tank room - Paper debris to the floor adjacent the pipework

Item No:	000171	Laboratory sample no:	SP CF009259	
Accessibility:		N/A		
Installation:		Paper / cardboard		
Approx extent (m² unless stated)		N/A		
Asbestos Type:		NAD		
Condition:	N/A	Surface Treatment:	N/A

Material Risk Assessment	0	Priority Risk Assessment (PA)	N/A	Total Risk	
Recommendation:	None				
Comments:

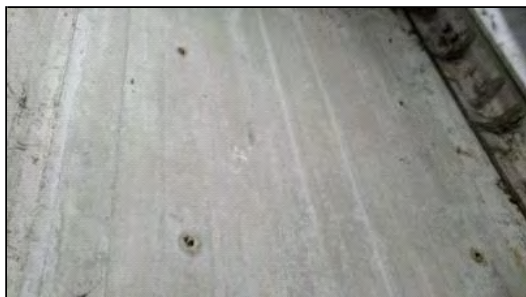
Location:		1 - 16 Marston - Roof Void - Tank room - Paper linings in the former pipe penetrations into the concrete walls

Item No:	000172	Laboratory sample no:	CF009260	
Accessibility:		N/A		
Installation:		Paper / cardboard		
Approx extent (m² unless stated)		N/A		
Asbestos Type:		NAD		
Condition:	N/A	Surface Treatment:	N/A

Material Risk Assessment	0	Priority Risk Assessment (PA)	N/A	Total Risk	
Recommendation:	None				
Comments:

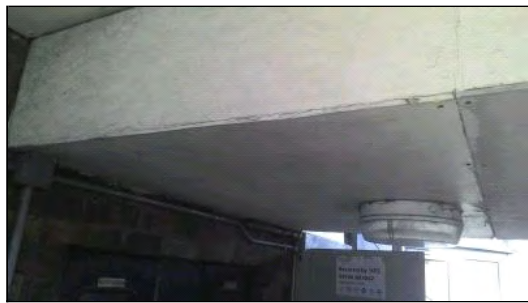
Location:	1 - 16 Marston - External - Third floor landing - Panels to the ceiling outside flats 13 and 14

Item No:	000173	Laboratory sample no:	CF009261	
Accessibility:	N/A			
Installation:	Boarding			
Approx extent (m <sup>2</sup> unless stated)	N/A			
Asbestos Type:	NAD			
Condition:	N/A	Surface Treatment:	N/A

Material Risk Assessment	0	Priority Risk Assessment (PA)	N/A	Total Risk	
Recommendation:	None				
Comments:

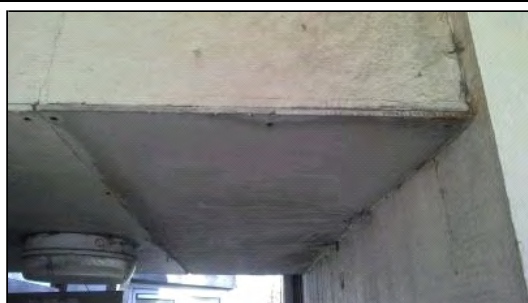
Location:	1 - 16 Marston - External - Third floor landing - Panel to the ceiling outside flats 13 and 14

Item No:	000174	Laboratory sample no:	CF009262	
Accessibility:	N/A			
Installation:	Boarding			
Approx extent (m <sup>2</sup> unless stated)	N/A			
Asbestos Type:	NAD			
Condition:	N/A	Surface Treatment:	N/A

Material Risk Assessment	0	Priority Risk Assessment (PA)	N/A	Total Risk	
Recommendation:	None				
Comments:

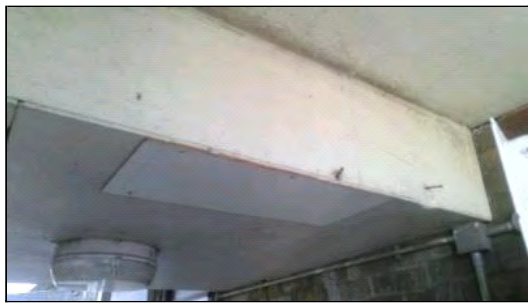
Location:	1 - 16 Marston - External - Third floor landing - Panels to the ceiling outside flats 15 and 16

Item No:	000175	Laboratory sample no:	CF009263	
Accessibility:	N/A			
Installation:	Boarding			
Approx extent (m² unless stated)	N/A			
Asbestos Type:	NAD			
Condition:	N/A	Surface Treatment:	N/A

Material Risk Assessment	0	Priority Risk Assessment (PA)	N/A	Total Risk	
Recommendation:	None				
Comments:

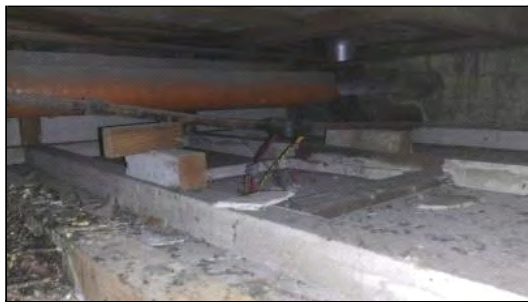
Location:	1 - 16 Marston - External - Third floor landing - Boarding debris within the ceiling void the ceiling outside flats 15 and 16

Item No:	000176	Laboratory sample no:	SP CF009263	
Accessibility:	N/A			
Installation:	Boarding			
Approx extent (m² unless stated)	N/A			
Asbestos Type:	NAD			
Condition:	N/A	Surface Treatment:	N/A

Material Risk Assessment	0	Priority Risk Assessment (PA)	N/A	Total Risk	
Recommendation:	None				
Comments:

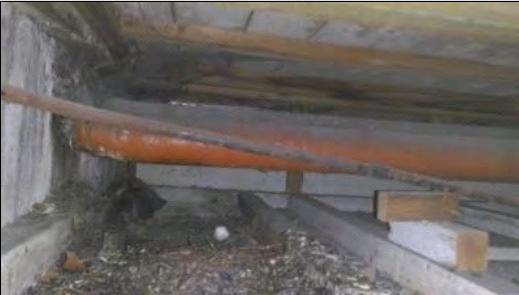
Location:		1 - 16 Marston - External - Third floor landing - Paper condensate layer to the pipework within the ceiling void outside flats 15 and 16

Item No:	000177	Laboratory sample no:	SP CF009259	
Accessibility:		N/A		
Installation:		Paper / cardboard		
Approx extent (m² unless stated)		N/A		
Asbestos Type:		NAD		
Condition:	N/A	Surface Treatment:	N/A

Material Risk Assessment	0	Priority Risk Assessment (PA)	N/A	Total Risk	
Recommendation:	None				
Comments:

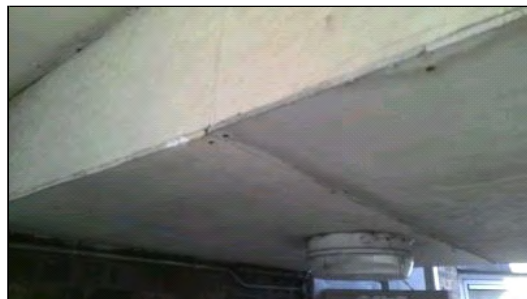
Location:		1 - 16 Marston - External - Third floor landing - Paper condensate layer to the pipework within the ceiling void outside flats 13 and 14

Item No:	000178	Laboratory sample no:	Not sampled (Presumed)	
Accessibility:		No access gained		
Installation:		Paper / cardboard (2)		
Approx extent (m² unless stated)		21m		
Asbestos Type:		Crocidolite (or unknown) (3)		
Condition:	Low damage (1)	Surface Treatment:	Surface sealed (1)

Material Risk Assessment	7	Priority Risk Assessment (PA)	N/A	Total Risk	N/A
Recommendation:	Remove				
Comments:	please note no access was gained above the sampled ceiling, it is assumed the pipes are present

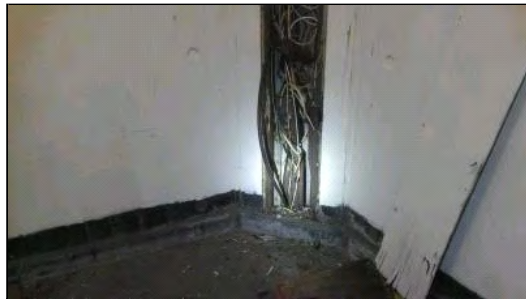
Location:		1 - 16 Marston - External - First floor landing - Loose panels in the electrical riser

Item No:	000179	Laboratory sample no:	CF009264	
Accessibility:		Moderate		
Installation:		Boarding (2)		
Approx extent (m² unless stated)		<1		
Asbestos Type:		Amosite (2)		
Condition:	Low damage (1)		Surface Treatment:	
				Unsealed AIB/encapsulated lagging (2)

Material Risk Assessment	7	Priority Risk Assessment (PA)	N/A	Total Risk	N/A
Recommendation:	Remove				
Comments:

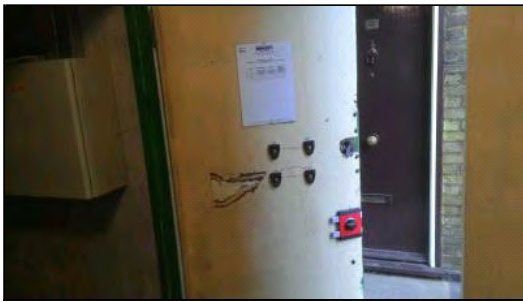
Location:		1 - 16 Marston - External - Electrical meter cupboard - Panel within the fire door

Item No:	000180	Laboratory sample no:	CF009265	
Accessibility:	N/A			
Installation:	Boarding			
Approx extent (m² unless stated)	N/A			
Asbestos Type:	NAD			
Condition:	N/A	Surface Treatment:	N/A

Material Risk Assessment	0	Priority Risk Assessment (PA)	N/A	Total Risk	
Recommendation:	None				
Comments:

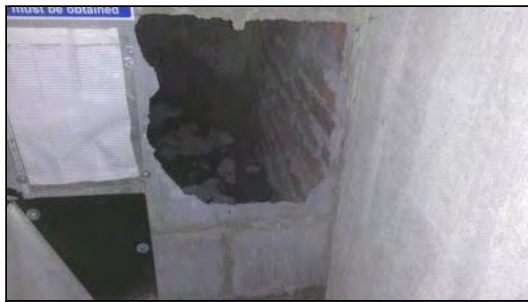
Location:		1 - 16 Marston - External - Understairs void - No suspect materials

Item No:	000181	Laboratory sample no:	Not sampled	
Accessibility:		N/A		
Installation:		Unknown		
Approx extent (m² unless stated)		N/A		
Asbestos Type:		NAD		
Condition:	N/A	Surface Treatment:	N/A

Material Risk Assessment	0	Priority Risk Assessment (PA)	N/A	Total Risk	
Recommendation:	None				
Comments:

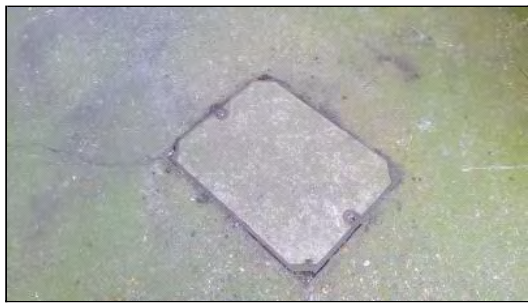
Location:		1 - 16 Marston - External - Sewage ducts - No suspect materials

Item No:	000182	Laboratory sample no:	Not sampled	
Accessibility:		N/A		
Installation:		Unknown		
Approx extent (m² unless stated)		N/A		
Asbestos Type:		NAD		
Condition:	N/A	Surface Treatment:	N/A

Material Risk Assessment	0	Priority Risk Assessment (PA)	N/A	Total Risk	
Recommendation:	None				
Comments:

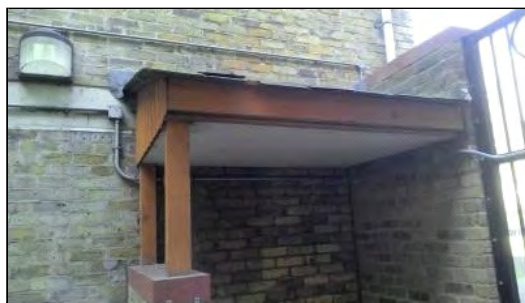
Location:		1 - 16 Marston - External - Bin store flat 2 - Supalux boarding the ceiling

Item No:	000183	Laboratory sample no:	CF009266	
Accessibility:		N/A		
Installation:		Boarding		
Approx extent (m² unless stated)		N/A		
Asbestos Type:		NAD		
Condition:	N/A		Surface Treatment:

Material Risk Assessment	0	Priority Risk Assessment (PA)	N/A	Total Risk	
Recommendation:	None				
Comments:

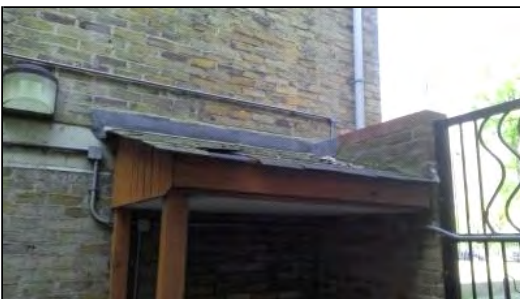
Location:		1 - 16 Marston - External - Bin store flat 2 - Felt tiles to the roof

Item No:	000184	Laboratory sample no:	CF009267	
Accessibility:		N/A		
Installation:		Roofing felt		
Approx extent (m² unless stated)		N/A		
Asbestos Type:		NAD		
Condition:	N/A	Surface Treatment:	N/A

Material Risk Assessment	0	Priority Risk Assessment (PA)	N/A	Total Risk	
Recommendation:	None				
Comments:

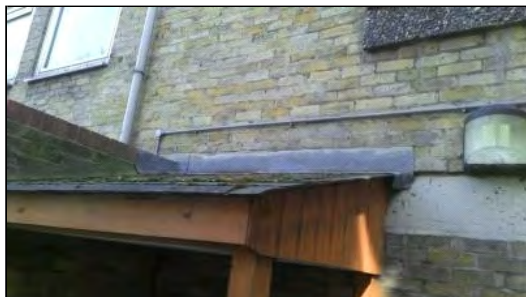
Location:		1 - 16 Marston - External - Bin store flat 3 - Felt tiles to the roof

Item No:	000186	Laboratory sample no:	SP CF009267	
Accessibility:		N/A		
Installation:		Roofing felt		
Approx extent (m² unless stated)		N/A		
Asbestos Type:		NAD		
Condition:		N/A	Surface Treatment:	N/A

Material Risk Assessment	0	Priority Risk Assessment (PA)	N/A	Total Risk	
Recommendation:		None			
Comments:

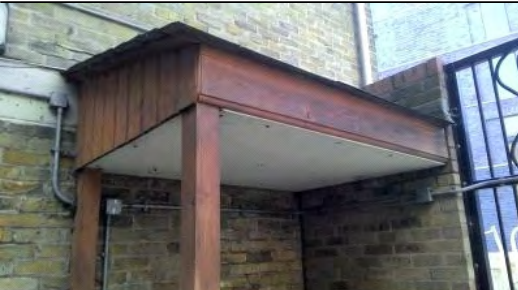
Location:		1 - 16 Marston - External - Bin store flat 4 - Supalux boarding the ceiling

Item No:	000187	Laboratory sample no:	SP CF009266	
Accessibility:		N/A		
Installation:		Boarding		
Approx extent (m² unless stated)		N/A		
Asbestos Type:		NAD		
Condition:	N/A	Surface Treatment:	N/A

Material Risk Assessment	0	Priority Risk Assessment (PA)	N/A	Total Risk	
Recommendation:	None				
Comments:

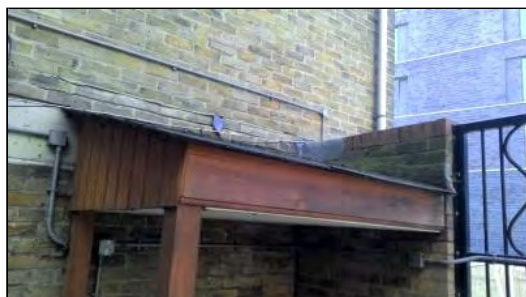
Location:		1 - 16 Marston - External - Bin store flat 4 - Felt tiles to the roof

Item No:	000188	Laboratory sample no:	SP CF009267	
Accessibility:		N/A		
Installation:		Roofing felt		
Approx extent (m² unless stated)		N/A		
Asbestos Type:		NAD		
Condition:	N/A		Surface Treatment:

Material Risk Assessment	0	Priority Risk Assessment (PA)	N/A	Total Risk	
Recommendation:	None				
Comments:

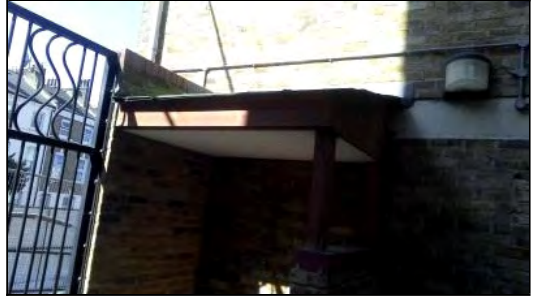
Location:		1 - 16 Marston - External - Bin store flat 1 - Supalux boarding the ceiling

Item No:	000189	Laboratory sample no:	SP CF009266	
Accessibility:		N/A		
Installation:		Boarding		
Approx extent (m² unless stated)		N/A		
Asbestos Type:		NAD		
Condition:		N/A	Surface Treatment:	N/A

Material Risk Assessment	0	Priority Risk Assessment (PA)	N/A	Total Risk	
Recommendation:		None			
Comments:

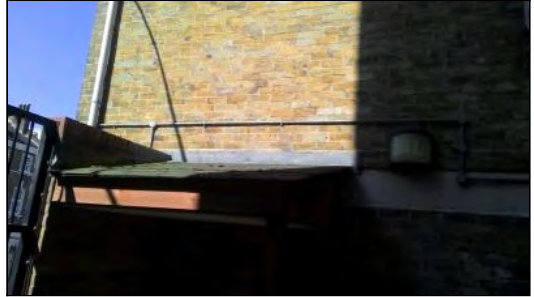
Location:		1 - 16 Marston - External - Bin store flat 1 - Felt tiles to the roof

Item No:	000190	Laboratory sample no:	SP CF009267	
Accessibility:		N/A		
Installation:		Roofing felt		
Approx extent (m² unless stated)		N/A		
Asbestos Type:		NAD		
Condition:		N/A	Surface Treatment:	N/A

Material Risk Assessment	0	Priority Risk Assessment (PA)	N/A	Total Risk	
Recommendation:		None			
Comments:

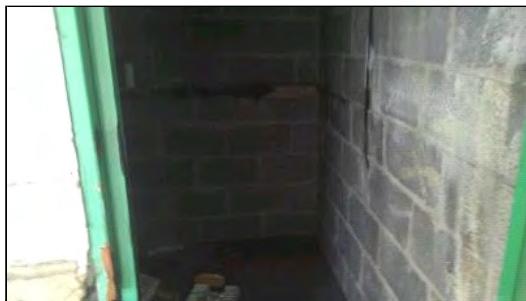
Location:		1 - 16 Marston - External - Tenants store 20 - No suspect materials

Item No:	000191	Laboratory sample no:	Not sampled	
Accessibility:		N/A		
Installation:		Unknown		
Approx extent (m <sup>2</sup> unless stated)		N/A		
Asbestos Type:		NAD		
Condition:		N/A	Surface Treatment:	N/A

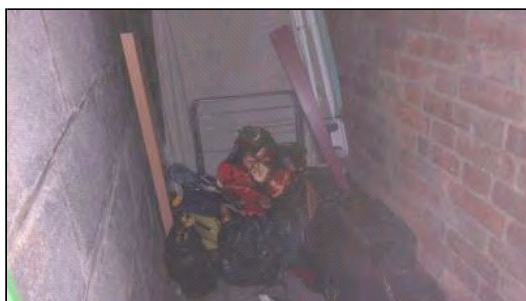
Location:		1 - 16 Marston - External - Tenants store 21 - No suspect materials

Item No:	000192	Laboratory sample no:	Not sampled	
Accessibility:		N/A		
Installation:		Unknown		
Approx extent (m <sup>2</sup> unless stated)		N/A		
Asbestos Type:		NAD		
Condition:		N/A	Surface Treatment:	N/A

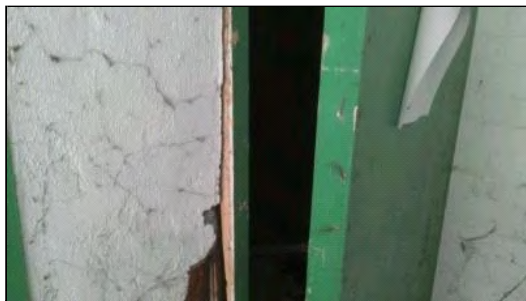
Location:		1 - 16 Marston - External - Tenants store 22 - No suspect materials

Item No:	000193	Laboratory sample no:	Not sampled	
Accessibility:		N/A		
Installation:		Unknown		
Approx extent (m <sup>2</sup> unless stated)		N/A		
Asbestos Type:		NAD		
Condition:		N/A	Surface Treatment:	N/A

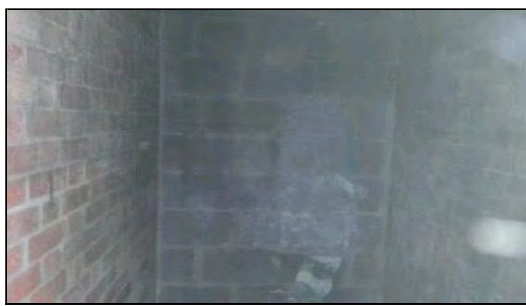
Location:		1 - 16 Marston - External - Tenants store 13 - No suspect materials

Item No:	000194	Laboratory sample no:	Not sampled	
Accessibility:		N/A		
Installation:		Unknown		
Approx extent (m <sup>2</sup> unless stated)		N/A		
Asbestos Type:		NAD		
Condition:		N/A	Surface Treatment:	N/A

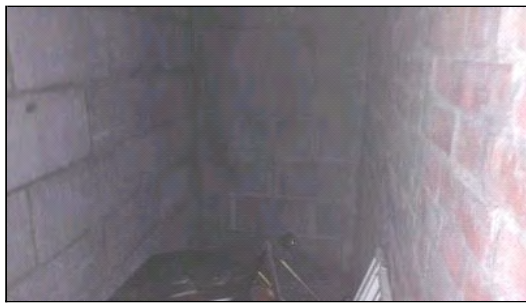
Location:		1 - 16 Marston - External - Tenants store 12 - No suspect materials

Item No:	000195	Laboratory sample no:	Not sampled	
Accessibility:		N/A		
Installation:		Unknown		
Approx extent (m <sup>2</sup> unless stated)		N/A		
Asbestos Type:		NAD		
Condition:		N/A	Surface Treatment:	N/A

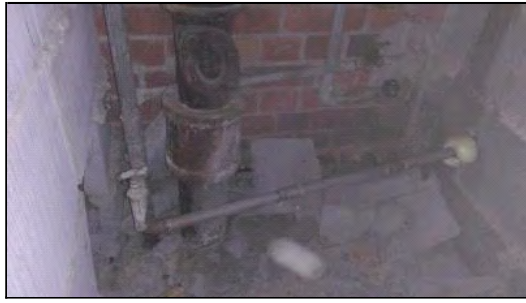
Location:		1 - 16 Marston - External - Tenants store 11 - Textile to joints to the steel pipework behind blockwork wall

Item No:	000196	Laboratory sample no:	CF009268	
Accessibility:		N/A		
Installation:		Textile		
Approx extent (m <sup>2</sup> unless stated)		N/A		
Asbestos Type:		NAD		
Condition:		N/A	Surface Treatment:	N/A

Material Risk Assessment	0	Priority Risk Assessment (PA)	N/A	Total Risk	
Recommendation:		None			
Comments:
