MANAGEMENT ASBESTOS SURVEY WITH A  
LOCALISED REFURBISHMENT AND DEMOLITION  
ASBESTOS SURVEY REPORT TO

STURMINSTER  
AGAR GROVE  
LONDON

APRIL 2018

Report prepared for:	Hill Holdings (Essex) Ltd The Power House Gunpowder Mill Powdermill Lane Waltham Abbey Essex EN9 1BN
Report reference:	J113685
Issue date:	April 2018
Survey completed by: Richard Watts Senior Surveyor	 
Approved by: Laurence Stear Project Manager

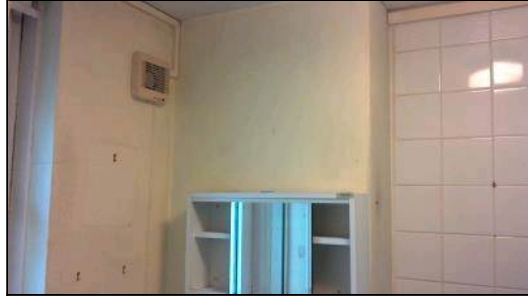
Location:	1 Sturminster, Agar, London, NW1 9TA - Ground floor - Bathroom - Textured coating to walls and timber boxing

Item No:	000021	Laboratory sample no:	CX001694	
Accessibility:	N/A			
Installation:	Textured coating			
Approx extent (m² unless stated)	N/A			
Asbestos Type:	NAD			
Condition:	N/A	Surface Treatment:	N/A

Material Risk Assessment	0	Priority Risk Assessment (PA)	N/A	Total Risk	
Recommendation:	None				
Comments:

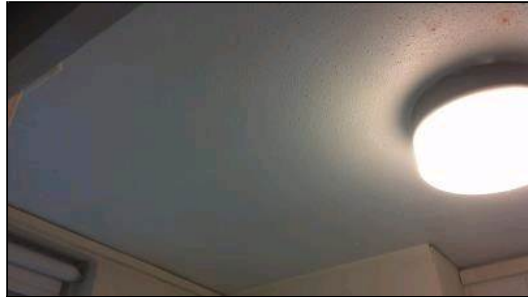
Location:	1 Sturminster, Agar, London, NW1 9TA - Ground floor - Bathroom - Textured coating to walls and timber boxing

Item No:	000022	Laboratory sample no:	CX001695	
Accessibility:	N/A			
Installation:	Textured coating			
Approx extent (m² unless stated)	N/A			
Asbestos Type:	NAD			
Condition:	N/A	Surface Treatment:	N/A

Material Risk Assessment	0	Priority Risk Assessment (PA)	N/A	Total Risk	
Recommendation:	None				
Comments:

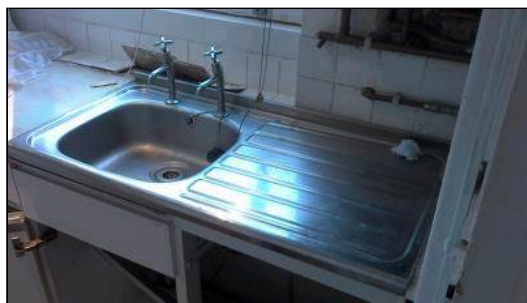
Location:		1 Sturminster, Agar, London, NW1 9TA - Ground floor - Kitchen - Bitumen pad to sink unit

Item No:	000025	Laboratory sample no:	CX001697	
Accessibility:		N/A		
Installation:		Sink pad		
Approx extent (m² unless stated)		N/A		
Asbestos Type:		NAD		
Condition:	N/A	Surface Treatment:	N/A

Material Risk Assessment	0	Priority Risk Assessment (PA)	N/A	Total Risk	
Recommendation:	None				
Comments:

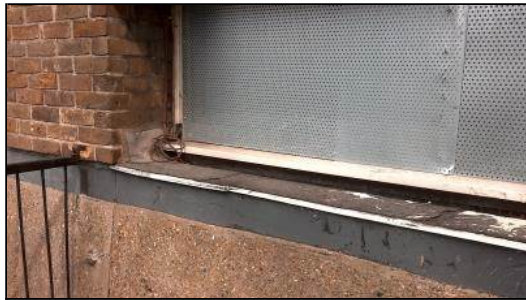
Location:	3 Sturminster, Agar Grove, London, NW1 9TA - External - External - Bitumen felt to metal strip below window to rear of property

Item No:	000033	Laboratory sample no:	CX001703	
Accessibility:	N/A			
Installation:	Bitumen			
Approx extent (m² unless stated)	N/A			
Asbestos Type:	NAD			
Condition:	N/A	Surface Treatment:	N/A

Material Risk Assessment	0	Priority Risk Assessment (PA)	N/A	Total Risk	
Recommendation:	None				
Comments:

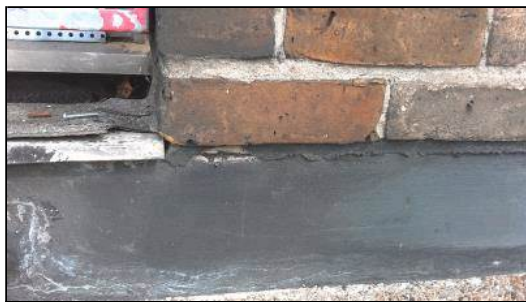
Location:	3 Sturminster, Agar Grove, London, NW1 9TA - External - External - Bitumen damp proof course to all low level walls

Item No:	000034	Laboratory sample no:	CX001704	
Accessibility:	N/A			
Installation:	Bitumen			
Approx extent (m² unless stated)	N/A			
Asbestos Type:	NAD			
Condition:	N/A	Surface Treatment:	N/A

Material Risk Assessment	0	Priority Risk Assessment (PA)	N/A	Total Risk	
Recommendation:	None				
Comments:

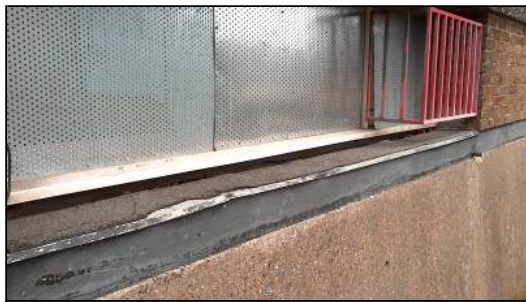
Location:	1 Sturminster, Agar, London, NW1 9TA - External - External - Bitumen felt to metal strip below window to rear of property

Item No:	000035	Laboratory sample no:	CX001705	
Accessibility:	N/A			
Installation:	Bitumen			
Approx extent (m² unless stated)	N/A			
Asbestos Type:	NAD			
Condition:	N/A	Surface Treatment:	N/A

Material Risk Assessment	0	Priority Risk Assessment (PA)	N/A	Total Risk	
Recommendation:	None				
Comments:

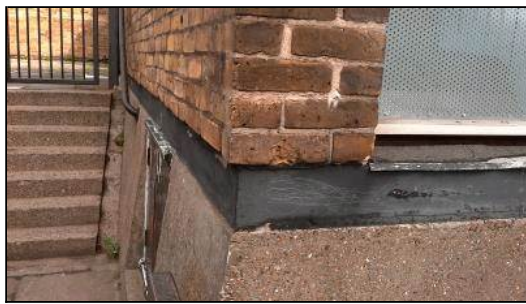
Location:	1 Sturminster, Agar, London, NW1 9TA - External - External - Bitumen damp proof course to all low level walls

Item No:	000036	Laboratory sample no:	CX001706	
Accessibility:	N/A			
Installation:	Bitumen			
Approx extent (m² unless stated)	N/A			
Asbestos Type:	NAD			
Condition:	N/A	Surface Treatment:	N/A

Material Risk Assessment	0	Priority Risk Assessment (PA)	N/A	Total Risk	
Recommendation:	None				
Comments:

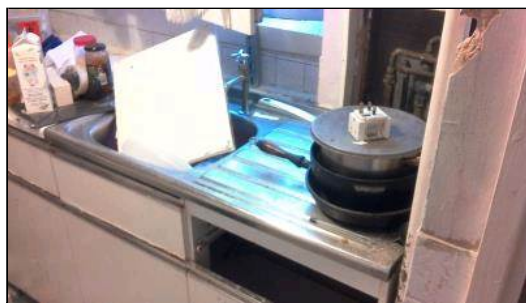
Location:		2 Sturminster, Agar Grove, London, NW1 9TA - Ground floor - Kitchen - Bitumen pad to sink unit

Item No:	000045	Laboratory sample no:	CX001718	
Accessibility:		N/A		
Installation:		Sink pad		
Approx extent (m² unless stated)		N/A		
Asbestos Type:		NAD		
Condition:	N/A		Surface Treatment:

Material Risk Assessment	0	Priority Risk Assessment (PA)	N/A	Total Risk	
Recommendation:	None				
Comments:

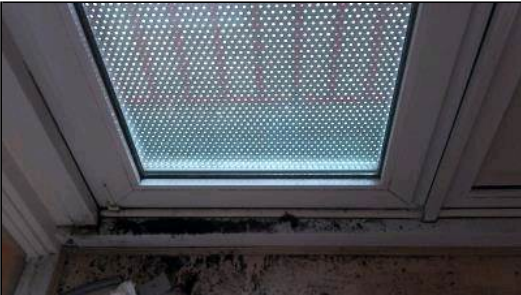
Location:		2 Sturminster, Agar Grove, London, NW1 9TA - External - External - Bitumen felt to metal strip below window to rear of property

Item No:	000052	Laboratory sample no:	CX001723	
Accessibility:		N/A		
Installation:		Bitumen		
Approx extent (m² unless stated)		N/A		
Asbestos Type:		NAD		
Condition:	N/A		Surface Treatment:	N/A

Material Risk Assessment	0	Priority Risk Assessment (PA)	N/A	Total Risk	
Recommendation:	None				
Comments:

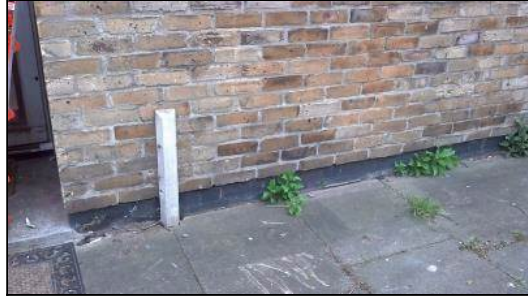
Location:	2 Sturminster, Agar Grove, London, NW1 9TA - External - External - Bitumen damp proof course to all low level walls

Item No:	000053	Laboratory sample no:	CX001724	
Accessibility:	N/A			
Installation:	Bitumen			
Approx extent (m <sup>2</sup> unless stated)	N/A			
Asbestos Type:	NAD			
Condition:	N/A	Surface Treatment:	N/A

Material Risk Assessment	0	Priority Risk Assessment (PA)	N/A	Total Risk	
Recommendation:	None				
Comments:
