45059
45059
06/07/2016 10:03:05

Site Details
THE HOPE PROJECT
CAMDEN HIGH STREET
LONDON
NW1 7JE

CCTV SURVEY REPORT

Drawing Title: UNDERGROUND DRAINAGE LAYOUT DRAWING
BASEMENT PLAN

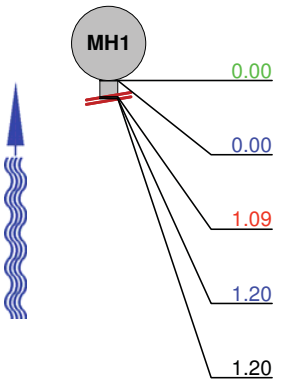
MH	Start node type, manhole, reference number : MH1	(Constr) 0
	WL	Water level, 0% of the vertical dimension	(Serv) 0
	JDM	Joint displaced, medium Remarks: 1.09	(Struct) 1
	DES	Settled deposits, fine, 80% cross-sectional area loss	(Serv) 5
	SA	Survey abandoned Remarks: DUE TO DEBRIS	(Misc) 0

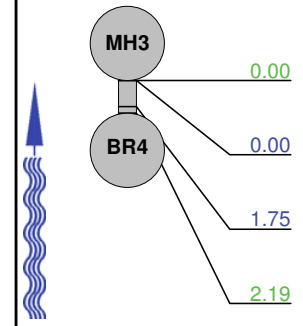
MH	Start node type, manhole, reference number : MH3	(Constr) 0
		WL	Water level, 5% of the vertical dimension	(Serv) 0
		LU	Line deviates up Remarks: SHARP	(Serv) 0
		OCF	Finish node type, other special chamber reference number: BR4 Remarks: BASE OF STACK	(Constr) 0

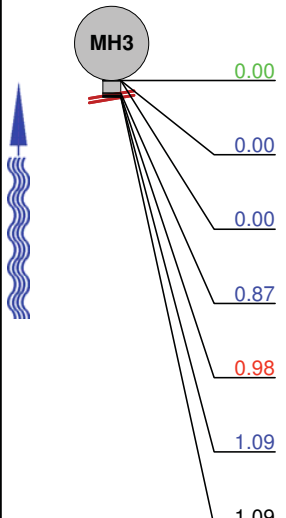
MH	Start node type, manhole, reference number : MH3	(Constr) 0
	0.00	WL	Water level, 5% of the vertical dimension	(Serv) 0
	0.00	LL	Line deviates left Remarks: SHARP	(Serv) 0
	0.87	LR	Line deviates right Remarks: SHARP	(Serv) 0
	0.98	JDM	Joint displaced, medium	(Struct) 1
	1.09	DER	Settled deposits, coarse, 60% cross-sectional area loss	(Serv) 4
	1.09	SA	Survey abandoned Remarks: DUE TO DEBRIS	(Misc) 0

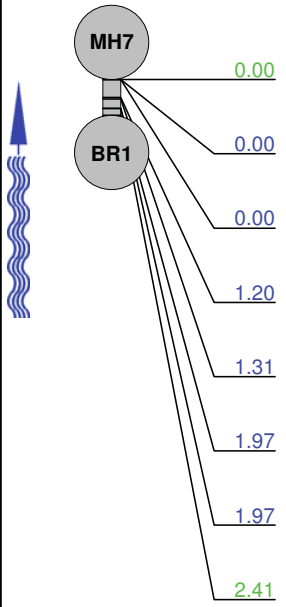
MH	Start node type, manhole, reference number : MH7	(Constr) 0
	WL	Water level, 5% of the vertical dimension	(Serv) 0
	LL	Line deviates left Remarks: SHARP	(Serv) 0
	DER	Settled deposits, coarse, 10% cross-sectional area loss	(Serv) 3
	DER	Settled deposits, coarse, 10% cross-sectional area loss	(Serv) 3
	LU	Line deviates up Remarks: SHARP	(Serv) 0
	LR	Line deviates right Remarks: SLIGHT	(Serv) 0
	OCF	Finish node type, other special chamber reference number: BR1 Remarks: BASE OF STACK	(Constr) 0

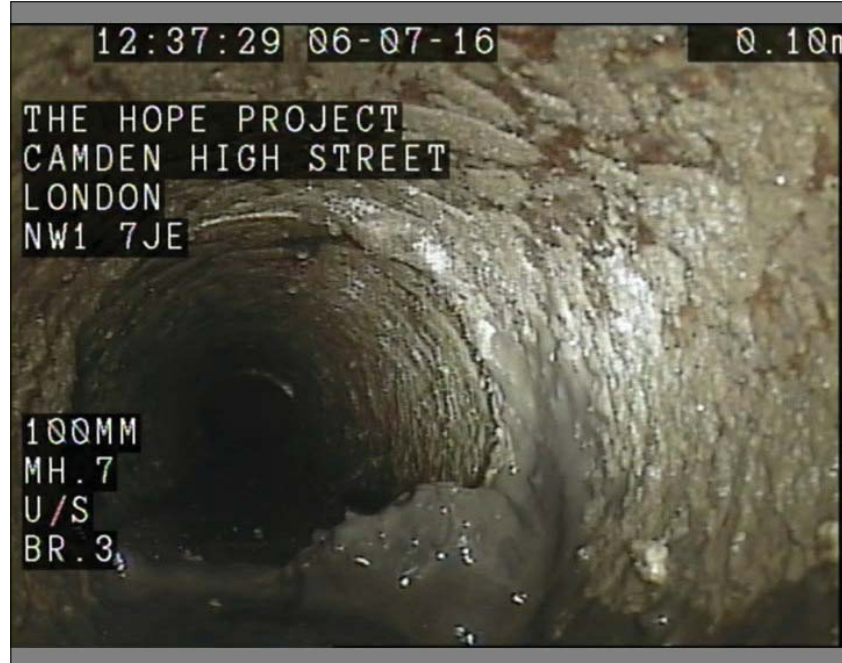
12:37:29 06-07-16 0.10m
THE HOPE PROJECT
CAMDEN HIGH STREET
LONDON
NW1 7JE
100MM
MH.7
U/S
BR.3

Photo: 21_21_136_A.JPG
0.1m, Attached deposits, encrustation at joint, from 3 to 6 o'clock, 20% cross-sectional area loss

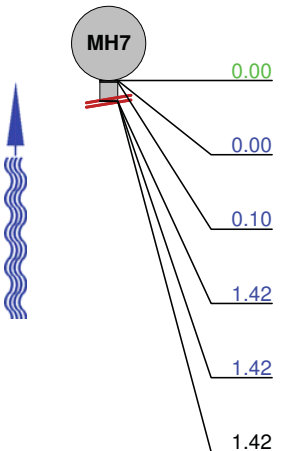
0.00	MH	Start node type, manhole, reference number : MH7	(Constr) 0
	0.00	WL	Water level, 5% of the vertical dimension	(Serv) 0
	0.10	S01	DER Settled deposits, coarse, 20% cross-sectional area loss, Start	(Serv) 4
	1.42	DER	Settled deposits, coarse, 40% cross-sectional area loss	(Serv) 4
	1.42	F01	DER Settled deposits, coarse, 20% cross-sectional area loss, End	(Serv) 4
	1.42	SA	Survey abandoned Remarks: DUE TO DEBRIS	(Misc) 0

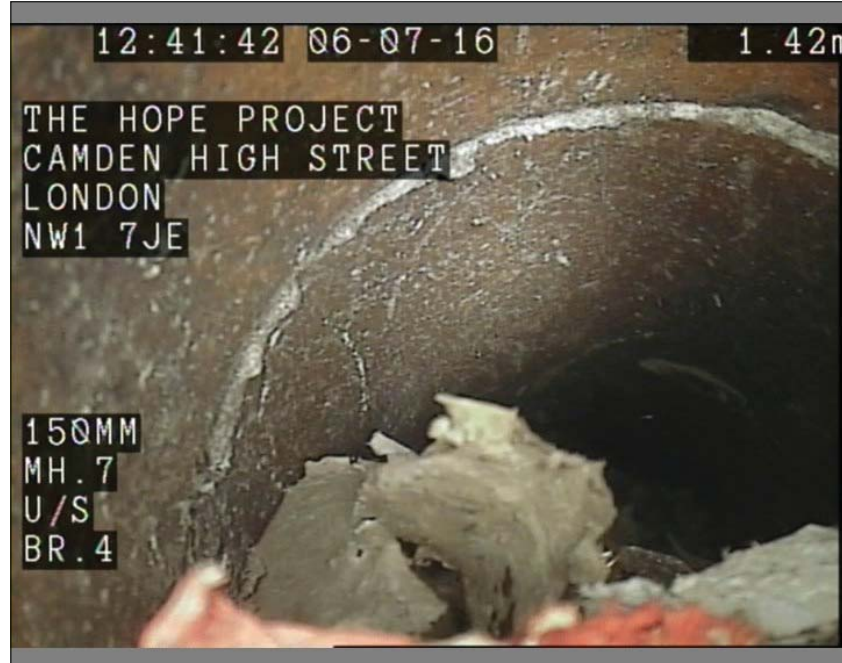
12:41:42 06-07-16 1.42m
THE HOPE PROJECT
CAMDEN HIGH STREET
LONDON
NW1 7JE
150MM
MH.7
U/S
BR.4

Photo: 22_22_141_A.JPG
1.42m, Settled deposits, coarse, 40% cross-sectional area loss

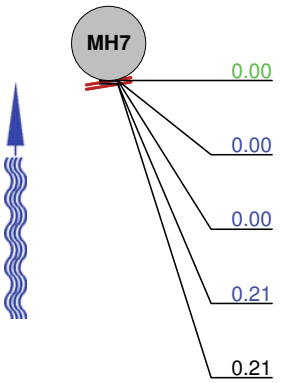
MH	Start node type, manhole, reference number : MH7	(Constr) 0
		WL	Water level, 5% of the vertical dimension	(Serv) 0
		LR	Line deviates right Remarks: SHARP	(Serv) 0
		DEEJ	Attached deposits, encrustation at joint, from 4 to 7 o'clock, 20% cross-sectional area loss	(Serv) 4
		SA	Survey abandoned Remarks: DUE TO DEE	(Misc) 0

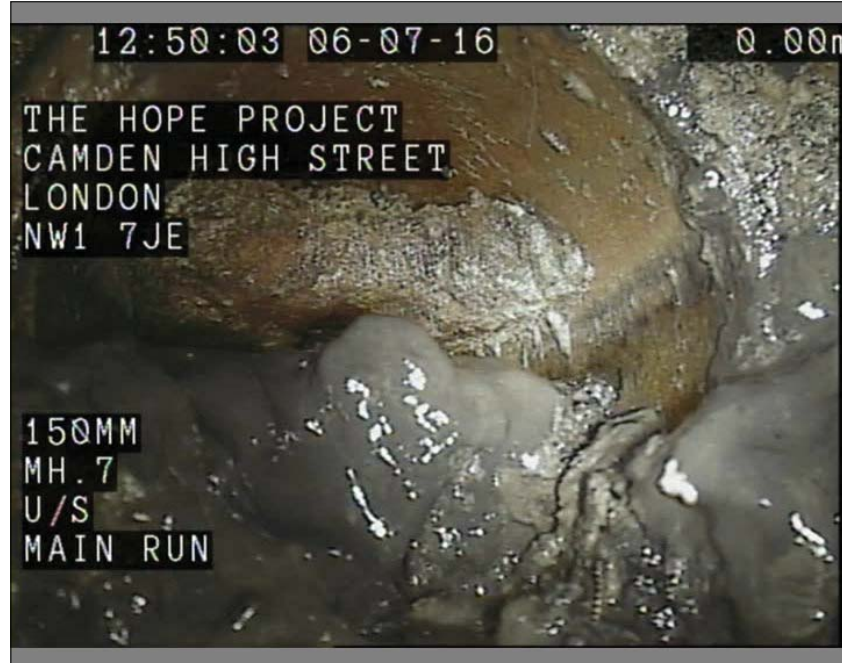
12:50:03 06-07-16 0.00m
THE HOPE PROJECT
CAMDEN HIGH STREET
LONDON
NW1 7JE
150MM
MH . 7
U/S
MAIN RUN

Photo: 24_24_151_A.JPG
0m, Settled deposits, coarse, 60% cross-sectional area loss

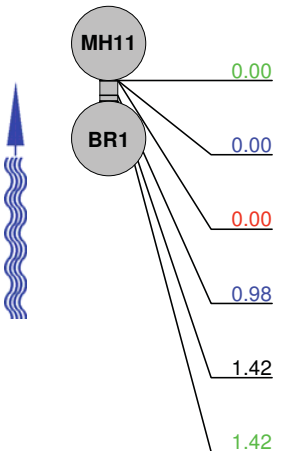
1:500	Position	Code	Observation	Grade
Depth: 1				
	MH11	0.00	MH Start node type, manhole, reference number : MH11	(Constr) 0
	BR1	0.00	WL Water level, 5% of the vertical dimension	(Serv) 0
		0.00	CC Crack, circumferential, from 10 to 2 o'clock	(Struct) 2
		0.98	LL Line deviates left Remarks: SHARP	(Serv) 0
		1.42	REM General remark Remarks: REAR OF TRAP	(Misc) 0
		1.42	OCF Finish node type, other special chamber reference number: BR1 Remarks: REAR OF GULLY TRAP REACHED	(Constr) 0

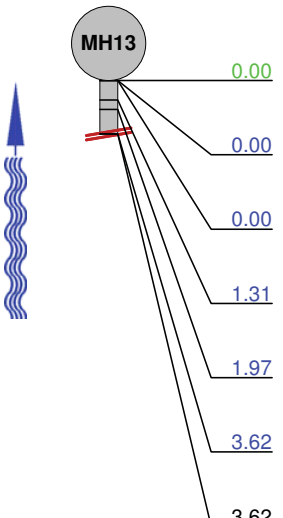
MH13	Start node type, manhole, reference number : MH13	(Constr) 0
	0.00	WL	Water level, 5% of the vertical dimension	(Serv) 0
	0.00	LL	Line deviates left Remarks: SHARP	(Serv) 0
	1.31	LU	Line deviates up Remarks: SLIGHT	(Serv) 0
	1.97	LR	Line deviates right Remarks: SLIGHT	(Serv) 0
	3.62	DER	Settled deposits, coarse, 10% cross-sectional area loss	(Serv) 3
	3.62	SA	Survey abandoned Remarks: DUE TO DEE	(Misc) 0

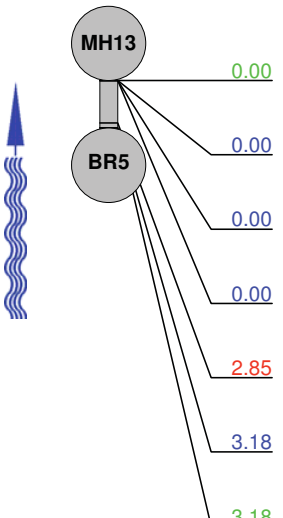
MH	Start node type, manhole, reference number : MH13	(Constr) 0
		WL	Water level, 5% of the vertical dimension	(Serv) 0
		LL	Line deviates left Remarks: SLIGHT	(Serv) 0
		LU	Line deviates up Remarks: SLIGHT	(Serv) 0
		CC	Crack, circumferential, from 9 to 3 o'clock	(Struct) 2
		LU	Line deviates up Remarks: SHARP	(Serv) 0
		OCF	Finish node type, other special chamber reference number: BR5 Remarks: BASE OF STACK	(Constr) 0
