Investigation
Report and
Recommendations

Our Reference No: MP/180833481/CP

RE: 8 WOBURN WALK, LONDON, WC1H OJL

Damp Investigation Report

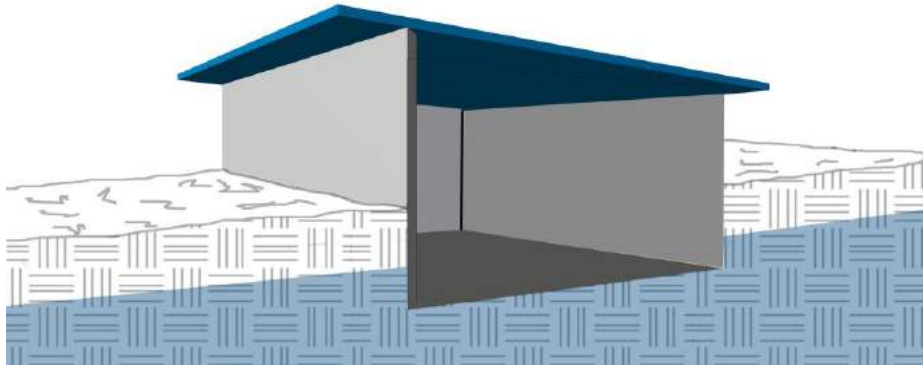
Tapco HomeDry Structural waterproofing to prevent lateral damp penetration from the ground

Apply a Tapco HomeDry cementitious, Structural Waterproofing System to the walls specified, under the terms of our insurance backed 10-year guarantee. (shown in blue on our floor plan).

Overlap the structural waterproofing system, 150mm onto the existing concrete floor, to create a surface floor/wall joint.
