# Bedford Row Chambers

## STRUCTURAL INSPECTION REPORT

Job No: 1800

Document: 1800 IR1 Rev 0

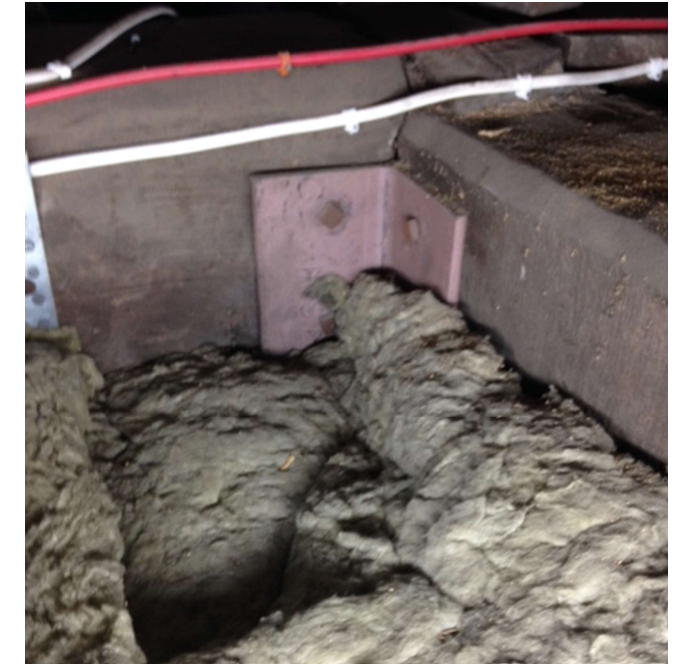
Figure 9. Typical timber loft transfer beams

Both the joists and transfer beams appear to be in good condition with no major deterioration or section loss due to insect attack or rot noted. However, neither the joists nor transfer beams appear to be original suggesting that at some point in the past they have been installed as part of a refurbishment of the building – this could possibly explain why they appear to be in good condition.

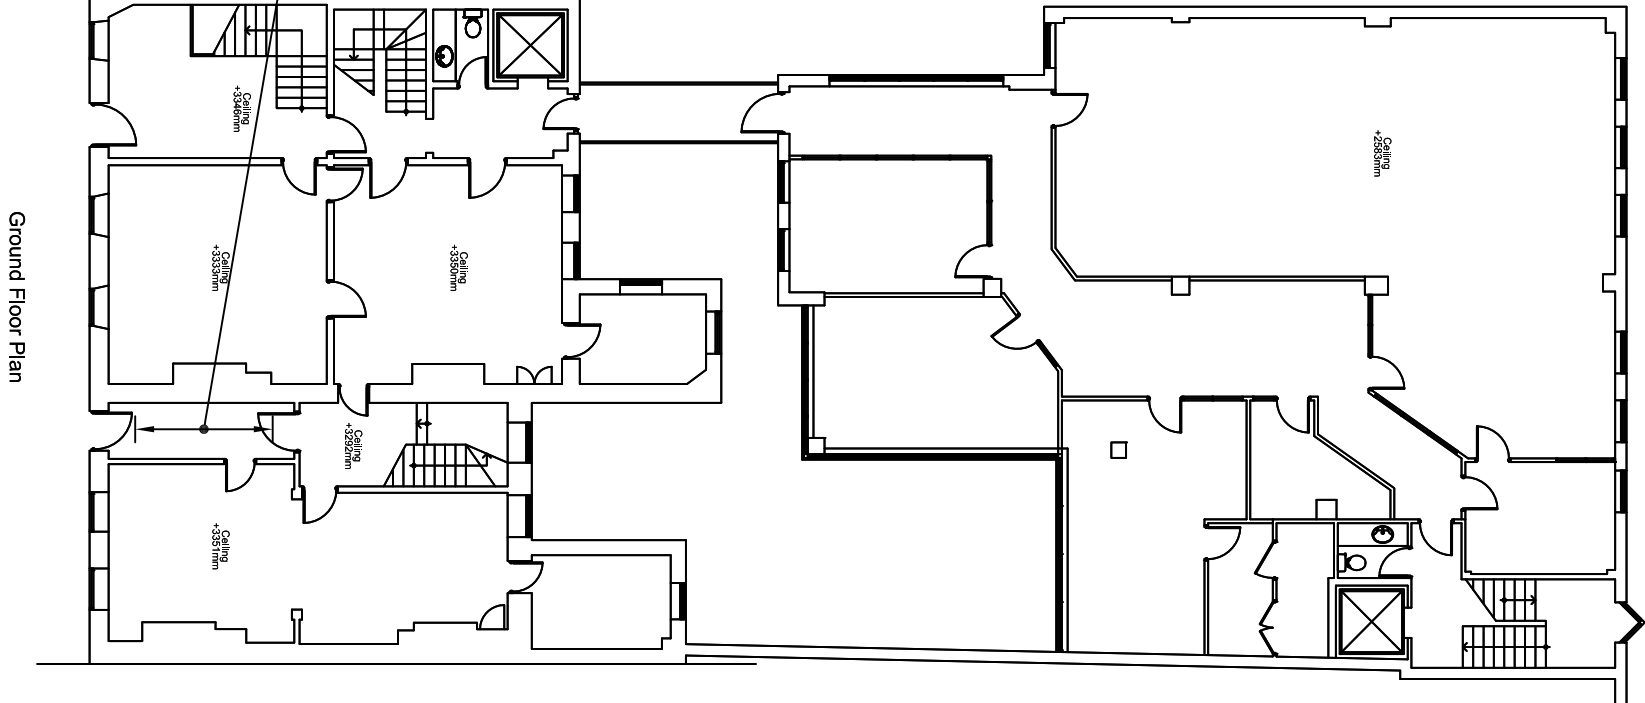
Title:  
**LOWER GROUND &  
GROUND FLOOR PLANS**

REMOVE WALL  
PANELLING  
*Brickwork appears to  
be poor quality but  
no evidence of  
cracking or significant  
movement*
