Our reference: K34  
25<sup>th</sup> October 2018

**Tree management at 107 Highgate West Hill**

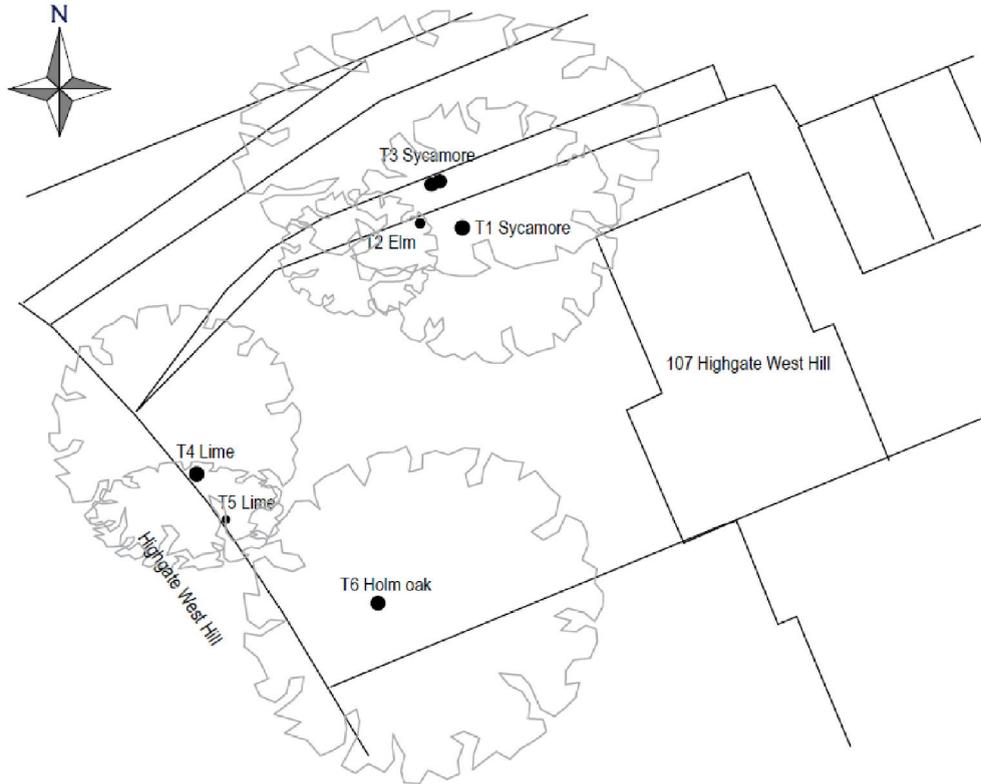
ANNEX 1 – Site plan

2. I visited the property on 22<sup>nd</sup> October 2018 for the purposes of carrying out an inspection. A sketch plan showing the trees inspected and an indication of their crown spreads has been provided at Annex 1 and a tree schedule at Annex 2.
