## 106 ALBERT STREET, LONDON NW1 7NE

### SCHEDULE OF WORKS CARRIED OUT AND DESCRIPTION OF INTERVENTIONS OCTOBER 2018

This document provides information on the most recent alterations (post-consented 2014 scheme – REF: 2014/2836/P;2014/2964/L ) that have been identified as unauthorised. The information is arranged in a table format and includes photographs of the identified alterations as they exist currently and, where possible, older photos taken in 2002 and 2013.

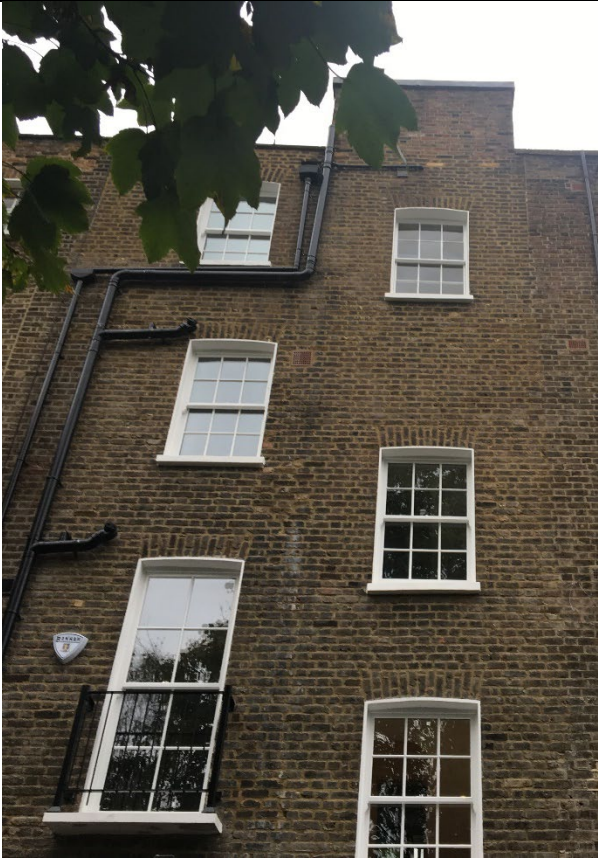
Schedule of Works and Impact Assessment					
Location and element	Action	Impact Assessment & Description of the Works/Intervention		Relevant Photographs (Current – post consented 2014 refurbishment)	Relevant Photographs (2002, 2013 and 2014 works)
Rear Elevation					
Rear elevation - Repointing of brickwork	Apply for LBC	<p><b>Minor-Moderate / Beneficial</b></p> <p>Prior to the most recent works, the brickwork to the rear elevation was in poor condition. The ribbon pointing and hard cement mortar were harmful to the appearance of the building. It was also encouraging water retention and evaporation through the bricks.</p> <p>The new mortar is repointing to a brushed finish – mix 5 sharp: 1 soft: 1 cement: 1 lime with recessed profile. This is a more compatible ratio for the historic bricks and the profile and brushed finish are suitable.</p> <p>The removal of the hard cement mortar has caused some damage around the edges of the bricks, however, in the long term, the repointing with the current mortar improves the breathability of the wall and overall condition of the building.</p>

<p>Figure 1: Current rear elevation.</p>

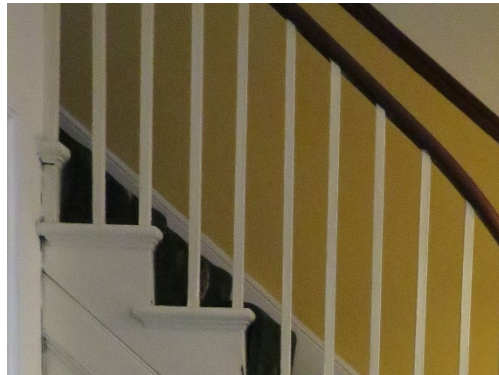
</div> <p>Figure 5: Simple timber balustrade on floor of lower hierarchy in a house of similar status and period.</p>		<div>

Schedule of Works and Impact Assessment					
Location and element	Action	Impact Assessment & Description of the Works/Intervention		Relevant Photographs (Current – post consented 2014 refurbishment)	Relevant Photographs (2002, 2013 and 2014 works)
Lower Ground Floor					
Glass balustrade to stairs	Replace existing balustrade with simple timber one with timber handrail. Details to be approved via conditions.	<p><b>Minor / Beneficial</b></p> <p>Originally, this staircase would have had a simple bannister in keeping with the utilitarian character of the basement level.</p> <p>Prior to the works carried out in 2014, the basement level was a separate residential unit. It was brought to 21<sup>st</sup> century standards as part of the 2014 works and amalgamated with the house, as originally intended. This new glass balustrade is a contemporary addition to the later staircase from the latest phase of works.</p> <p>The entire basement level has a contemporary design and it was largely altered in the 2014 works, including the lowering of the floor, the removal of partitions, new finishes and a new kitchen. The proposal for this staircase in the 2014 application was to “reinstater bannister to match extg. at other levels” (see Figure 8). This was consented, however, it would have been inappropriate to replicate the bannister on the upper levels, as this would have not been in keeping with the original hierarchy of the house and there would have been no differentiation between the utilitarian area and family living areas.</p> <p>The proposal is to reinstate a simple, ‘utilitarian’ balustrade. This will be timber with a simple timber handrail (see image below for intended design). Exact details to be approved via conditions.</p> <div>

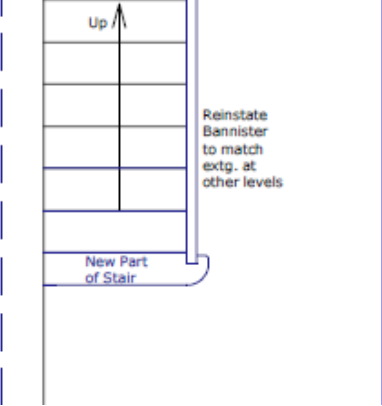
<p>Figure 8: 2014 application – plan 'as proposed'. This shows the new stair thread to make up the height difference (to accommodate the lowering of the floor).</p>

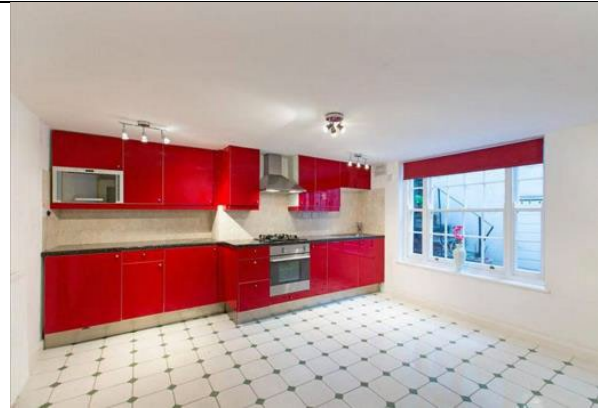
Cooking equipment installed adjacent to chimney breast in front room	No action needed	<p><b>Negligible</b></p> <p>Earlier photographs from 2014 and 2002 show that there was no fireplace in the front room at lower ground level in more recent years. The kitchen equipment was installed as part of the 2014 works (2014/2836/P) and clearly shown in the 'as proposed' drawings –no. 3013-00-011. Demolition drawing no. 3013-00-21 shows that kitchen units had already been installed, and the fireplace that was once there was already lost.</p> <p>Prior to the most recent works, there was no fireplace here. The chimney breast is still legible, arguably more legible than pre-2014 works (see Figure 11). It is in an area that has been altered in the past.</p>

<p>Figure 11: Kitchen in the basement front room (photo from 2013).</p>

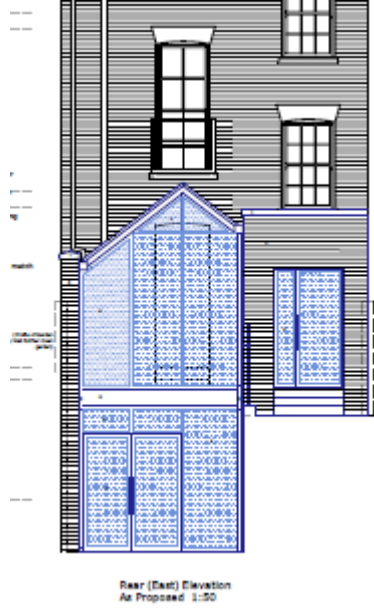
Schedule of Works and Impact Assessment					
Location and element	Action	Impact Assessment & Description of the Works/Intervention		Relevant Photographs (Current – post consented 2014 refurbishment)	Relevant Photographs (2002, 2013 and 2014 works)
Rear Extension	Apply for LBC	<p><b>Negligible</b></p> <p>A two storey glazed extension was consented in 2014. Although the current rear extension differs to the consented scheme, is it set back from the consented scheme at lower ground floor and has been constructed in appropriate materials. The current configuration to the rear is smaller in bulk, mass and generally more modest than the consented scheme. It is therefore considered the current extension is more appropriate in heritage terms than the consented scheme and generally a more subtle extension than the 2014 proposed.</p>

<p>Figure 16: Consented 2014 scheme in elevation shows the considerable extension that was granted consent. It is considered that the current extension is far more appropriate in heritage terms than the consented scheme.</p>

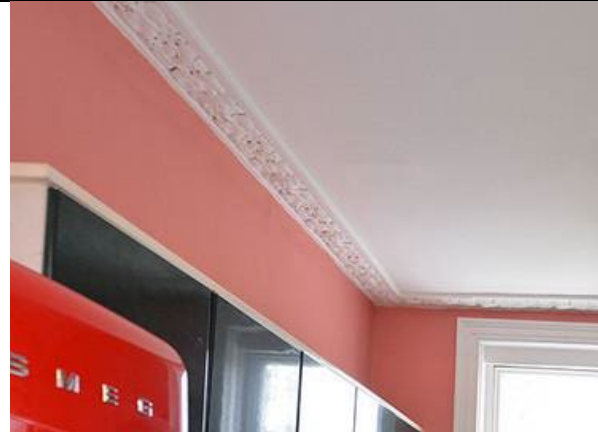
Ground Floor Level					
All rooms – suspended ceilings (concealing historic cornices)	Carefully remove the suspended ceiling and make good any areas that may have been damaged.	<p><b>N/A</b></p> <p>An appreciable difference was made to the historic character of the rooms. The suspended ceiling detracts from the historic patina of the house and the existing cornice is not historically in keeping with the period of the house.</p> <p>Camden’s September 2017 letter states ‘removal’ of cornice, whereas it appears to have been retained above the suspended ceiling, see Figure 17. The window head to ceiling height difference appears to have been reduced compared with earlier photos. Figure 18 shows a ceiling void above the suspended ceiling, and what appears to be the cornice in situ.</p>

<p>Figure 18: Image of void between ceiling and suspended ceiling. Cornice is just about visible in the background. It is likely these have all been retained. The image of the cornice from the 2014 D&amp;A statement shows a later cornice, possibly Arts and Crafts.</p>		
Front room, rear room and hallway - Spotlights	Carefully remove the suspended ceiling which contain the spotlights. Central pendants to be reinstated.	N/A  Both front and rear room appear to have a suspended plasterboard ceiling with embedded spotlights. These are to be removed.

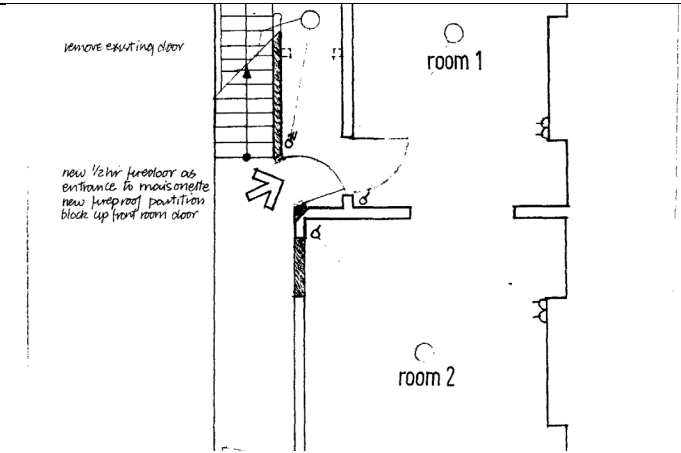
Door into the front room	No action needed	Original fabric, namely the door and architrave, have been removed and the opening infilled. The opening was infilled in 1978 when the ground floor and basement were subdivided from the house. See consented drawings from 1978 - Figure 22.

<p>Figure 22: Ground floor showing proposed plan of the ground floor where the front room door from drawings in the consented 1978 application package.</p>

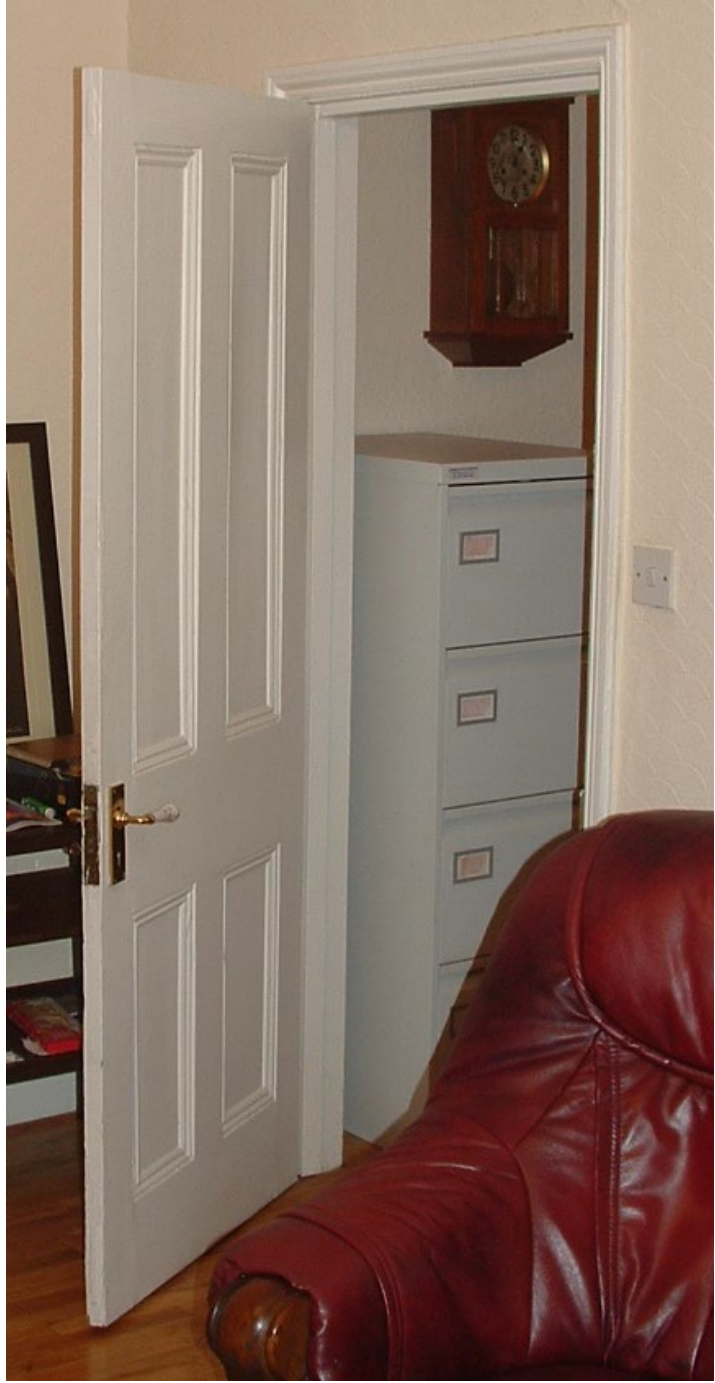
<p>Figure 25: Door into first floor front room – photo from 2002.</p>

Schedule of Works and Impact Assessment					
Location and element	Action	Impact Assessment & Description of the Works/Intervention		Relevant Photographs (Current – post consented 2014 refurbishment)	Relevant Photographs (2002, 2013 and 2014 works)
Door to rear room	Reinstate door to match the original/ early door as seen in Figure 25. Details to be approved via conditions.	<p><b>N/A</b></p> <p>The door will be reinstated. The existing architrave in the rear ground floor room (Figure 23 and Figure 24) appears to match that of the first floor door architrave for the front room (see Figure 25 and Figure 26). Decoratively, it's very likely that these mouldings would have been the same for ground and first floor.</p>

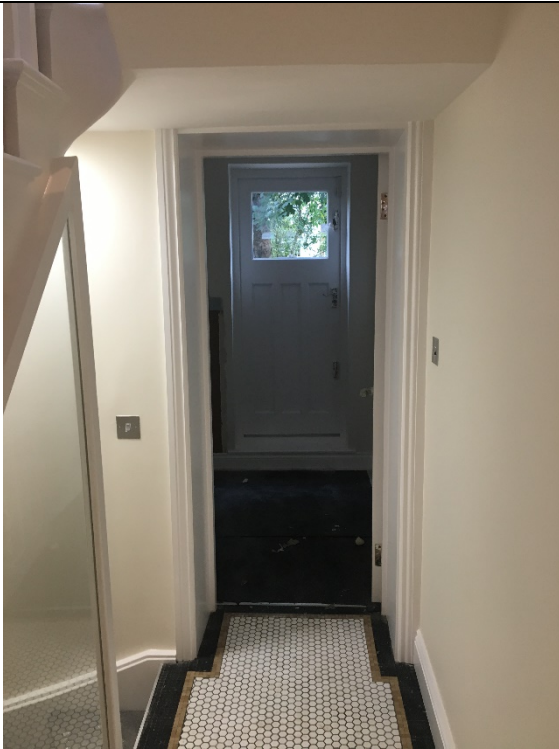
<p>Figure 27: Current photograph of existing cornice</p>

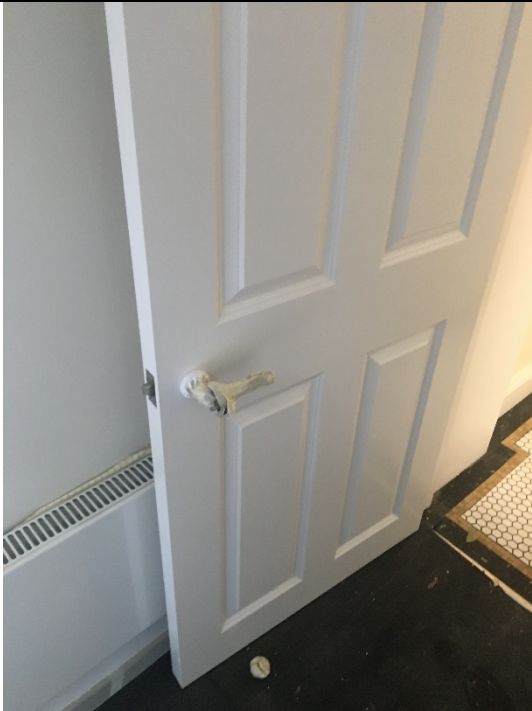
Figure 28: Existing door		
Hallway - Glass balustrade leading to lower ground floor	Replace with timber panel  Details to be approved via conditions.	<b>Minor / Beneficial</b>  Originally there would have been a stud wall, possibly panelled, to separate the servants from the main house and prevent odours rising from the kitchen.  This part of the staircase was concealed behind a partition wall as part of the conversion of the basement and ground floor into separate residential units (see Figure 22) in 1978. When the the house was reinstated into a single dwelling in 2014, the removal of the partition left the basement stairway open.  Removal of original fabric occurred during the 1978 works and subsequent phases of the subdivision.  The proposed timber panel will resemble the below image – taken from a house of similar period. The details are to be approved via conditions.

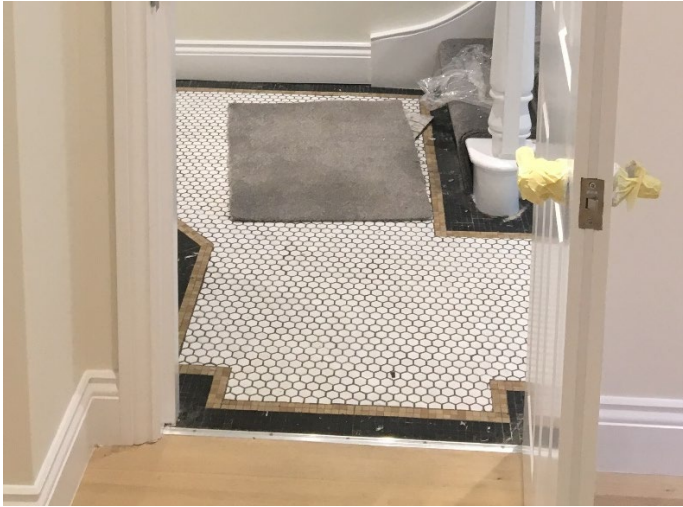
<p>Figure 31: New floor finish in the entrance hall</p>

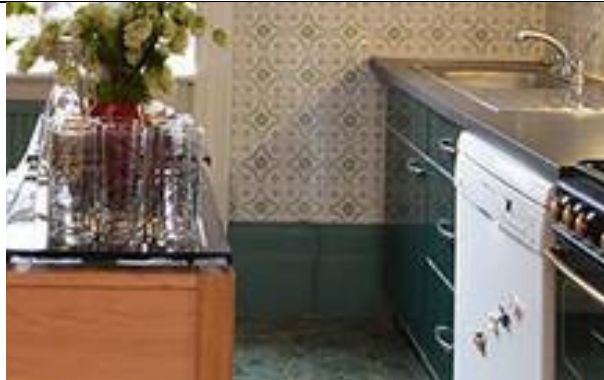
<p>Figure 33: Photo of rear room from 2013 shows the original skirting</p>

Front room, rear room and hallway - Floor finishes and skirting	<p><b>Apply for LBC for floor finishes and skirting in the hallway. Details to be approved via conditions.</b></p> <p><b>Replace existing skirting with one to match original material and profile as seen in Figure 33. Details to be approved via conditions.</b></p>	<p><u>Floor finishes and hallway skirting: Impact Minor / Adverse</u></p> <p>The floor finish in the rear room pre 2014 works appears to be either tiled or linoleum. The skirting in both rooms, as seen in the 2013 photos, was original.</p> <p>The front room floor, as seen in Figure 34, appears to be original.</p> <p>The floorboards were retained under the current floor finish. The finish is a laminate set on underlay.</p> <p>The skirting in the hallway that existed before the latest works was of a similar height and profile to the existing one (see Figure 40 and Figure 35). The impact is therefore minor.</p> <p><u>Skirting: Impact N/A</u></p> <p>The current skirting is lower than the original. The profile and material of the new existing are of a generic traditional design. Existing skirting is to be replaced with original design.</p>

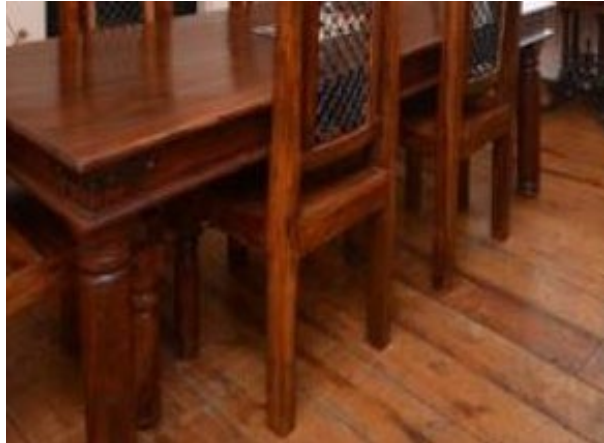
<p>Figure 34: Photo from 2013 of the front room shows original floorboards and original skirting.</p>

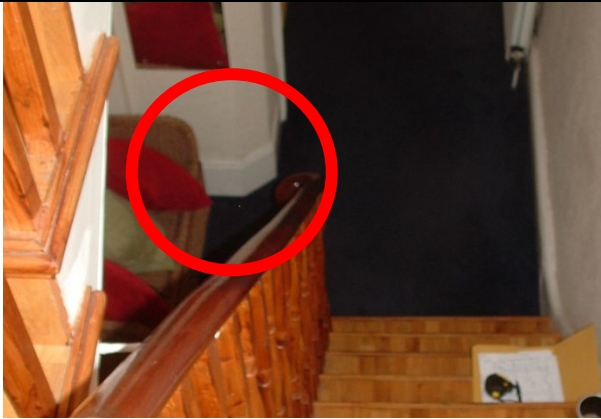
<p>Figure 35: Skirting in the entrance hallway in 2002</p>	
Front and rear room - Windows	No action needed	N/A The application from 2014 shows photos of the windows as they are today, i.e. there have been no changes to the windows on this level since the last consented scheme.

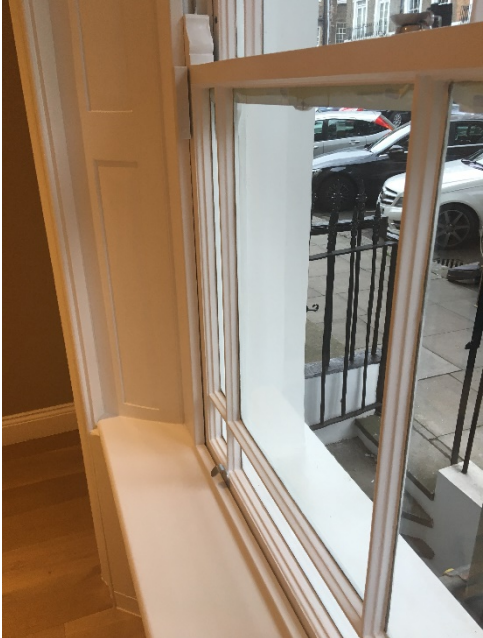
<p>Figure 36: The glazing bars and their configuration match those in the earlier photographs and appear to be early/original.</p>

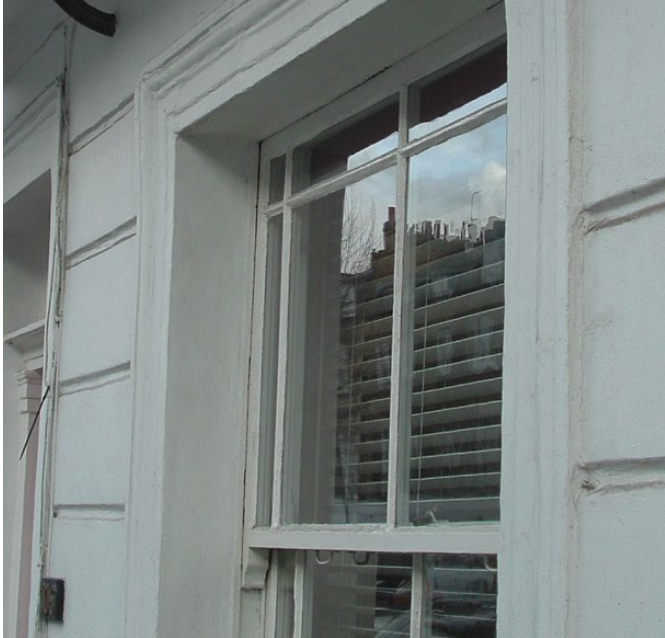
<p>Figure 38: Photo of front room ground floor window in 2002.</p>

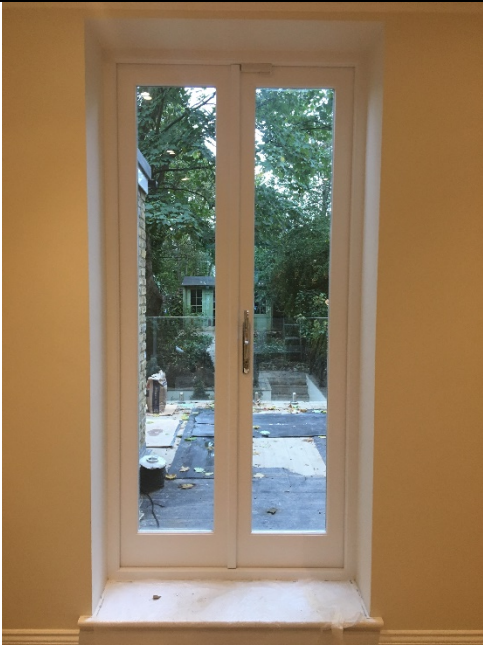
Figure 37: The full-length glazed doors were consented in the 2014 application.		
Front and rear room - Removed Fire Places	<b>Reinstate the fireplace in the front room as per original design (as seen in Figure 41).</b>  <b>Exact details to be approved via conditions.</b>	<b>N/A</b>  Photos taken before the 2014 works show that the rear room did not have a fireplace by the time the most recent works took place. There is no archival evidence of when it was removed (pre-listing or post listing).  The fireplace to the front room (see Figure 41) appears to be original and is fitting for a house of this status and period. The current fireplace is clearly recent, sits on a raised hearth and is inconsistent with the house's historic character in terms of proportion and detail.

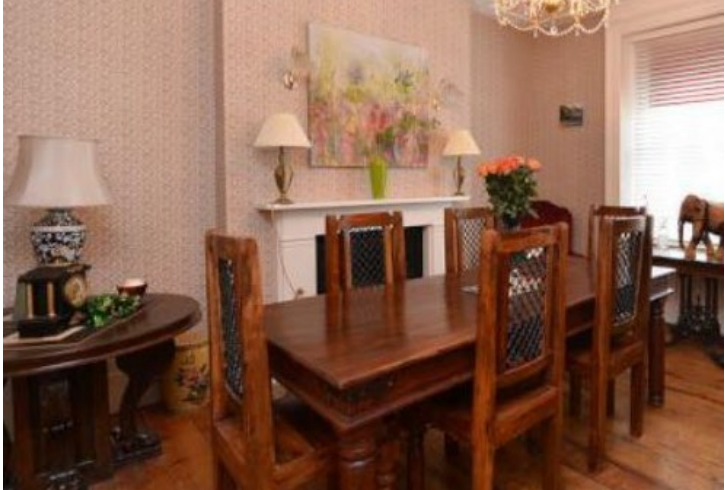
Figure 39: Current fire place in front room	Figure 41: The photo of the front room from 2013 shows a fire place that is likely to be original.

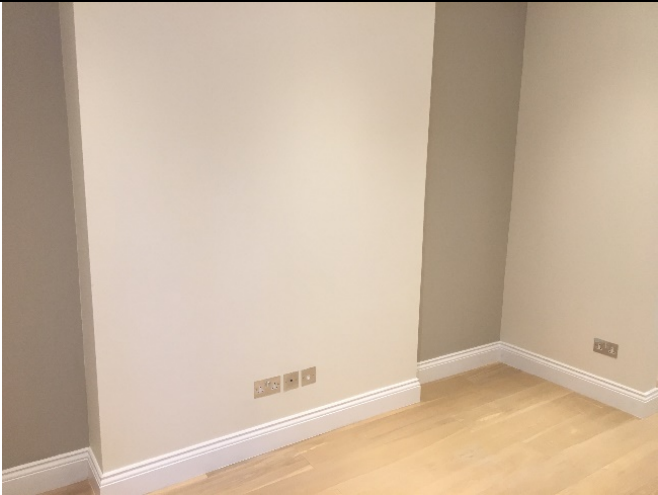
<p>Figure 40: Current rear room chimney breast</p>

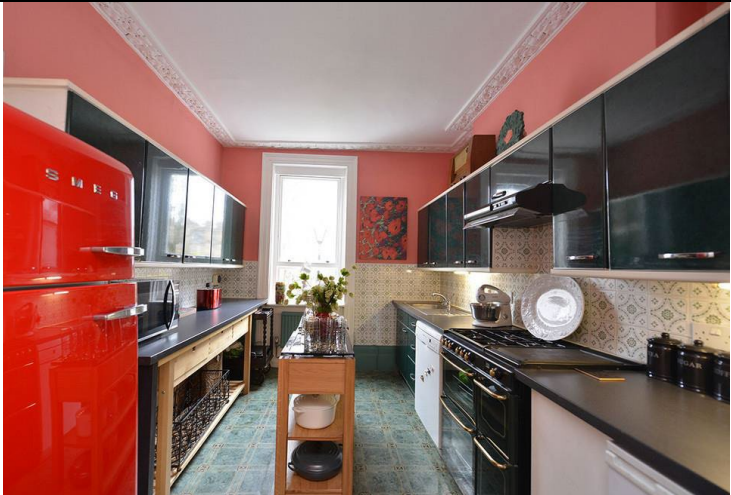
<p>Figure 42: Photo from 2013 shows that there was no fireplace at the time the photo was taken.</p>
Boundary Fence	Apply for LBC	<p><b>Negligible</b></p> <p>Timber fence on the southmost wall has consent (as per 2014 application). The northmost side is a timber fence that has replaced the later brick party wall between 106 and 108. As seen in Figure 44 and Figure 45, that wall was rebuilt recently and there was little or no original or early fabric.</p> <p>Originally there would have been a brick boundary wall, probably low level (as seen in the next door neighbour’s property in Figure 43).</p>

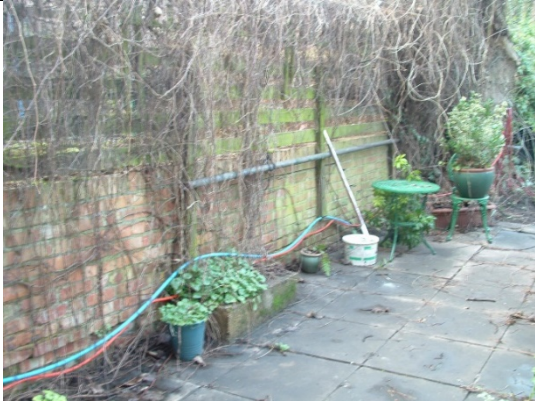
<p>Figure 44: Garden wall in 2002. Evidently, the garden wall was rebuilt</p>

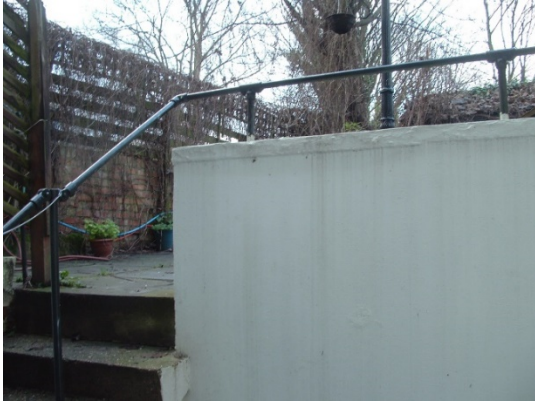
<p>Figure 45: Garden wall in 2002</p>

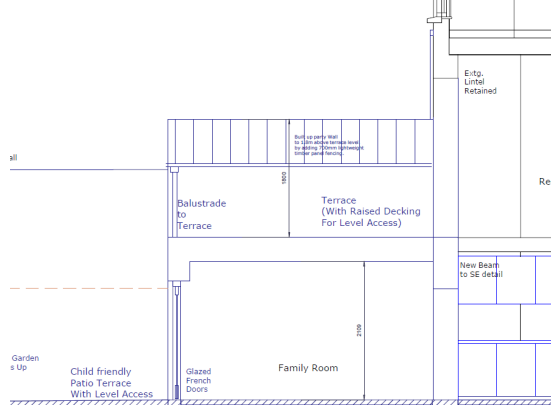
<p>Figure 46: Approved drawing from 2014 application</p>	
External glass balustrade	Apply for LBC	<b>Negligible</b> A glazed balustrade parraelle to the garden fence was consented in 2014. The existing balustrade is set further towards the fence than the consented scheme. The glazed balustrate is minimal in design and impact and follows the outline of the consented glazed scheme of 2014.

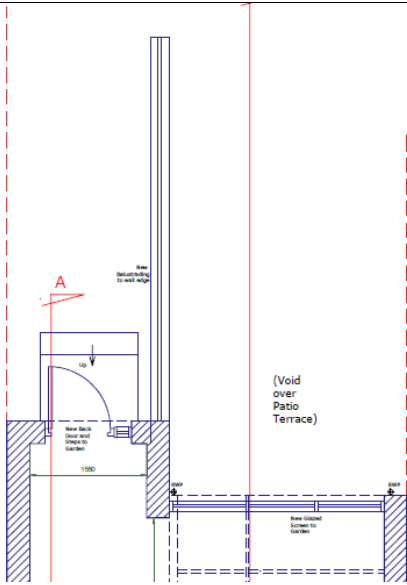
<p>Figure 47: Glazed balustrade to rear</p>	<p>Figure 48: Consented 2014 scheme</p>

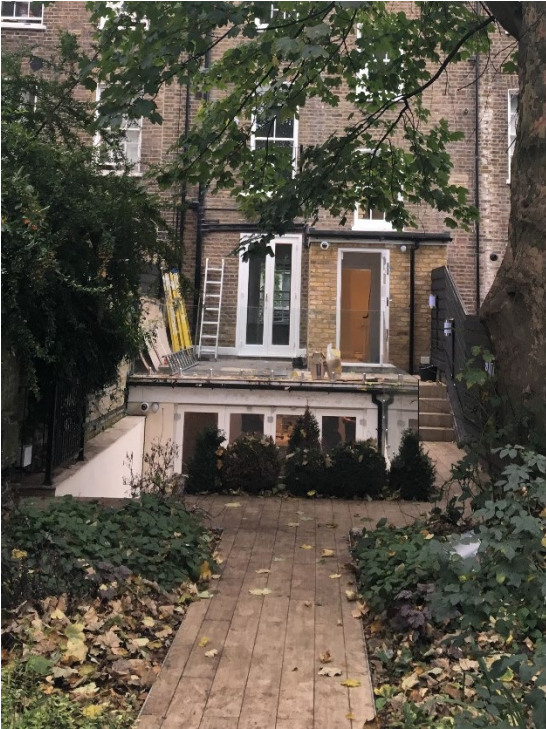
Schedule of Works and Impact Assessment					
Location and element	Action	Impact Assessment & Description of the Works/Intervention		Relevant Photographs (Current – post consented 2014 refurbishment)	Relevant Photographs (2002, 2013 and 2014 works)
Rear Extension	Apply for LBC	<p><b>Negligible</b></p> <p>At ground floor, the only extension to the house is the slight increase in footprint of the rear outrigger. The demolition of this was consented in 2014 along with the a new glazed infill extension.</p> <p>The replacement outrigger has been carefully constructed in materials to match existing. Its footprint is only marginally larger than that that existed in 2014 and is considered a more appropriate alteration to the house than the consented 2014 scheme.</p>

<p>Figure 49: Current photograph showing the rear extensions</p>

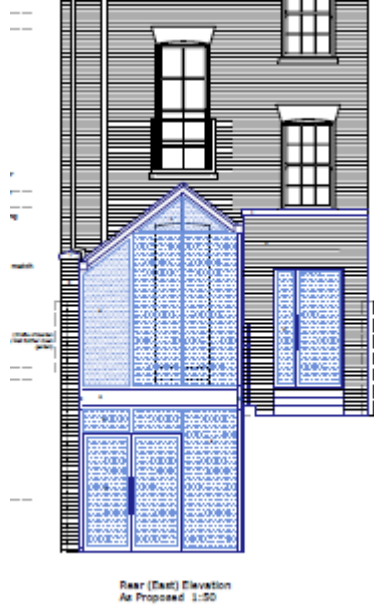
<p>Rear (East) Elevation As Proposed 1:50</p> <p>Figure 50: Consented 2014 scheme in elevation shows the considerable extension that was granted consent. It is considered that the current extension is far more appropriate in heritage terms than the consented scheme.</p>

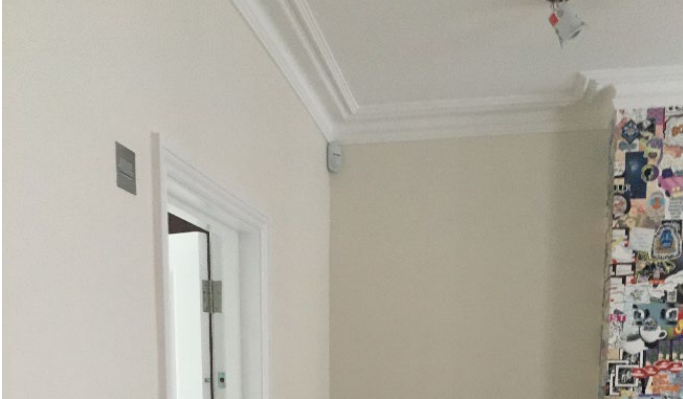
First Floor Level					
All rooms – suspended ceilings (concealing historic cornices)	Carefully remove the suspended ceiling and make good any areas that may have been damaged.	<p><b>N/A</b></p> <p>The suspended ceiling is evident in the window head and ceiling relationship. The ealier photos show a height difference between the cornice and the window heads (Figure 53 and Figure 54), whereas the recent photos show no gap (Figure 52 and Figure 55). The cornice is likely to have have been retained above the suspended ceiling (similar to ground floor level) and will be made good as necessasry.</p>

<p>Figure 51: Current cornice in front room. Rear room has same profile.</p>

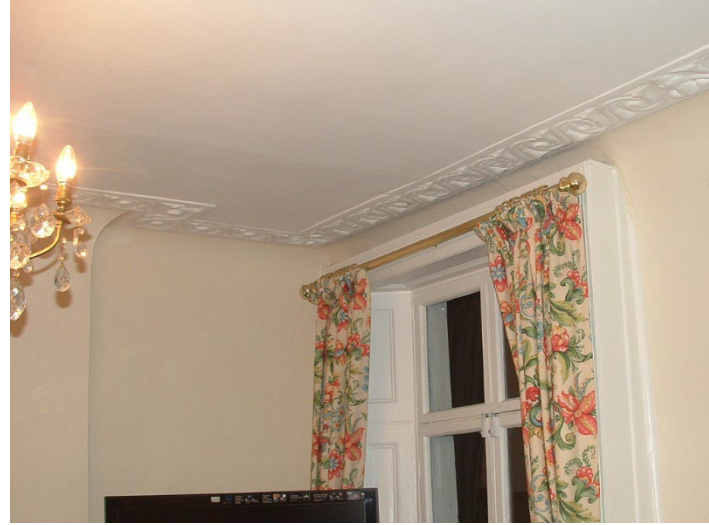
<p>Figure 53: Photo taken of front room in 2013 – cornice possibly Arts and Crafts</p>

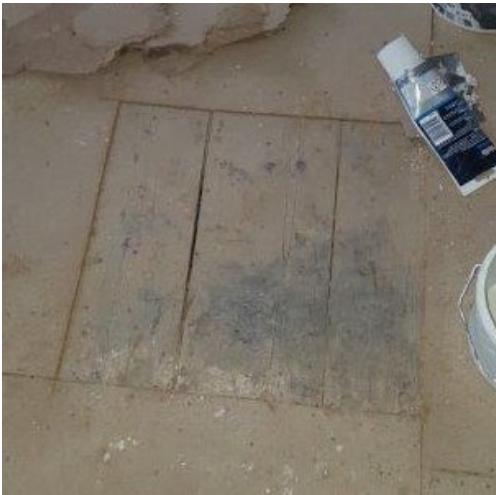
<p>Figure 57: 1st floor – floorboards exposed – appear to be original and have been retained.</p>

Schedule of Works and Impact Assessment					
Location and element	Action	Impact Assessment & Description of the Works/Intervention		Relevant Photographs (Current – post consented 2014 refurbishment)	Relevant Photographs (2002, 2013 and 2014 works)
Floor finishes and new skirting	<p><b>Apply for LBC for floor finishes and skirting in rear room. Details to be approved via conditions.</b></p> <p><b>Replace existing skirting with one to match original material and profile as seen in Figure 33. Front room only. Details to be approved via conditions.</b></p>	<p><u>Floor finishes: Impact - Negligible</u></p> <p>The floor finishes in both rooms had ‘timber effect’ floors as seen in the photos from 2013. The skirting in the front room, as seen in the 2013 photos, was original. The skirting in the rear room was removed before the 2014 consented works and there is no proof of its existence prior.</p> <p>The floorboards were retained under the current floor finish. The finish is a laminate set on underlay.</p> <p><u>Skirting: Impact - N/A</u></p> <p>The current skirting is lower than the original. The profile and material of the new existing are of a generic traditional design. Existing skirting is to be replaced with original design.</p>

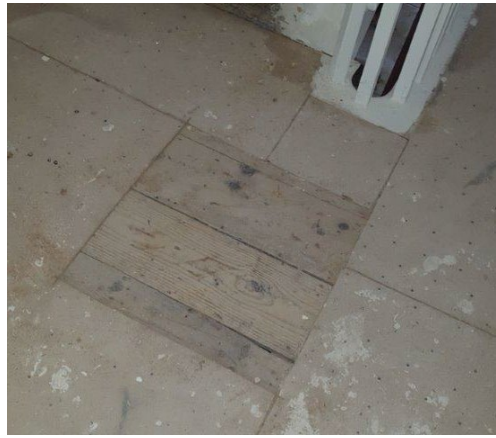
<p>Figure 58: First floor hallway floorboards – appear to be original and have been retained.</p>

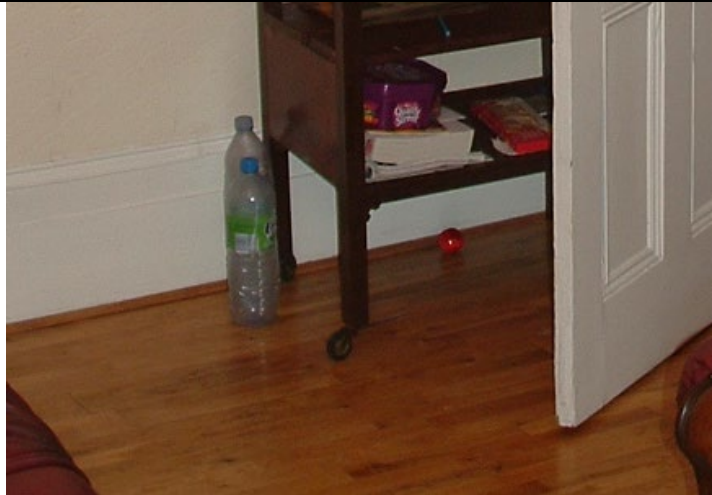
<p>Figure 59: Photo taken of front room in 2013 – wood or laminate floor finish. Skirting appears to be original.</p>

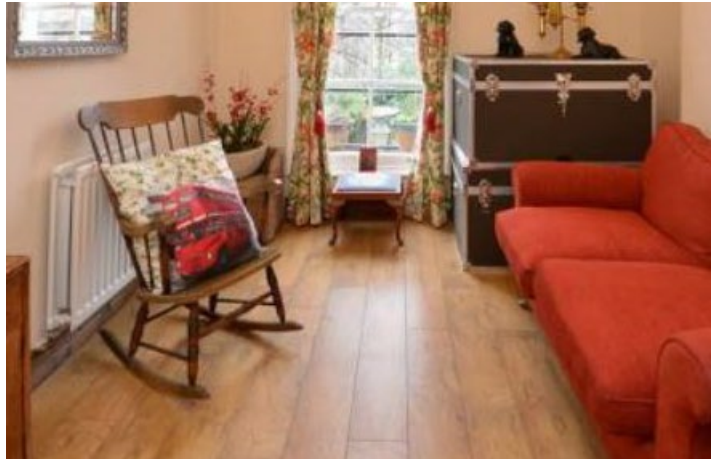
<p>Figure 60: Photo taken of rear room 2013– timber effect boards over original floorboards. Skirting in this room appears to be later – it does not match that of the front room, which it would have done originally.</p>

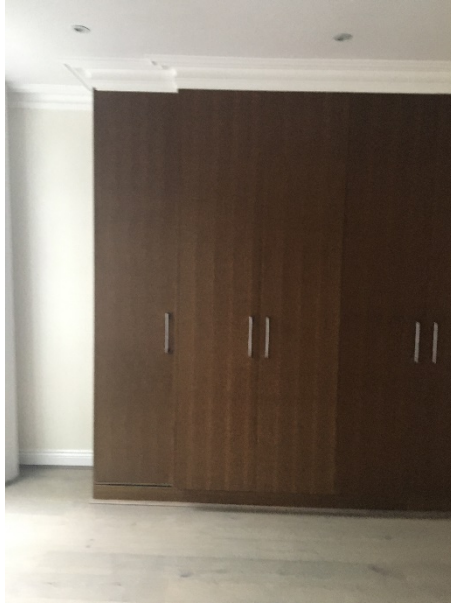
Schedule of Works and Impact Assessment					
Location and element	Action	Impact Assessment & Description of the Works/Intervention		Relevant Photographs (Current – post consented 2014 refurbishment)	Relevant Photographs (2002, 2013 and 2014 works)
Removed Fire Places	No action needed	N/A Photos taken before the 2014 works (Figure 53 and Figure 54) show that these rooms did not have a fireplace by the time the most recent works took place. There is no archival evidence of when they were removed (pre-listing or post listing). Their removal is adverse, however, the time of their removal is not archived.			
Fitted wardrobes	Remove fitted wardrobe, fit floor finish where necessary and make good	N/A The fitted wardrobe in the front room is full length with the cornice fitted around. This altered the original footprint of the room and will be removed. The full length wardrobe in the rear room was consented as part of the 2014 application.

Figure 61: Fitted wardrobe in front room - current

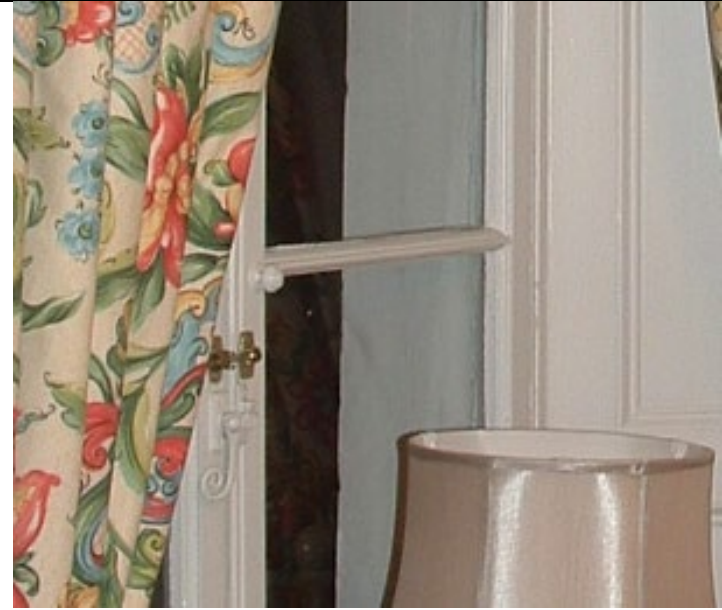
New Windows to all openings	Apply for LBC and Planning. Details to be approved via conditions.	Minor / Adverse Rear room: The windows to the rear elevation are double glazed timber sash and match the original windows in glazing bar pattern and materials. Though the windows that previously existed are lost (unknown whether or not these were original), the visual impact is limited as it faces the rear of the building and will not be seen from the public realm. Windows in the front room: The windows in this room are French doors opening onto a balconette. The difference between the current photo (Figure 62) and the 2002 one (Figure 64) is the profiles appear sharper and there are minor differences in the beading in the transoms and mullions. The windows appear to be new, replicated in profile, material and configuration. Overall, the historic character is retained by the change, as the materials and glazing bar profile and patterns match the early/original ones.

Figure 62: Current window in front room. Single glazed. This is a recent window installed post 2002.
