INVESTIGATION OF FLOORBOARDING TO ASCERTAIN AGING OF 16-18
CHENIES STREET FOR 18 MAY 2017, JOB NO. 147.17

RADA

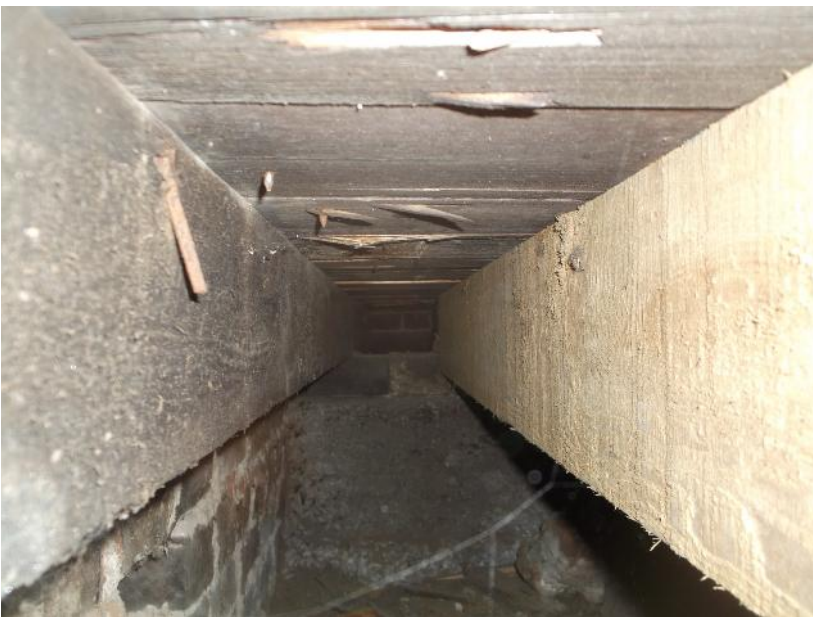
Fig 11:

- 1 Hatch 1: Likely original floorboards were of softwood of a tongue and groove pattern measuring approximately 30 x 150mm. They were significantly charred as a result of fire damage. Some were cupped as a result of the significant damp penetration that had occurred in the past and also possibly because they were of poorer quality flat sawn nature
- 2 Hatch 2: Plywood sheets overspanned the floor joists and no floorboards were visible
- 3 Hatch 3: Floorboards were of a tongue and groove nature and of softwood measuring approximately 20 x 115mm. As viewed from beneath adjacent to the hatch, the sheen to the underside of the floorboards indicated that they were of relatively recent origin possibly replacing fire damaged boards

Basement, Hatch 1; showing an overall view. Note the fire-damaged original joist indicated by the arrow partnered with new later large cross-sectional sized timber elements, detailed with a timber yard grade stamp. The overlying floorboards were fire-damaged but are likely to be original

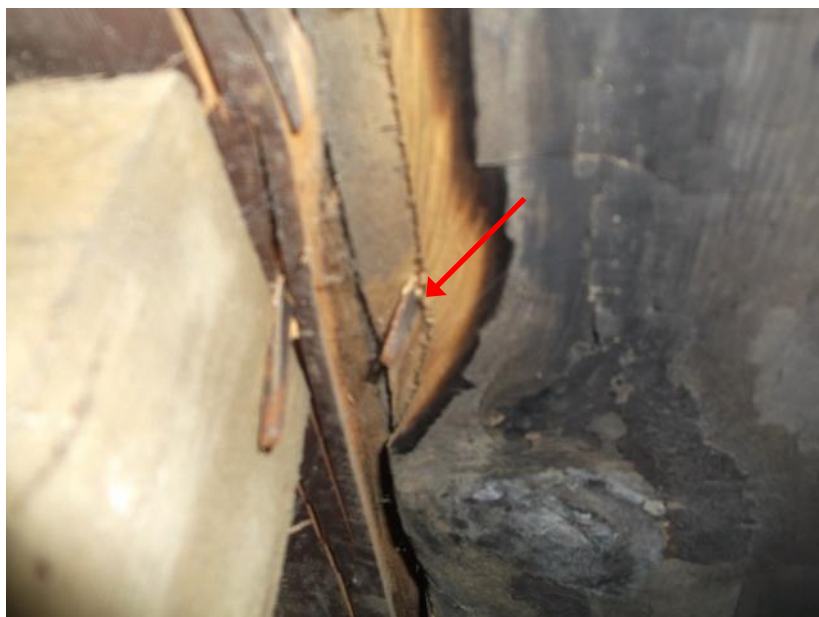
Fig 13:

Basement, Hatch 1; showing an overall view. The overlying floorboards were fire-damaged but are likely to be original. It is likely that the floorboards have been lifted and re-laid in this location as part of the post-fire refurbishment

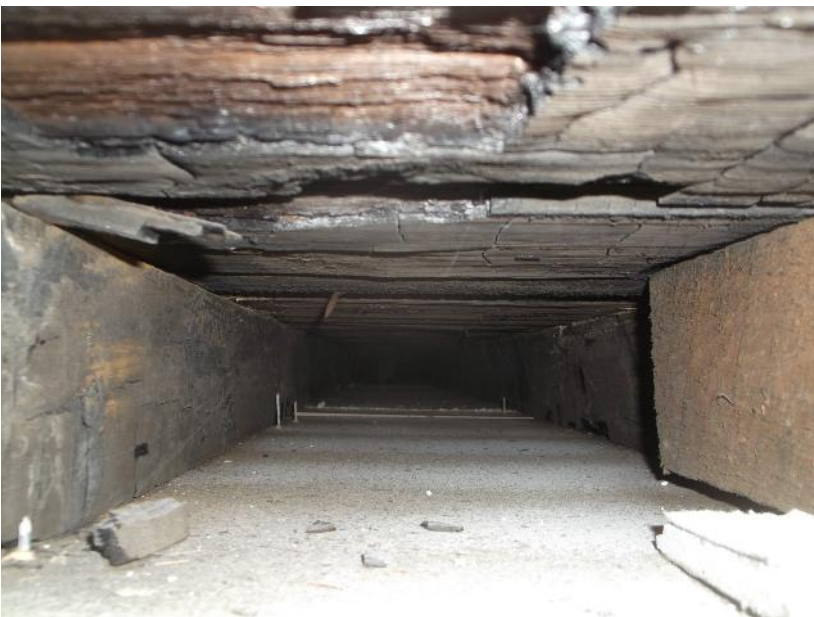
Fig 15:

- 3 Hatch 3: Floor joists measured approximately 110 x 50mm at 370mm centres and appeared to date back to the period of original construction. They had been partnered with later large cross sectional sized elements over the intermediate steel beams. Noggins and packing pieces had been inserted. Superficial fire damage had occurred to the joists

Basement, Hatch 3; showing the fire and smoke damaged boards in this location. The boards are likely to be original. Note the fire-damaged original joist partnered with newer large cross-sectional sized elements, dating to the post-fire refurbishment. It is highly likely that the floorboards would have been lifted and re-laid in this location

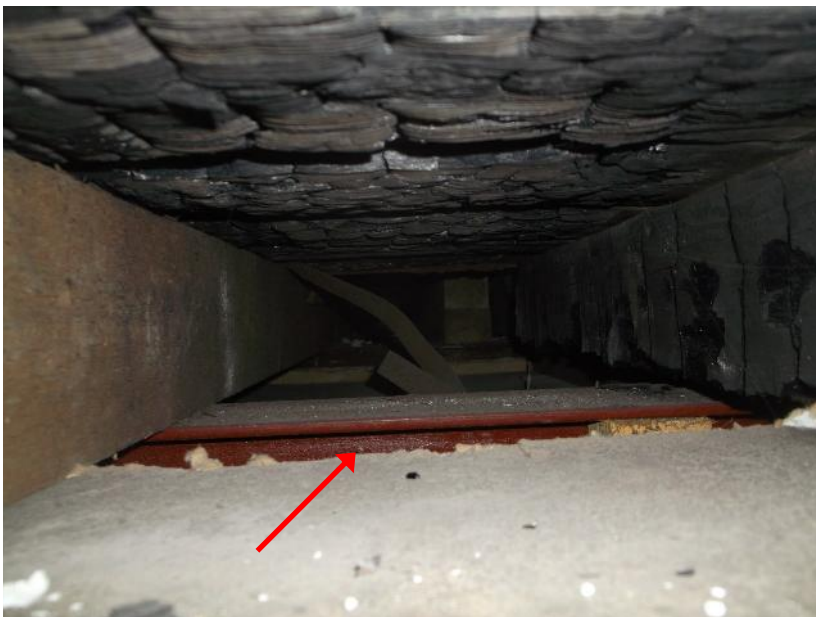
Fig 17:

Basement, Hatch 3; showing the fire and smoke damaged boards in this location. The boards are likely to be original. It is highly likely that the floorboards would have been lifted and re-laid in this location

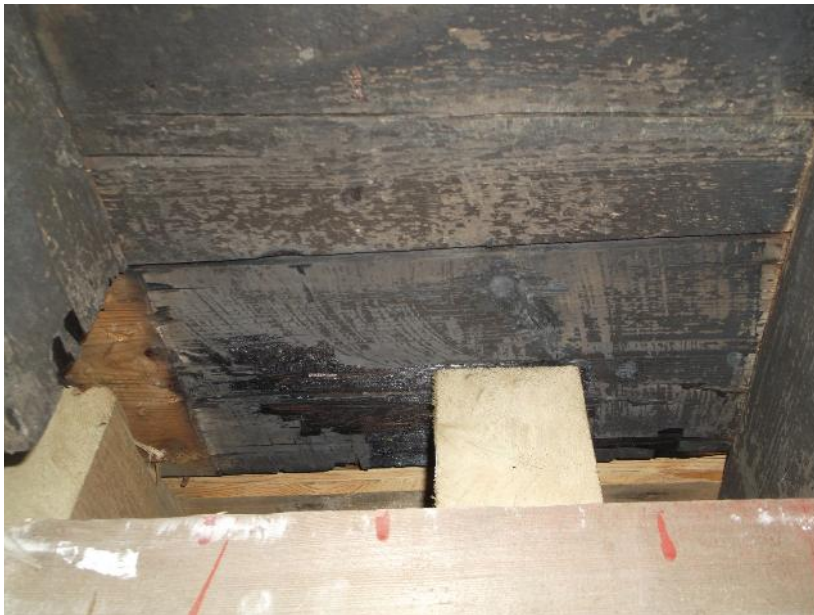
Fig 19:

- 5 Hatch 5: Likely original floorboards measured 30 x 170mm and appeared to be of a tongue and groove nature. There was extensive evidence of fire and smoke damage to the boards and new replacement floorboards extended beyond the wall head at basement level and under the area of the theatre staging above

Basement, Hatch 5; showing fire and smoke damaged floor joists and floorboards overspanning the new joist plate on the wall head upstand at basement level. The joists had been partnered with new large cross-sectional sized timber elements dating to the post-fire refurbishment and the floorboards beyond that area indicated in the photograph were new replacements extending beneath the theatre area

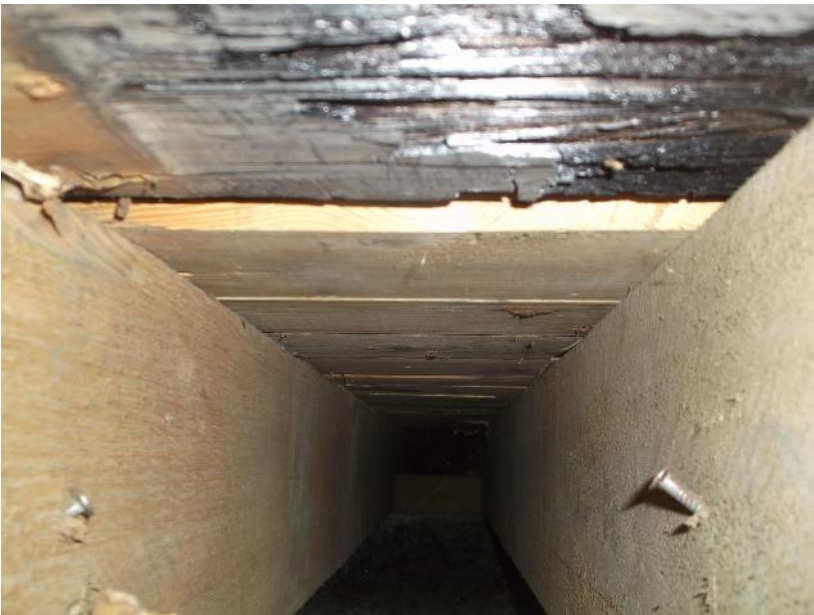
Fig 21:

Basement, Hatch 5; showing fire and smoke damaged floor joists and floorboards overspanning the new joist plate on the wall head upstand at basement level. The joists had been partnered with new large cross-sectional sized timber elements dating to the post-fire refurbishment and the floorboards beyond that area indicated in the photograph were new replacements extending beneath the theatre area

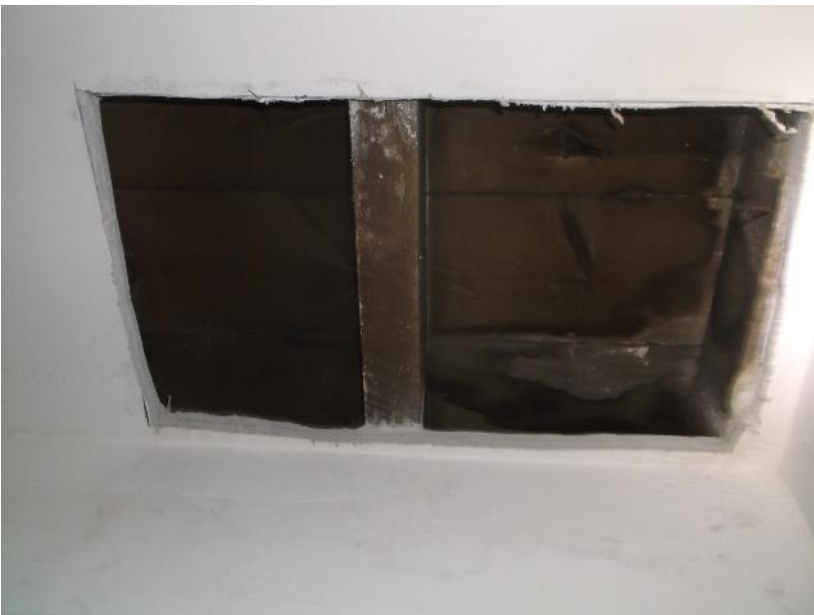
Fig 23:

Basement, Hatch 5; showing new floor joists and floorboards

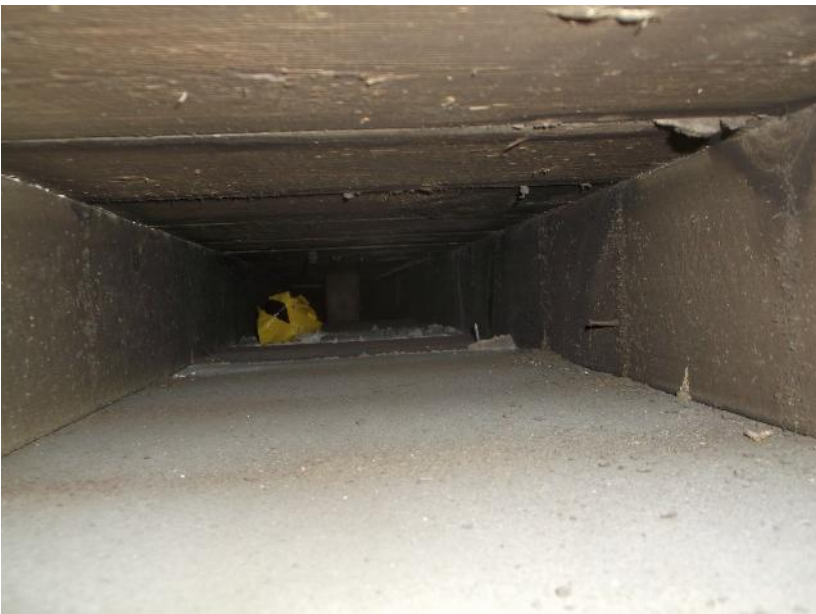
Fig 25:

Basement, Hatch 6; showing likely original floorboards and joists in this location fixed with squared shanked nails. There was no evidence of fire or smoke damage. However, it is still likely that the floorboards would have been lifted and re-laid in this location since the period of original construction

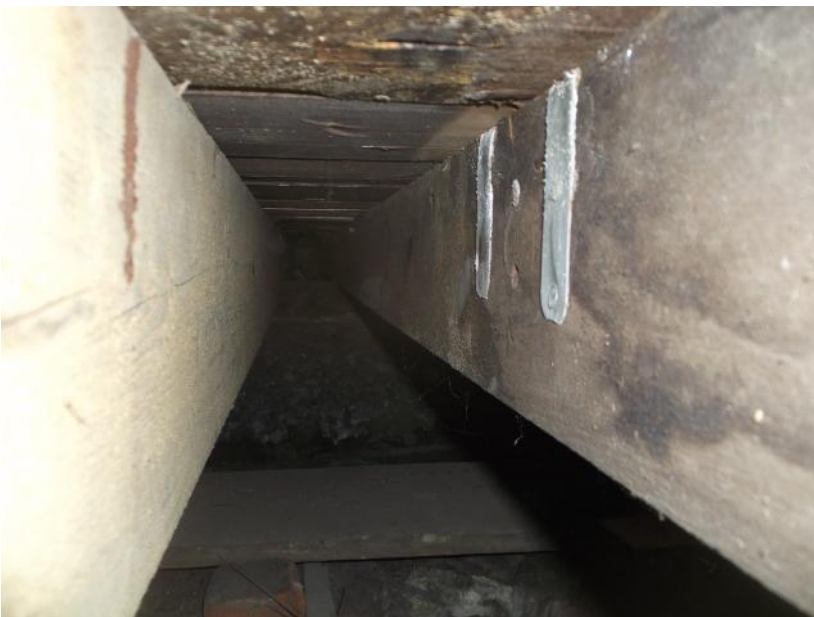
Fig 27:

Basement, Hatch 7; showing one of the relatively newly inserted airbricks dating back to the last major refurbishment providing some and through circulating ventilation beneath the theatre floor above. There was no evidence of fire or smoke damage to the timbers. However, it is likely that the floorboards would have been lifted and re-laid since the period of original construction

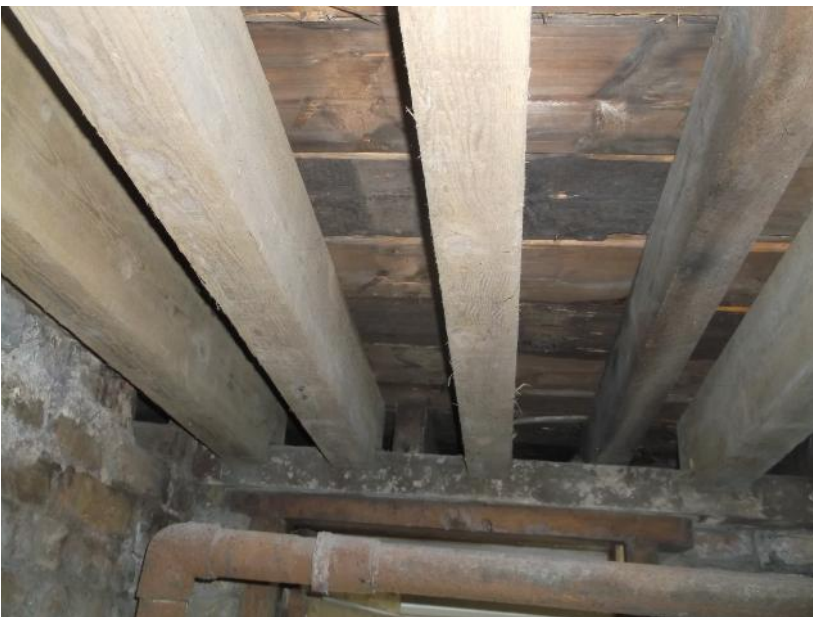
Fig 31:

- 8 Hatch 8: Likely original tongue and groove floorboards were of softwood measuring 30 x 120mm. This is smaller than the others. Some smoke staining was evident. Extensive structurally significant decay had occurred in this location and approximately 6m² of floorboards had been replaced with plywood

Basement, Hatch 8; showing a view of the combination of plywood and older likely original floorboards

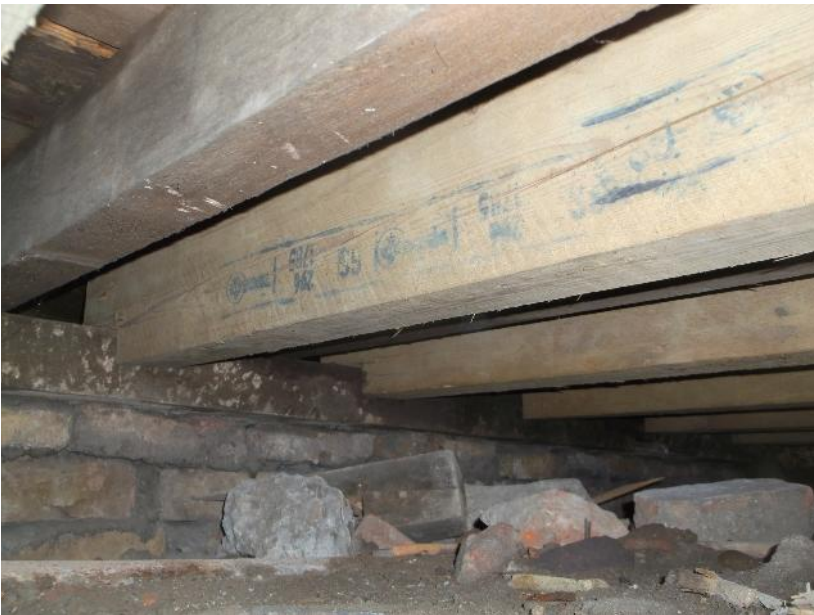
Fig 33:

Basement, Hatch 8; showing the extensive use of plywood replacing the original floorboards along the western side of the area

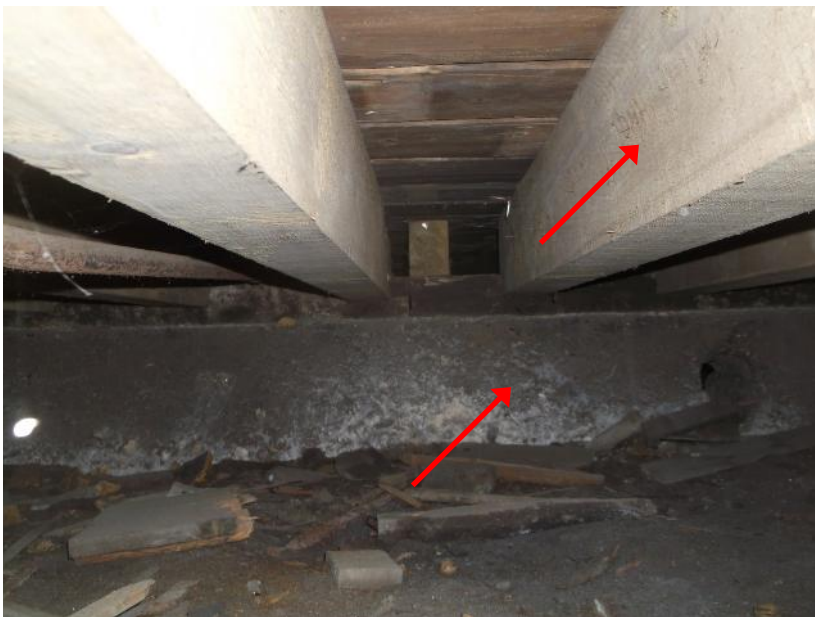
Fig 35:

- 1 Hatch C1: Floor joists post-dating the period of original construction spanned east to west supported on galvanised hangers to their west bearing ends to the external wall masonry. Joist bearing ends were highly vulnerable to structurally significant decay as a result of being in contact with saturated masonry
- 2 Hatch C2: Likely original floor joists spanned east to west partnered with new large cross sectional sized elements supported at their bearing ends on old plate measuring approximately 100 x 100mm running along the damp affected external wall. Both the joist bearing ends and the underlying plate would be vulnerable to structurally significant decay in this location

- 1 Hatch C1: Likely original floorboards measuring approximately 35 x 170mm had been lifted and re-laid over the floor joists beneath. Floorboards were in a fragmentary and partially decayed condition and were finished with 35mm thick plywood sheeting
- 2 Hatch C2: The likely original floorboards had been lifted and largely replaced and re-cut to act as furring pieces beneath the new 35mm thick ply. The extent of the replacement could not be easily ascertained but is likely to extend to approximately 5m² in this location

Western corridor, Hatch C1; showing an overall view. Plywood overlaid the likely original floorboards which had been lifted and re-laid over the floor joists which had been replaced in this location. The replacement joists were supported in hangers and were highly vulnerable to the decay at their bearing ends, being in contact with damp affected masonry

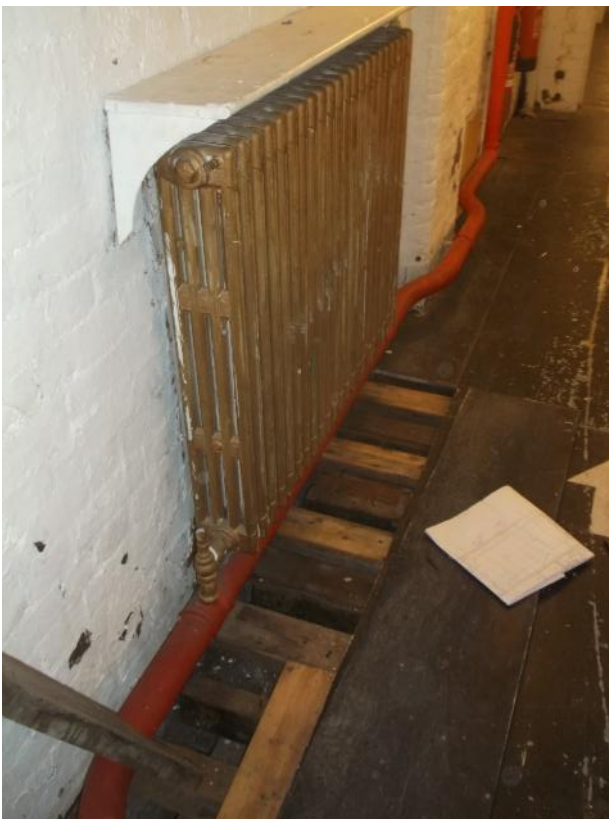
Fig 37:

Western corridor, Hatch C2; showing the contemporary plywood sheeting which in this location did not overlay the original floorboards which had been lifted

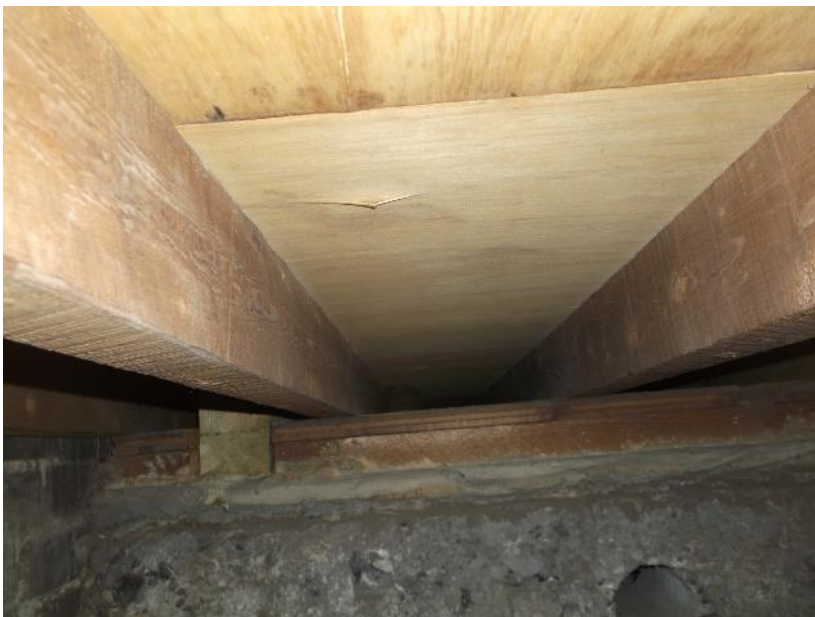
Fig 41:

- 9 Hatch 9: Floorboards had been replaced with 35mm plywood laid directly on the joists in an area extending to at least 12m² from the south-east corner of the Drill Hall

Drill Hall, Hatch 9; showing the plywood sheeting replacing the original floorboards and extensive repair and replacement work to the original underlying joists. Providing support to the joists was new trimmed timber plate supported in hangers onto the large cross-sectional sized primary joists. It appeared that supporting plate seated on the concrete sleeper walls was not original

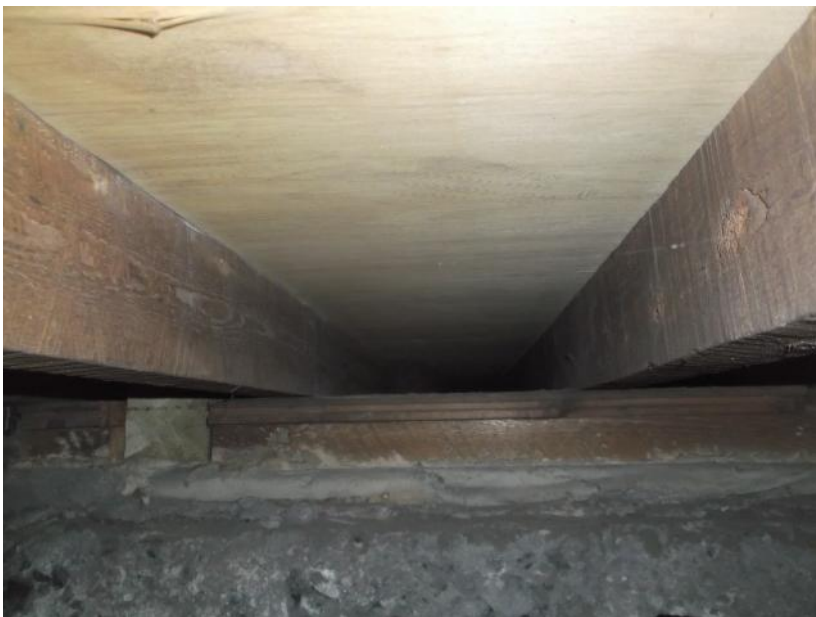
Fig 43:

Drill Hall, Hatch 9; showing the plywood sheathing replacing the original floorboards and extensive repair and replacement work to the original underlying joists. Providing support to the joists was new trimmed timber plate supported in hangers onto the large cross-sectional sized primary joists. It appeared that supporting plate seated on the concrete sleeper walls was not original

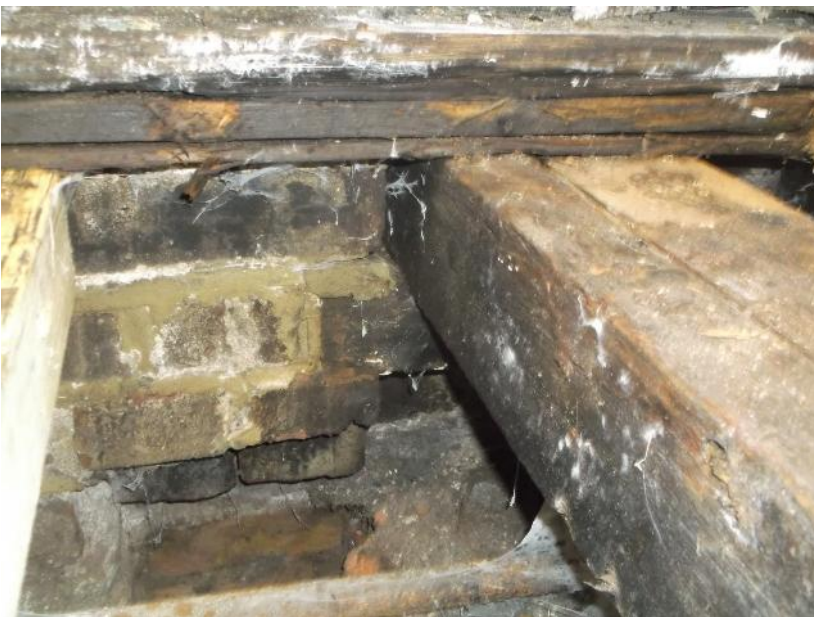
Fig 45:

- 10 Hatch 10: Likely original floor joists spanned east to west housed into masonry pockets to their east bearing ends. structurally significant wet rot decay had occurred to the built-in bearing ends in an area of saturated masonry as a result of failure to the white goods above. The floor was inadequately supported in this location. Partnering had occurred in the past to strengthen the floor but these elements were also decayed

Drill Hall, Hatch 10; showing original joists partnered with later elements as a result of progressive wet rot decay in this location. Decay was occurring to built-in bearing ends. Remnants of likely original floorboards remained but were structurally significantly decayed

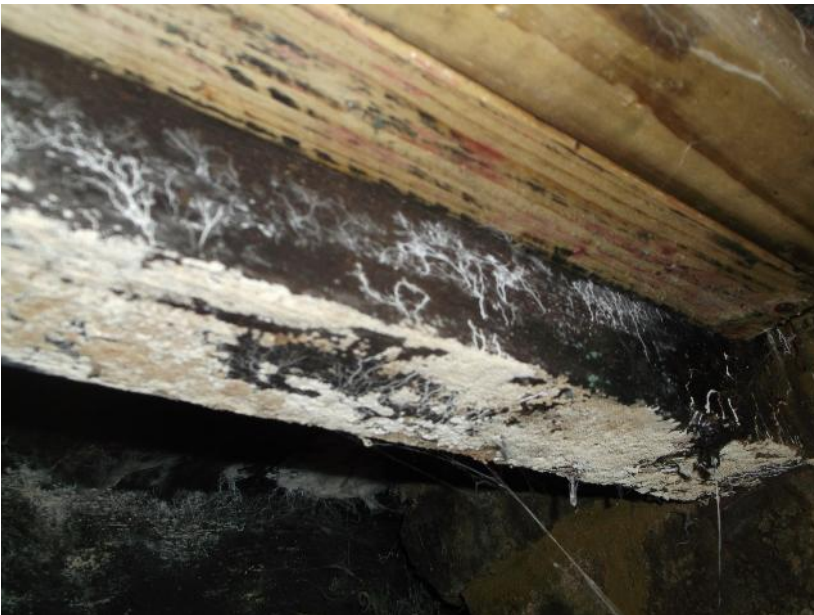
Fig 47:

Drill Hall, Hatch 10; showing original joists partnered with later elements as a result of progressive wet rot decay in this location. Decay was occurring to built-in bearing ends. Remnants of likely original floorboards remained but were structurally significantly decayed

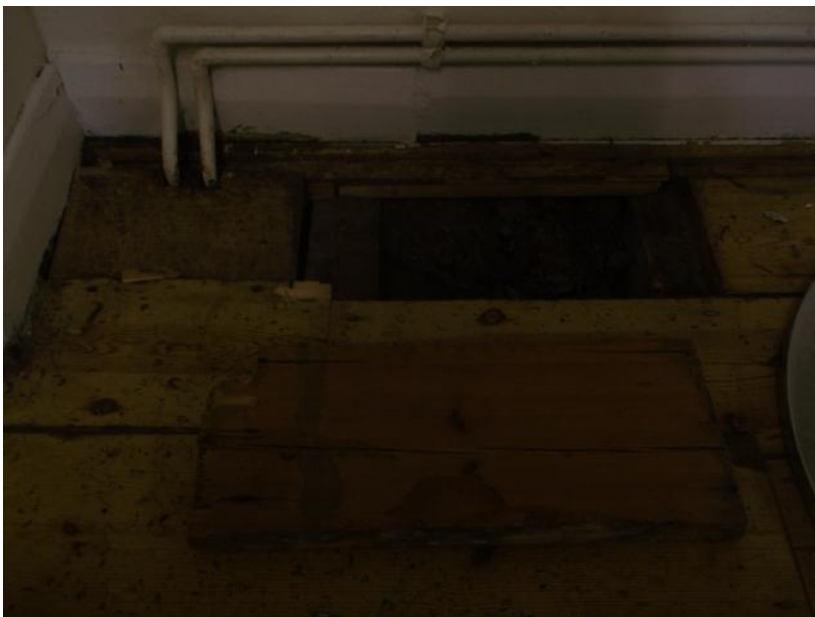
Fig 51:

Bar; showing an overall view of the sanded floor finish. In H+R's provisional opinion, none of the floorboards in the bar area dated back to the period of original construction

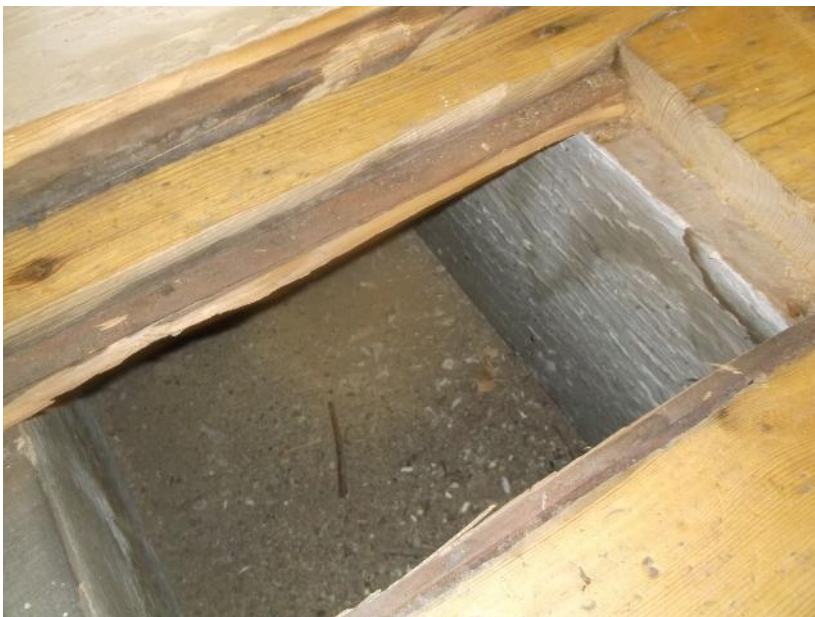
Fig 53:

Bar Hatch B2; showing floorboards painted with a limewash after they had been secured to the joists beneath. This was likely to have been applied as a preservative treatment against wood boring insect infestation and died away in the 1960s as a methodology. The underlying floor joists are likely to be original, but the floorboards are likely to date to the post WW2 refurbishment. The floorboards were rebated at their joints and were flat sawn and of a poorer quality than those likely original boards to the adjacent Drill Hall area

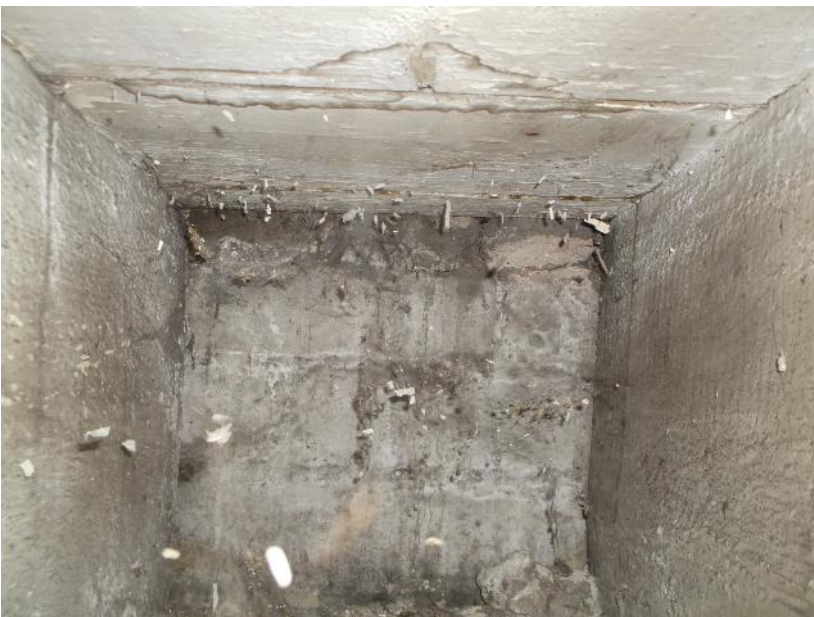
Fig 55:

Bar Hatch B2; showing herringbone strutting for lateral support

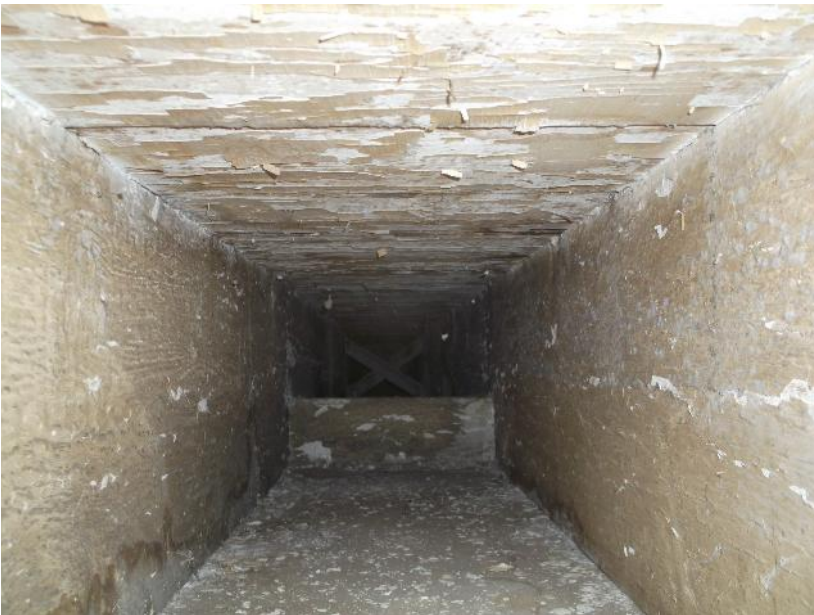
Fig 57:

Bar Hatch B3; showing a floorboard painted with limewash similar to that illustrated in fig. 53. Floorboards had been laid on a metal furring piece or tongue generally to the western half of the bar area. Judging by the nature of the metalwork, the boards were likely to have been laid using this methodology in the 1950s and 1960s

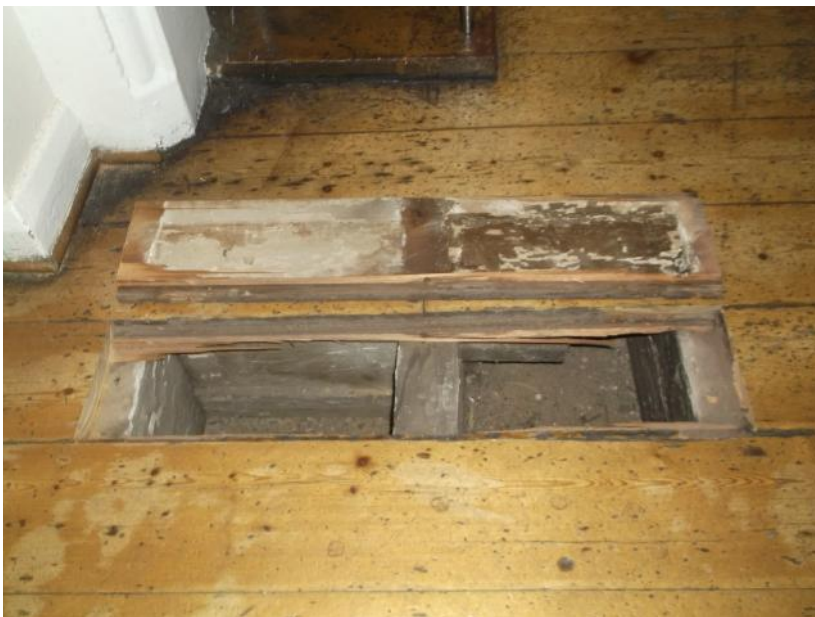
Fig 59:

Bar Hatch B3; showing a detail of the metal furring pieces or tongues and also the poorer quality flat sawn grain to the boards, indicating later origin

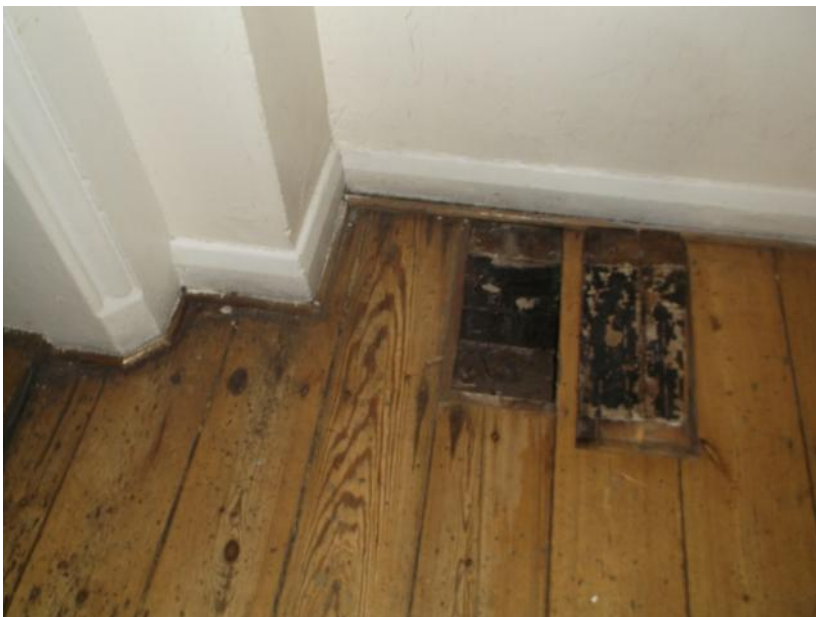
Fig 61:

Bar Hatch B4; showing some possible smoke damage to the joists but also limewash to the underside of the floorboards and herringbone strutting

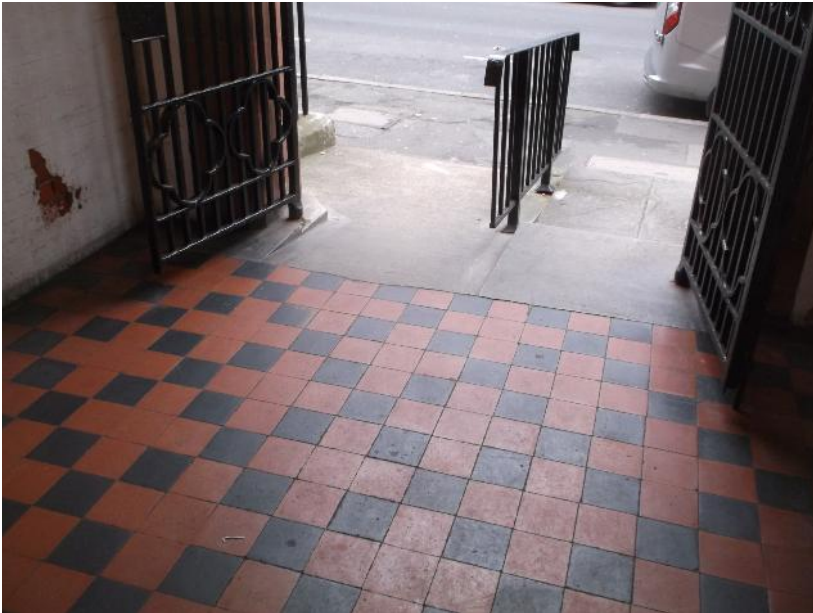
Fig 68:

Entrance; showing the original quarry tile floor subject to significant wear as a differential to the relative lack of wear to the more vulnerable timber floors to the adjacent Drill Hall and Bar. Such a degree of wear to the quarry tiling would almost certainly have been reflected in eventual failure and replacement of the original Deal floorboards to the Drill Hall and Bar
