## Arboricultural Consultancy for Lloyds Bank

### 1. Case Details

Insured		Address	50 Patshull Road, London, NW5 2LD	
Client		Contact		Claim No.
		Consultant		Contact No.
Report Date	11/12/2018

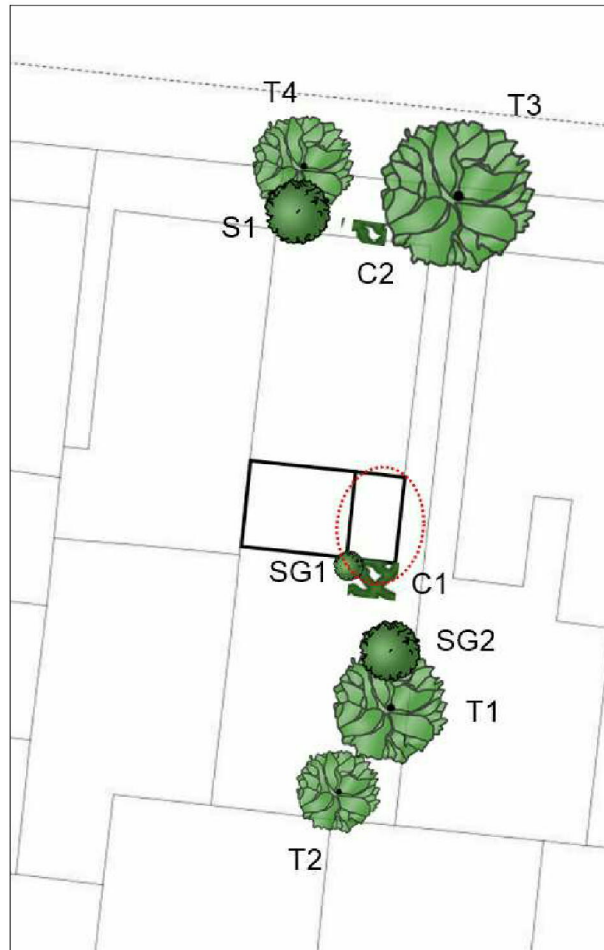
### 7. Site Plan

Based on our observations on site and with due regards to species profile, the Mixed Species Climbers (SG1) and Apple (T1) are the most likely source of the recovered root material and accordingly we have identified them as the principal cause of the subsidence damage.

The size and proximity of this vegetation is consistent with the location of damage and advised mechanism of movement.

In order to mitigate the current damage and allow soils beneath the property to recover to a position such that an effective engineering repair solution can be implemented we recommend a program of management as listed by this report.

Replacement planting is considered appropriate however due consideration must be given to the ultimate size of the replacement and future management requirements. Species selection should be appropriate for the chosen site and ultimate tree height should not exceed 75% of the available distance to built structures.
