ARBORICULTURAL IMPACT ASSESSMENT REPORT INCORPORATING TREE RADAR
REPORT

SITE

52 Eton Avenue,

DATE: 16.01.2019

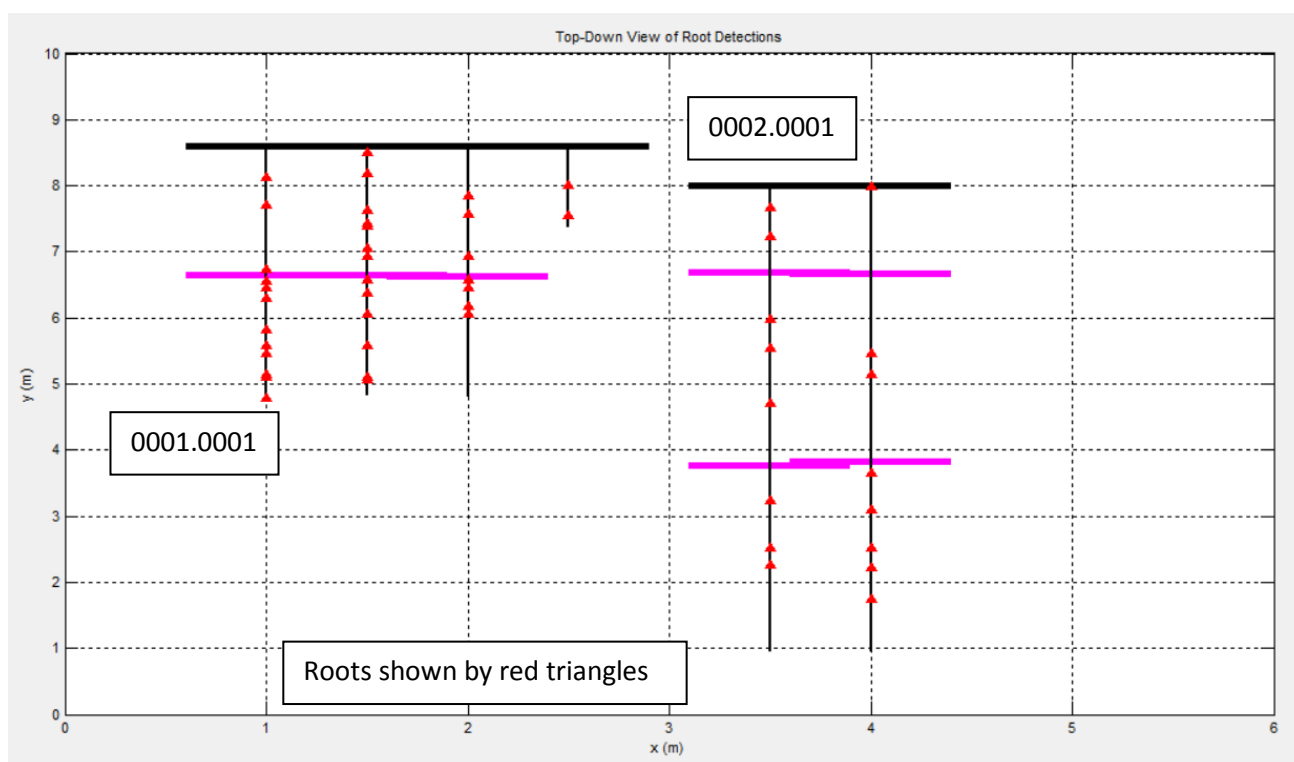
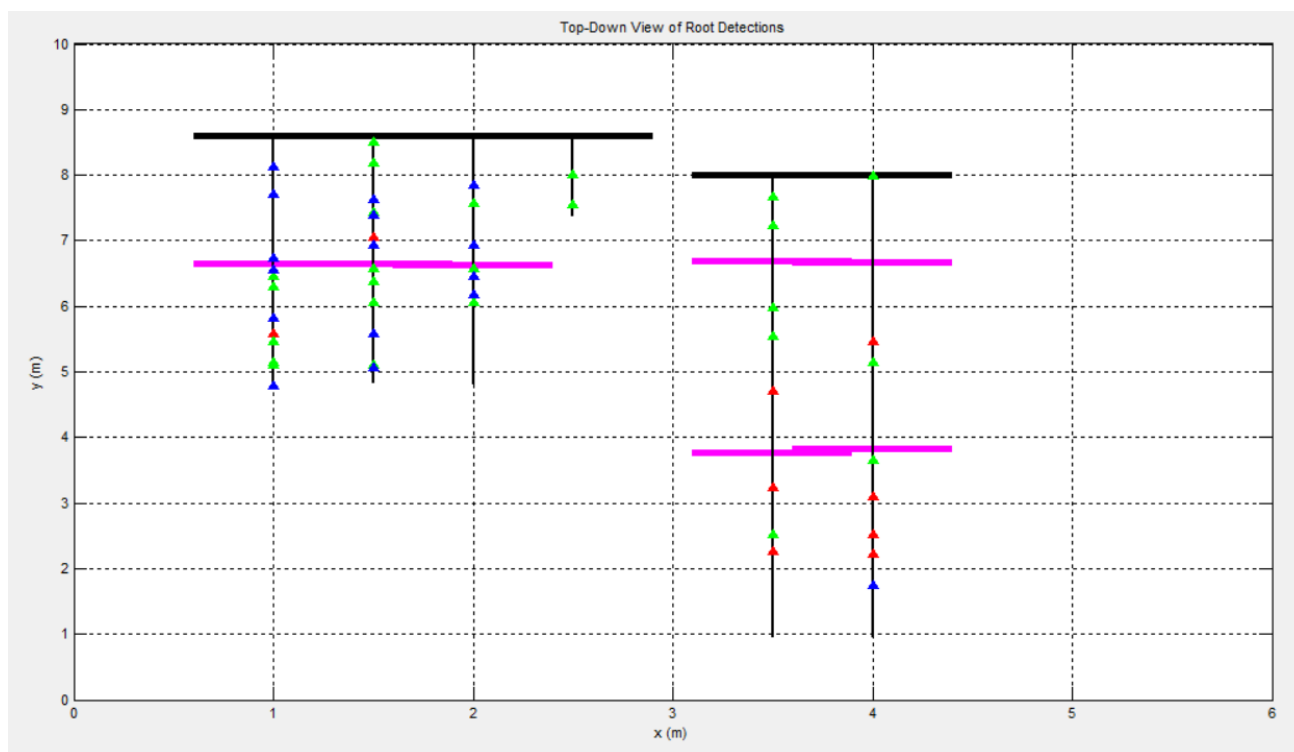
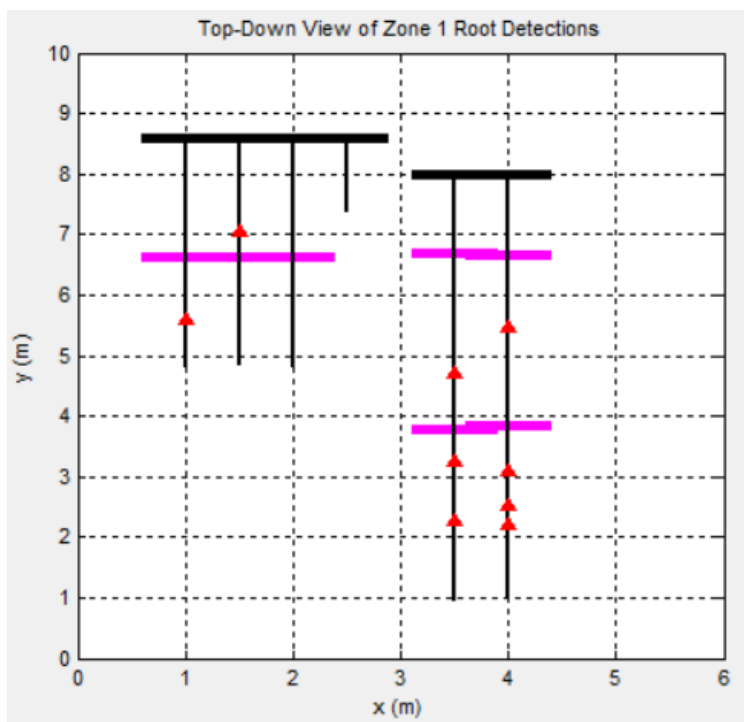
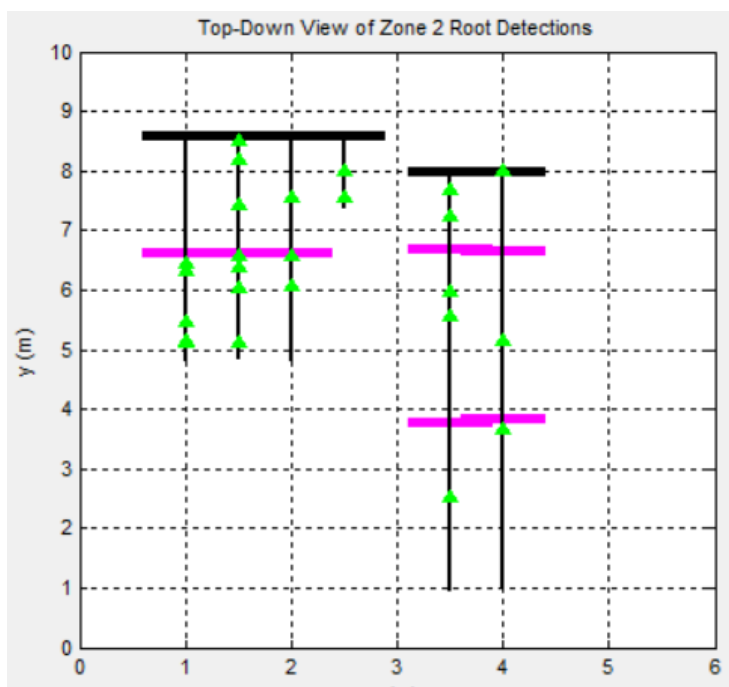
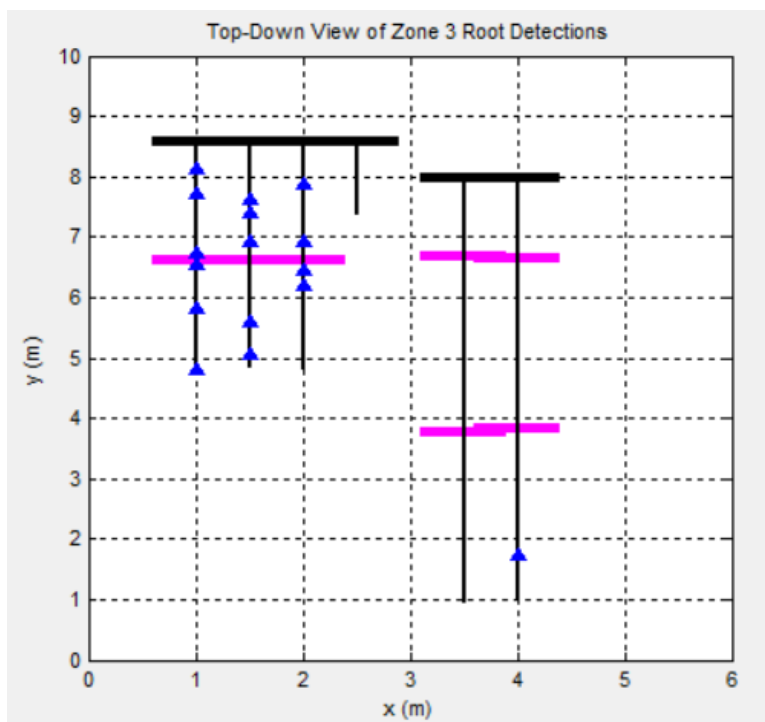
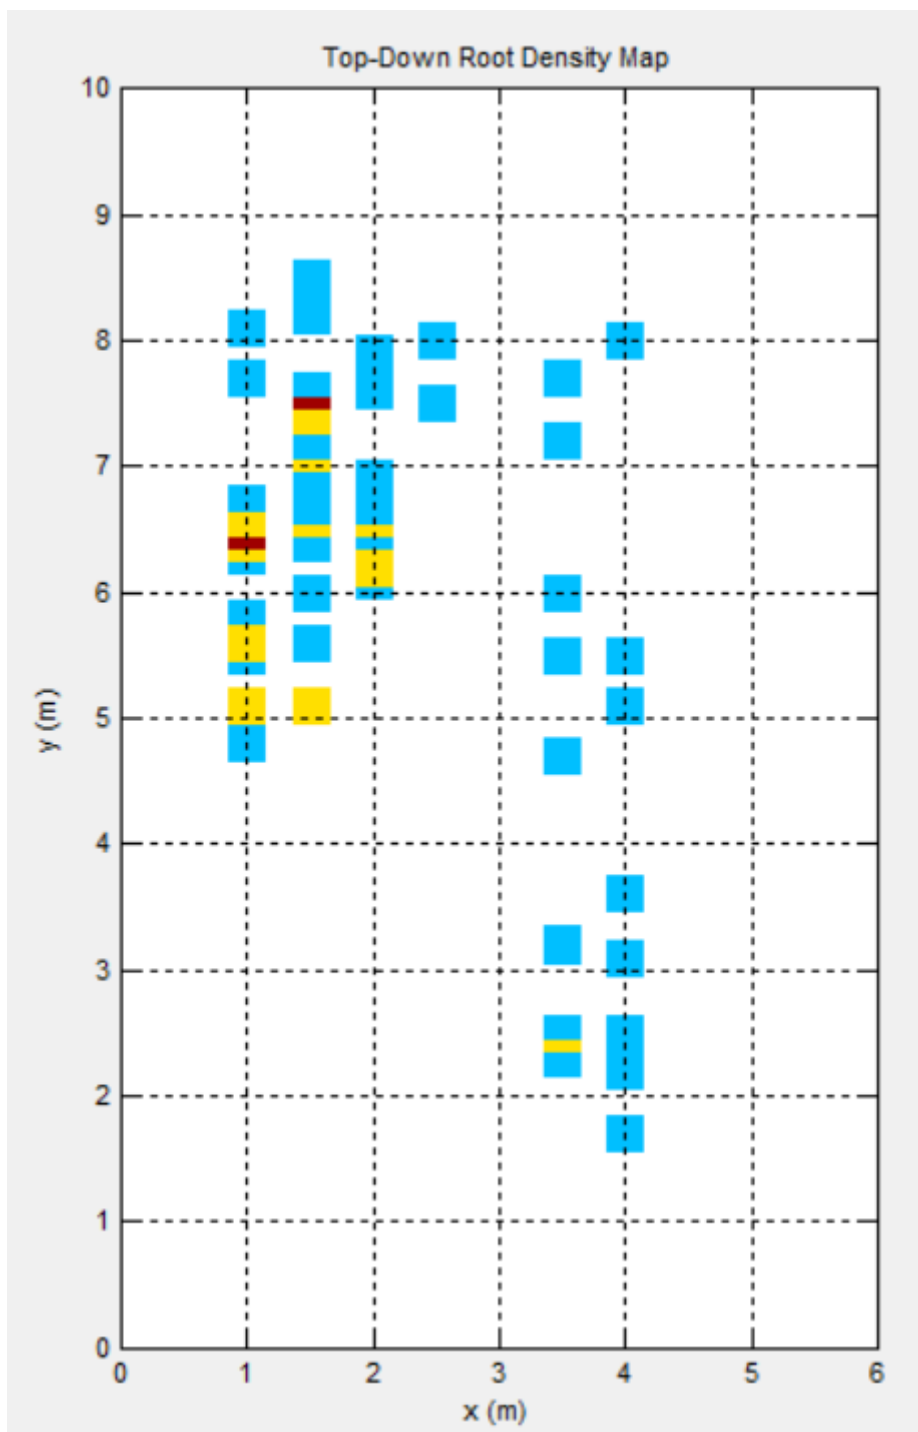
SCAN LINES 0001.0001-004 AND 0002.0001-0002- ROOTS (WITH A DIAMETER GREATER THAN 20MM) AT ALL DEPTHS

- iii. *“Beneath the site of the proposed new basement construction roots are found in low rooting densities and the majority of the roots clustered around towards the shrub beds containing the on-site trees and shrubs rather than the large London plane to the north west. Roots are also found at a relatively shallow depth beneath the patio and path, averaging in a band between 15-50cm deep. Given the standard construction of domestic patios and path and the proximity of the planted shrub bed*

- iv. *"The consistently shallow nature of the on-site roots in scan series 0001 and 0002 also indicate that the roots detected are unlikely to have been forced beneath the footings of the boundary wall, especially when compared to the depths found beneath the footpath. In this situation the wall appears to have formed a physical barrier to root growth."* N.B scan line series 0001 and 0002 refer to scans within the patio area and within the garden path
- v. *"The trees are rooting well within the public highway, extending beneath the footpath and beneath the road, extending to the north and south within the pavement as is evident from the deflection of the surfacing."*

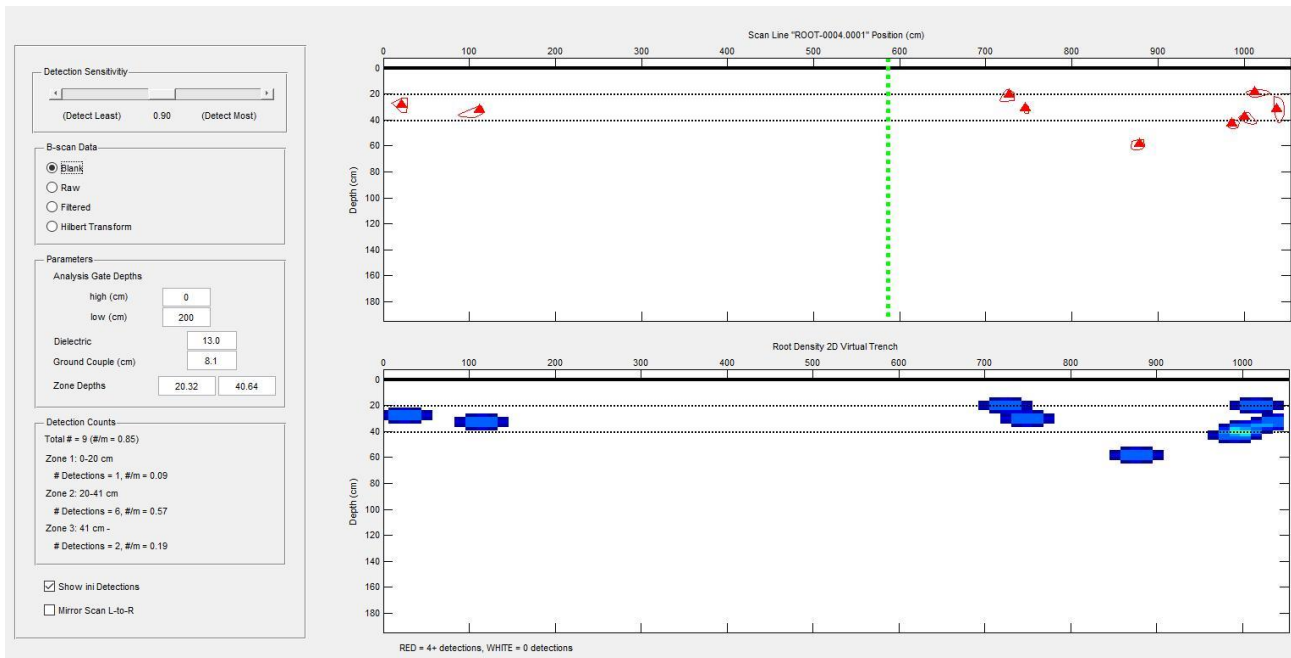
Scan line 0004.0001 in the footpath 0.5m from the western boundary wall and parallel to it.

6.10. The findings of the TreeRadar report were that, although the excavation is within the theoretical RPAs of trees T9 and T10, the footings of the boundary wall and the previous building's basement level have provided a physical barrier to tree root encroachment of the street trees into the site, and that the low density of roots found beneath the footprint of the proposed new structure were associated with the on-site trees and shrubs. This is shown when the depth of roots beneath the footpath (20-60cm on average) is compared with the rooting depth beneath the patio area (15-50cm average) as it is highly unlikely that the roots will have grown straight down beneath the footings of the substantial boundary wall and then come straight back up and levelled off. Were roots found at depths of 50-100cm deep beneath the patio, these roots would be far more likely to be associated with the off-site trees, but this is not the case.

6.11. Although the results of the TreeRadar show it is unlikely that roots of T9 and T10 extend beneath the footprint of the proposed basement and extension, the excavation for the top 1m of soil will be undertaken under arboricultural supervision and if roots from T9 and T10 are found, these will be pruned only where appropriate and necessary. The edge of the excavation will be lined with impermeable plastic sheeting to prevent alkali burn to any roots in surrounding soils from the use of concrete. The impact of these works is reduced even further by the cyclical heavy crown reduction works undertaken on the trees.

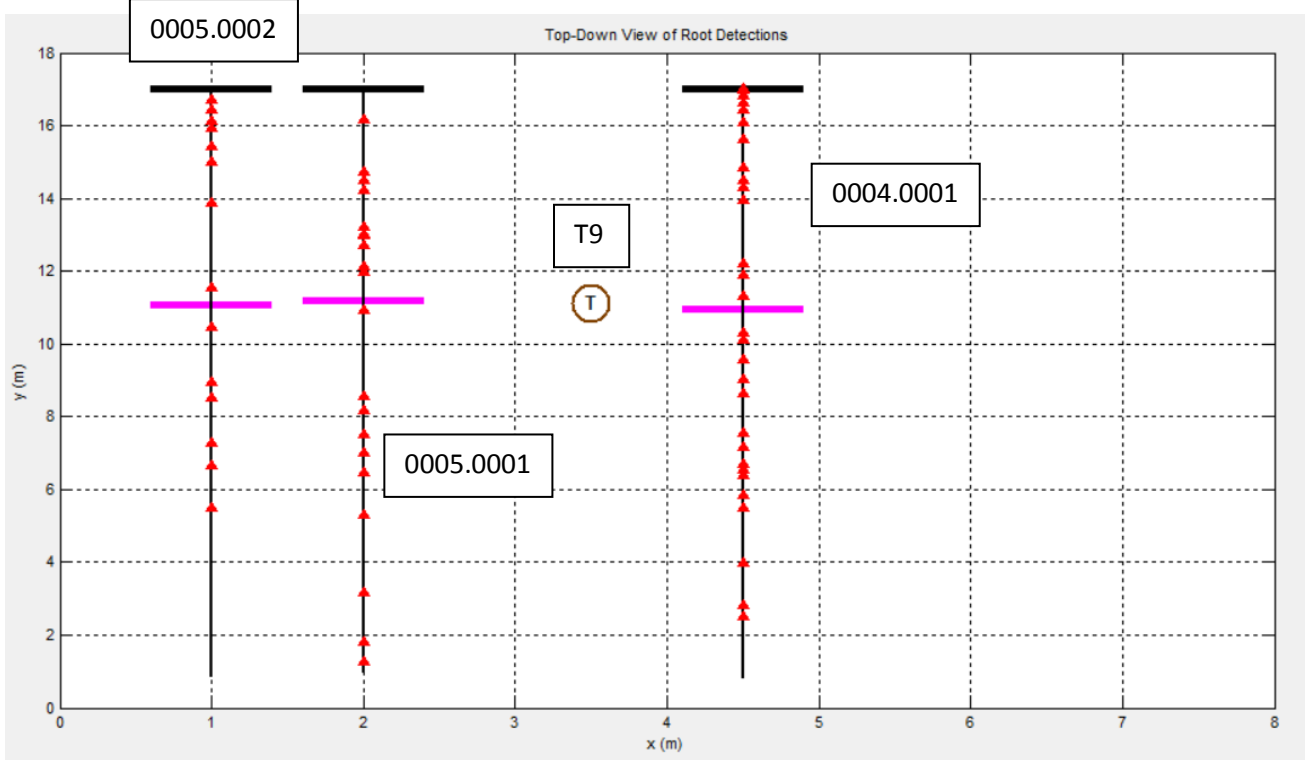
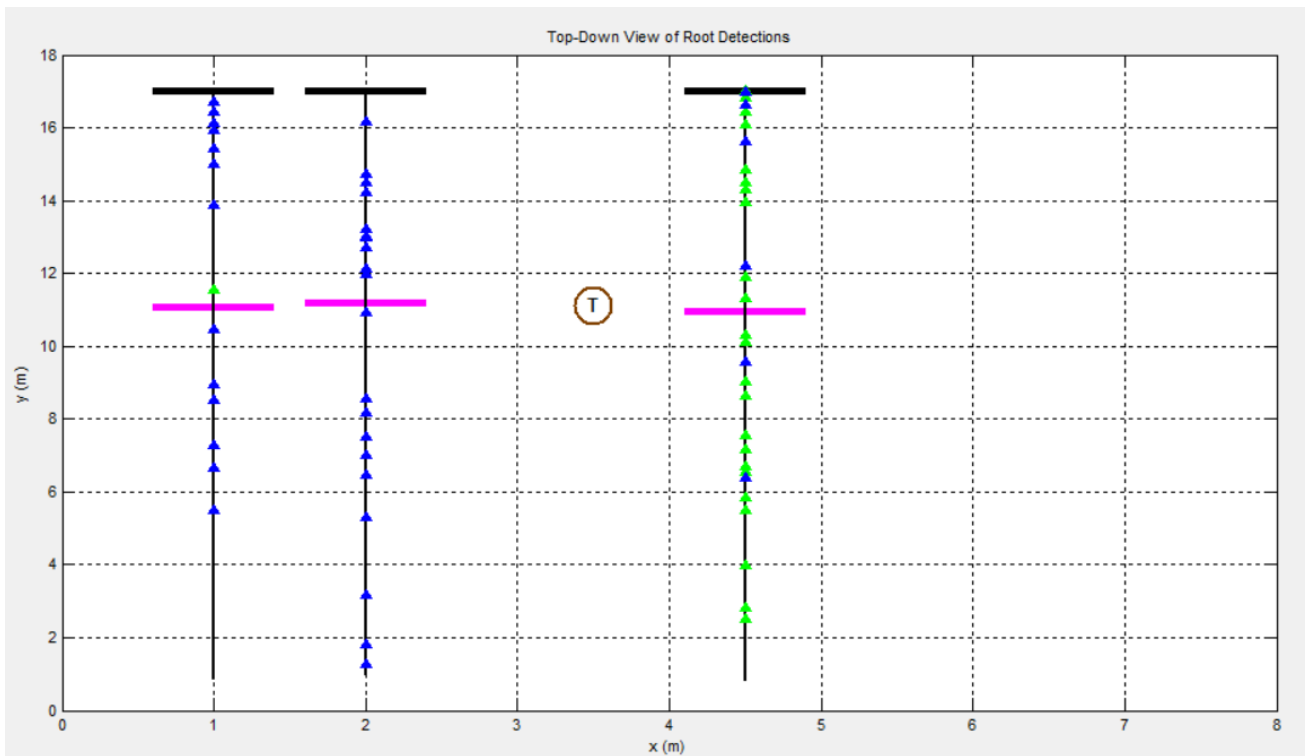
SCAN LINES 0004.0001 AND 0005.0001-0002 - ROOTS (WITH A DIAMETER GREATER THAN 20MM) AT ALL DEPTHS

4.4.1. Results: Roots are found in an overall low rooting density but in very uneven distributions along all of the scan lines, with areas of higher rooting density found at the start of the scan lines closest to T10, and either side of the point at which the lines pass T9. Within the footpath the roots are found in a band between 25-60 cm deep, with a few shallower roots visibly causing slight lifting of the surfacing, while beneath the road the roots are found predominantly between 70-120cm deep.
